## Cottonwood Creek Fish Habitat Assessment - Level 1

December 16, 2024

Prepared by:  
Masse Environmental Consultants  
812 Vernon Street  
Nelson, BC, V1L 4G4

Project Number 2024-1153

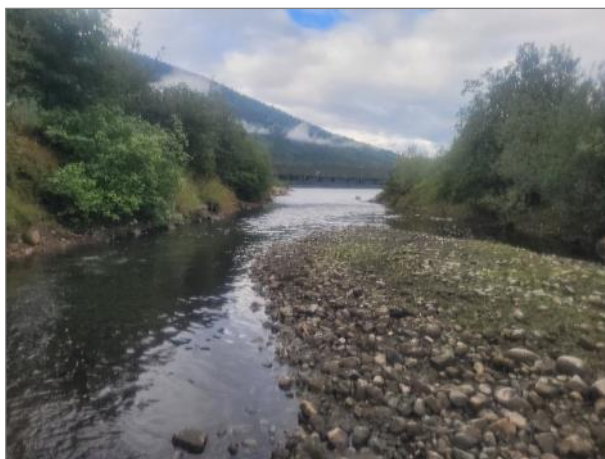
Photo 1. Looking down R1-S1 1 to Kootenay Lake. Area affected by lake levels.

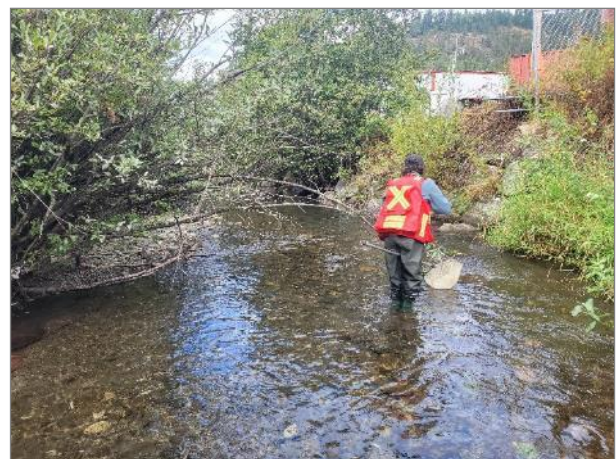
Photo 2. Upstream view of the upper portion of R1-S1, with riprap on the south bank.

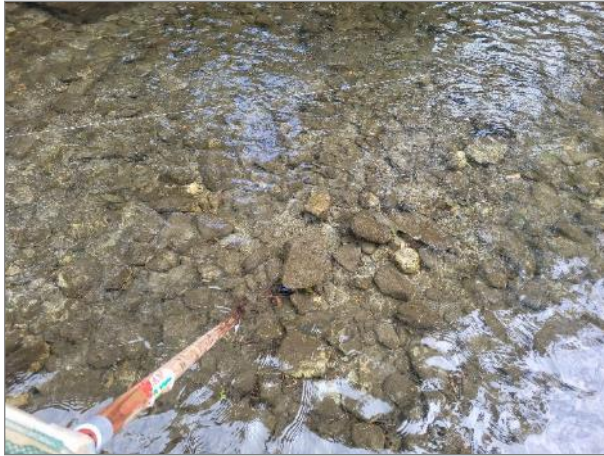
Photo 3. Embedded cobble and gravel substrate.

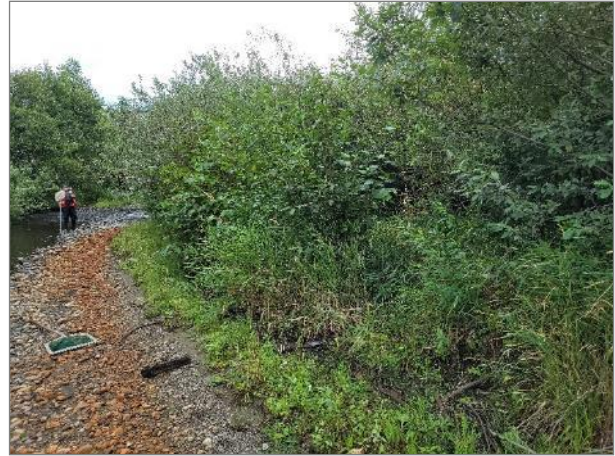
Photo 4. Swamp-like habitat on the south bank.

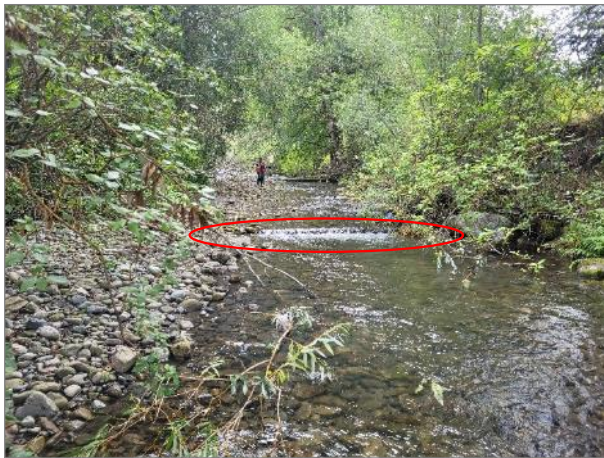
Photo 5. Representative photo of the lower portion of R1-S2, with an installed sill log. Facing upstream.

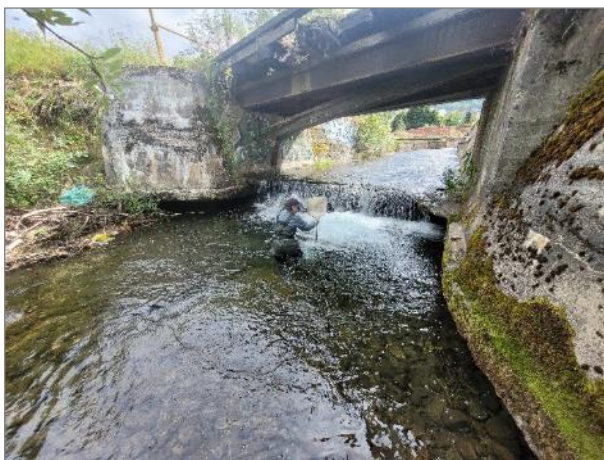
Photo 7. Plunge pool at the upstream end of R1-S2 formed at the outlet of a concrete flume.

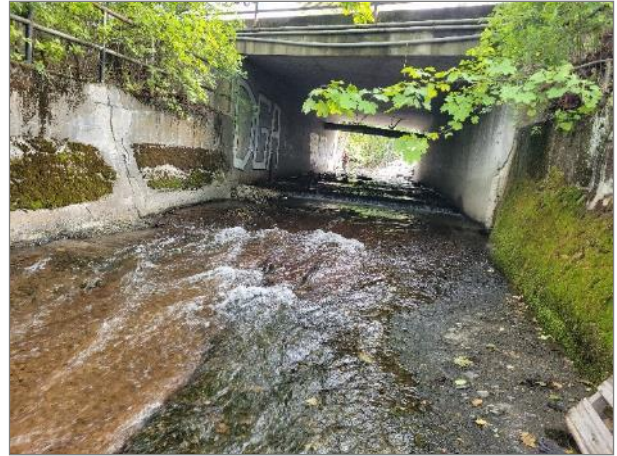
The drop at the outlet of the flume presents an obstacle to upstream fish migration, particularly for smaller fish and during low flow conditions (Photo 12). Smit (2014) suggested that the flume itself is likely only passable during freshet conditions (i.e., when water is high enough to permit upstream migration), and that water velocities and lack of areas to rest within the flume likely restrict upstream travel to larger fish during a short period during freshet. Habitat within the flume is considered poor due to shallow water depths and lack of complexity, except for the small pool areas mentioned above. Our sampling documented Rainbow Trout within this site, nearly all of which were captured in these pools. No natural LWD was present, though the portion of the flume under the Baker Street bridge had steel baffles which functioned as LWD (Photo 10).

Photo 10. Representative photo of flume under Baker Street bridge, with steel baffles on bottom.

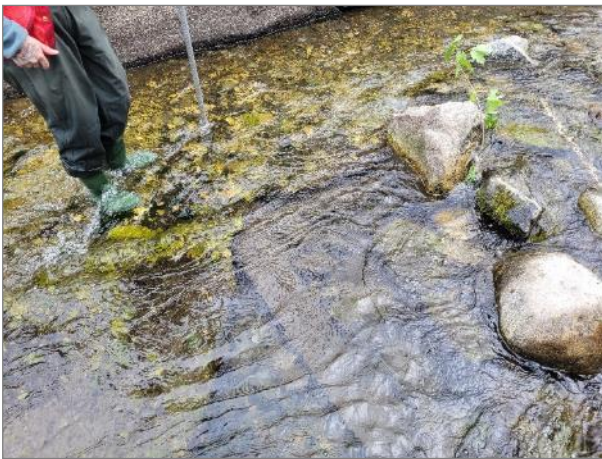
Photo 11. Example of a small pool formed where the concrete bottom of the flume had worn away.

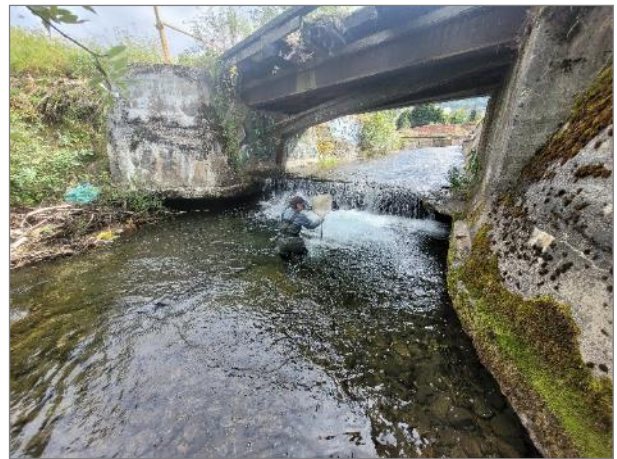
Photo 12. Obstacle to fish passage at flume outlet.

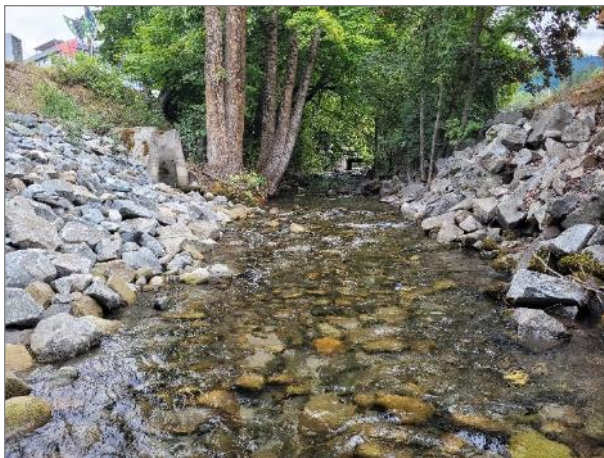
Photo 13. Riprap armoring on both sides of channel, just upstream of Baker Street Bridge.

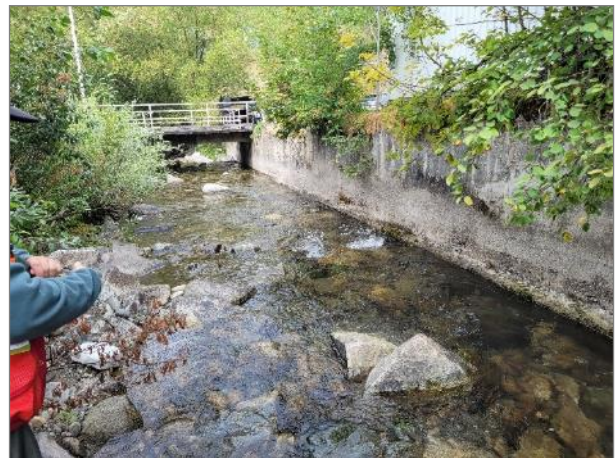
Photo 14. Concrete wall on east bank of the creek within R2-S2.

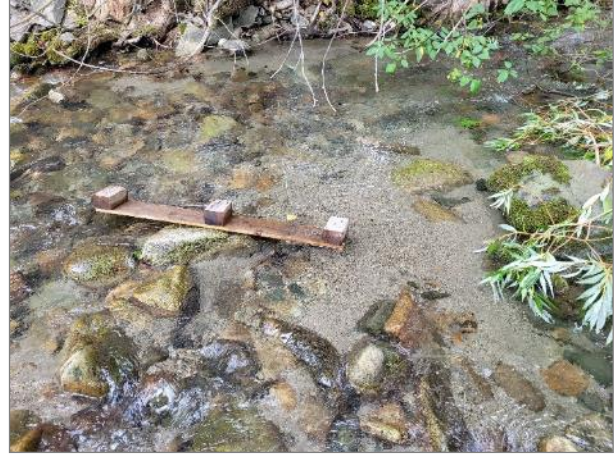
Photo 16. Substrates embedded with sand just downstream of a storm outfall.

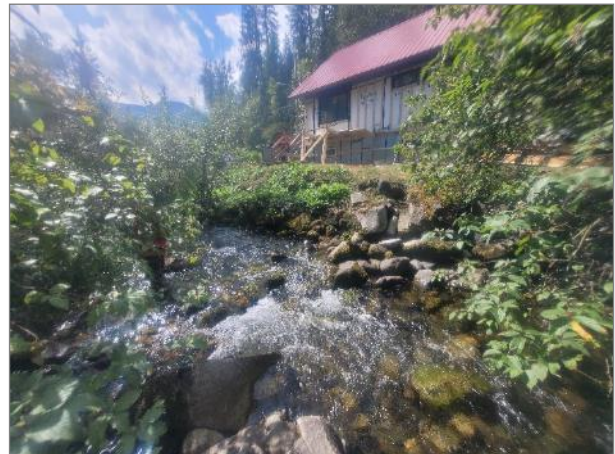
Photo 18. Residential lawns on the west bank of the creek. Photo taken facing upstream.

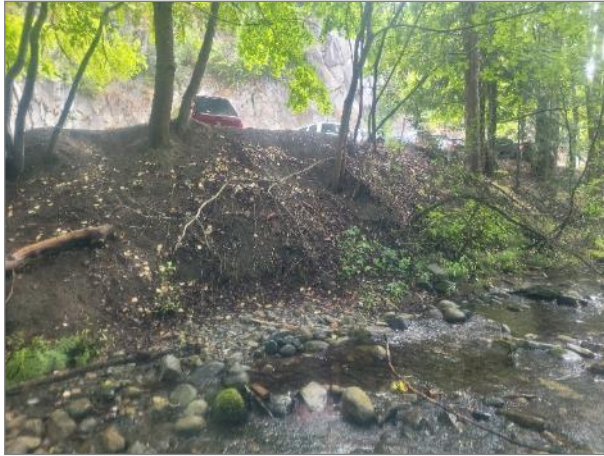
Photo 19. Section of eroded bank just below Hwy 6 Park and Ride.

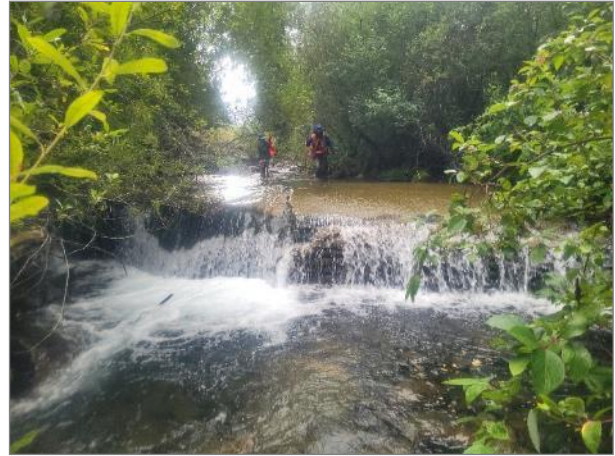
(Habitat Wizard, 2024). A constructed dam/platform created from concrete sandbags ~ 110 m upstream of Perrier Road creates a small set of falls (~ 0.9 m high; Photo 20). At the top of the falls, only ~ 10 cm of water was flowing over an ~3 m long section of concrete. The combination of the falls and shallow water at the top creates a barrier to fish passage during low flow conditions, and potentially during higher flows for smaller fish. This section of creek provides moderate quality rearing and overwintering habitat for resident Rainbow Trout. A moderate amount of cover was provided by overhanging vegetation, boulders, and pools. Boulders also provide good cover and refuge habitat for fish during high water flows. Twenty-two pieces of functional LWD were present. Spawning potential is poor, given the general lack of suitable spawning substrate.

Photo 20. Small falls created by a constructed dam/platform at the upstream end of Site 5.

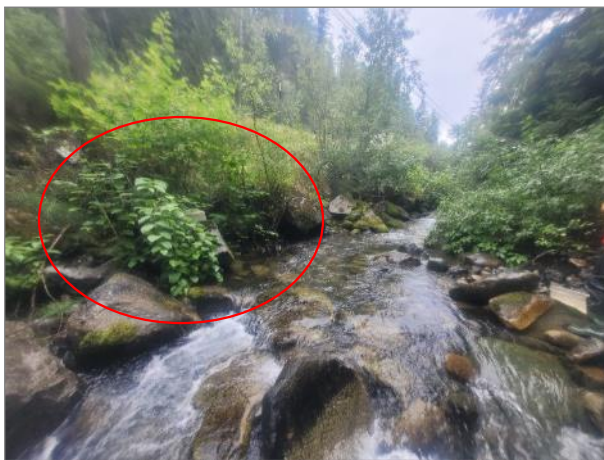
This area was markedly steeper than downstream sections, with an average gradient of 9.0%. Correspondingly, most of the habitat was cascades, with a trace amount of pool habitat units (i.e., 2% of the overall bankfull habitat). Flows were generally quite fast, and several sections of eroded bank and one LWD jam was noted in this section (Photo 23). Bankfull widths ranged from 4.3 – 11.0 m, and wetted widths ranged from 4.6 – 7.9 m at the time of the assessment. Substrates were predominantly boulders and cobbles, with trace amounts of gravel in stream margins. Riparian cover was generally minimal (usually less than 20% canopy closure), generally limited to narrow strips of young mixed forest and shrubs along the top of bank. One area of invasive Japanese knotweed (*Reynoutria japonica*) was noted on the Highway 6 road shoulder ~150 m downstream of upper Perrier Road/Highway 6 intersection (Photo 21).

Photo 21. Upstream view of a section of R3-S2, with the road shoulder of Hwy 6 located at top of bank. Patch of Japanese knotweed is circled.

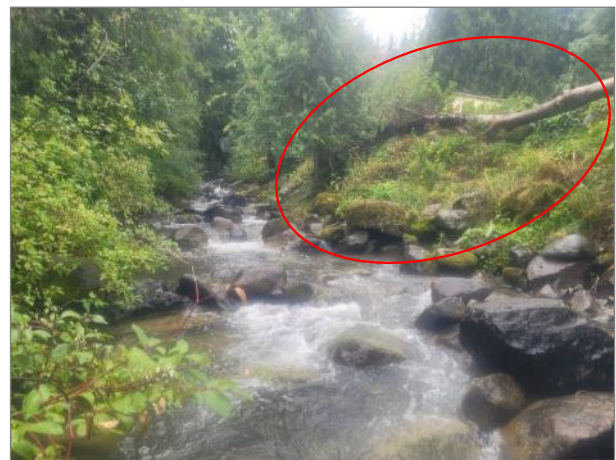
Photo 22. Riparian vegetation removal and relic riprap armoring on the east bank of R3-S2.

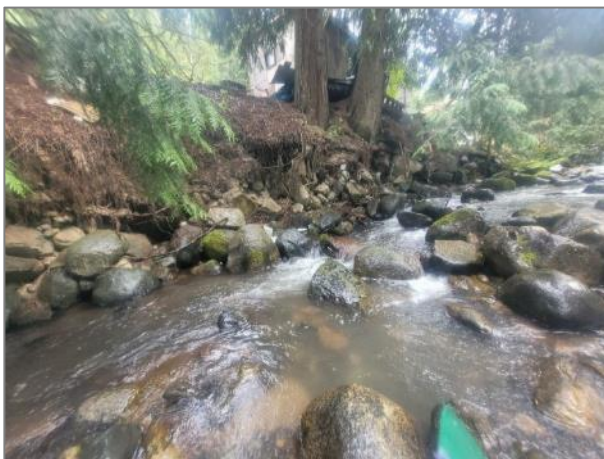
Photo 23. Section of eroded bank below a shed and driveway on residential property.

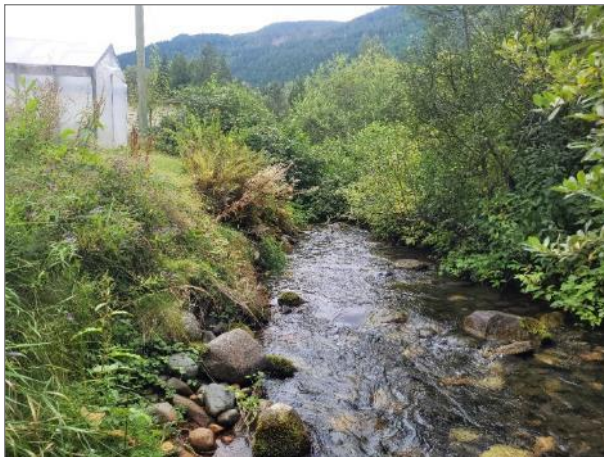
Photo 25. Residential property with channel armoring on east bank of Cottonwood Creek (facing upstream).

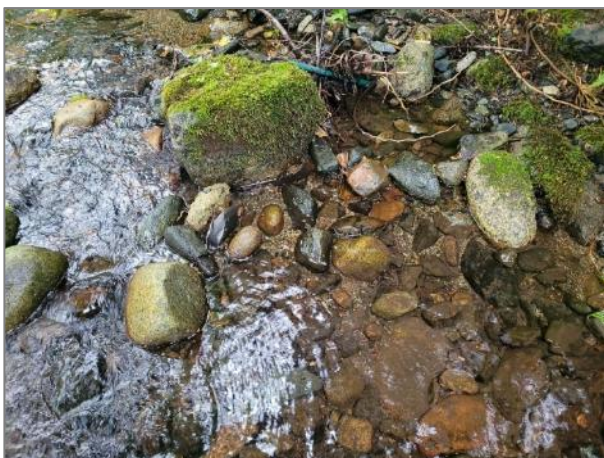
Photo 27. Embedded gravel and cobble substrate.

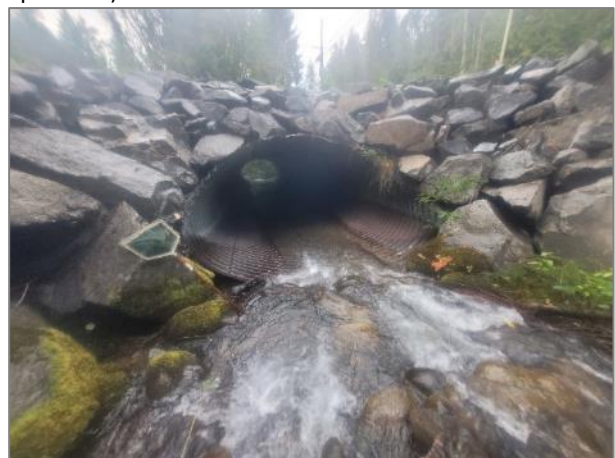
The culverts at the upstream and downstream ends restrict upstream fish migration during low flow conditions, and likely to smaller fish under all flow conditions. The corrugated steel pipe culvert under Kline Road is 24 m long, with a gradient of 2%, and is not embedded. This was assessed as a barrier by Silvatech (2014). At the time of our survey, there was approximately 10 cm of water in the culvert, and a 0.15 m drop from the culvert outlet to the plunge pool (Photo 28). The culvert under Highway 6 is a 50 m long concrete box culvert, with a gradient of 3.5%. The culvert was not embedded, and only had about 5 cm of water flowing through it at the time of the survey (Photo 29). Additionally, a trash rack at the upstream end of this culvert collects debris that may further impede fish passage through the feature. This feature was considered an obstacle to fish passage (i.e., passable under some conditions) by Silvatech (2014). Additionally, we noted several small constructed “weirs” next to residential properties in this section where property owners had apparently stacked natural substrates to create a dammed pool next to their property. Some of these were constructed across the entire stream channel (Photo 30) and were considered potential barriers to upstream fish movement during low flow conditions.

Photo 28. Upstream view of culvert outlet under Kline Road.

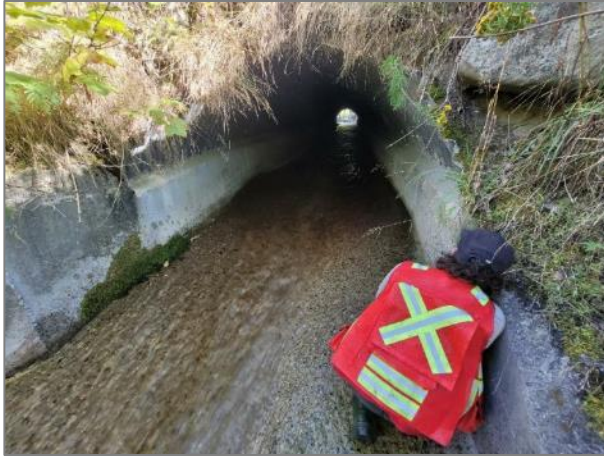
Photo 29. Culvert under Hwy 6.

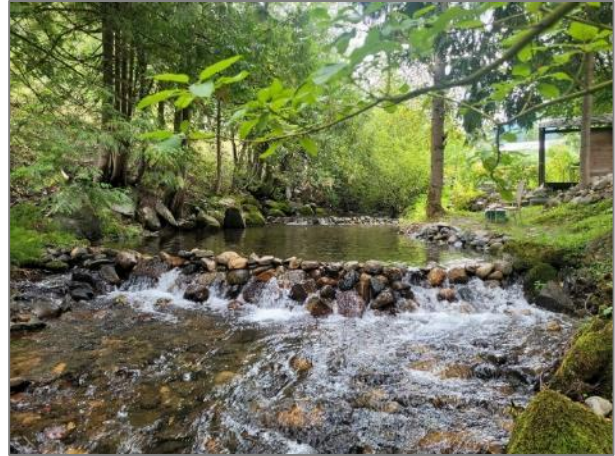
Photo 30. Constructed dam next to a residential property forming a fish barrier during low flow conditions.

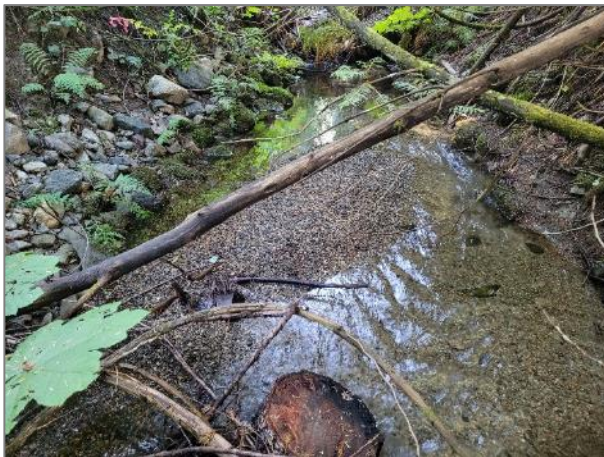
Photo 37. Accumulated sands and gravels at the base of the rail trail bed in Site 10.

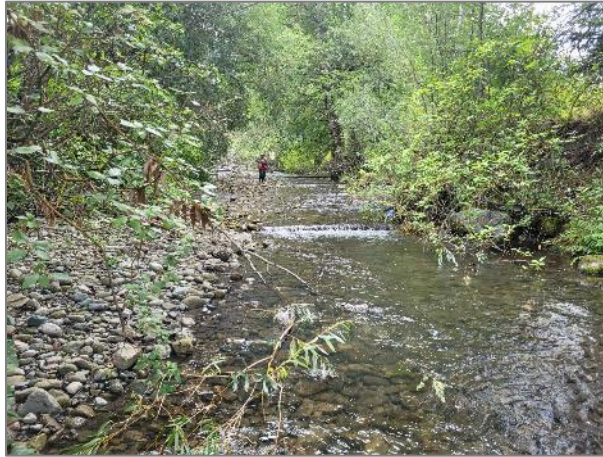
Photo 39. Site proposed for restoration in R1-S2.

To rehabilitate this habitat, restoration measures should focus on adding instream structures that improve habitat complexity and promote natural scouring and cleaning of substrate. This could include the placement of boulder clusters and LWD to create a more defined thalweg and create microhabitats that support various fish life stages. Boulders of varying sizes should be placed throughout the riffle section and arranged in clusters to create pockets of slower water and areas of turbulence. LWD or rock sills can be placed extending into the channel to create areas of slowed water flow and trap sediment, and to create scoured pools downstream. Retaining and enhancing suitable spawning gravels could also improve the habitat value of this area. Strategies could involve cleaning existing substrate, introducing new substrate materials, and/or ensuring that flow patterns are conducive to natural sorting, cleaning, and distribution of gravel substrates. Any introduction of spawning habitat in the lower reaches should be mindful of sedimentation concerns as previously documented, and restoration design should take sedimentation into account. Further studies are recommended to confirm that newly installed gravels would not be at risk of failing due to sedimentation. Additional riparian planting can also be undertaken on the banks or any created channel bars to further improve riparian habitat quality. Any plantings should include beaver protection given the beaver activity noted downstream during our assessment.

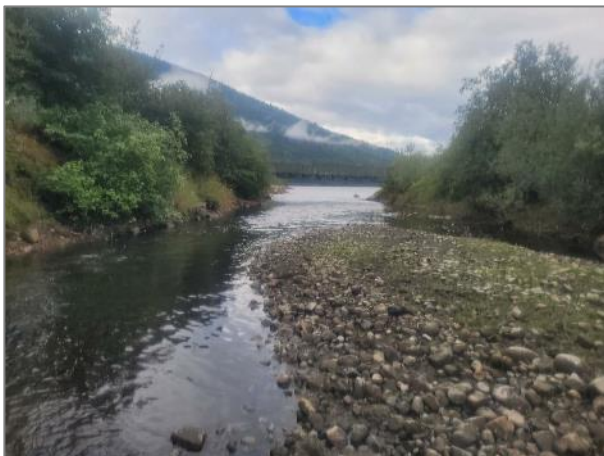
Photo 40. Site proposed for restoration in R1-S2

The area from the stream mouth to Lakeside Drive Bridge (Photo 40) could also benefit from restoring natural habitat complexity. While this area is also accessible to adfluvial fish, it is considered to be slightly lower on the priority list than R1-S2 as there is less existing riparian vegetation, and backwatering of this area during higher flows may inhibit the use by spawners. Nevertheless, this area can be improved for rearing and through installation of boulders and LWD as described above to create areas of refuge habitat and create a meandering thalweg. The mid-stream gravel bar could potentially be built up and revegetated with shrubs. As with R1-S2, any plantings should include beaver protection. It may also be possible to create a small side channel in the area of the swamp-like habitat (Photo 41) on the southwest bank to provide additional refuge habitat during higher flows.

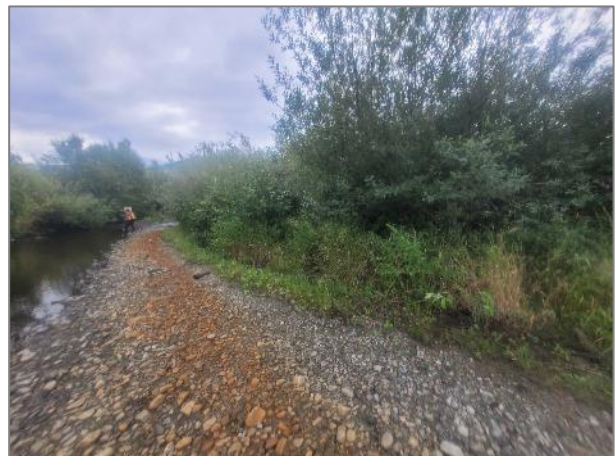
Photo 41. Swamp area on southwest bank of R1-S2 proposed for restoration.

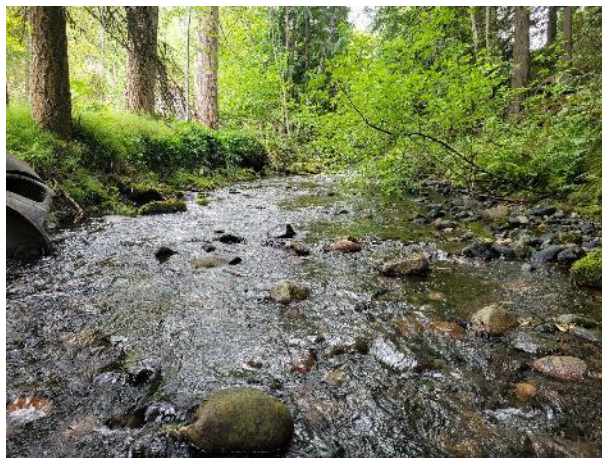
While areas of gravel substrate are present, they have been somewhat infilled with sediment. To enhance the habitat, we recommend creating a meandering thalweg through the channel to promote more natural flow dynamics and increase natural scour, which can help form pools that provide cover for fish. Scarification of the streambed substrates could be considered to temporarily improve spawning potential. However, this should only be done once the upstream sources of sediment are better understood and can be effectively managed to prevent future sedimentation issues.

Photo 42. Site proposed for restoration in R3-S2.1.

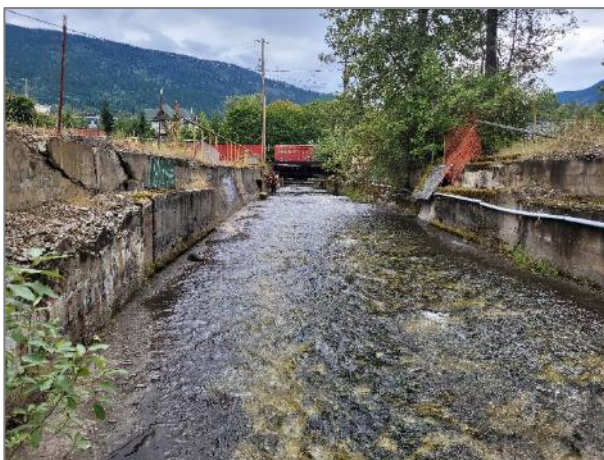
Photo 43. Concrete flume proposed to be replaced or enhanced.

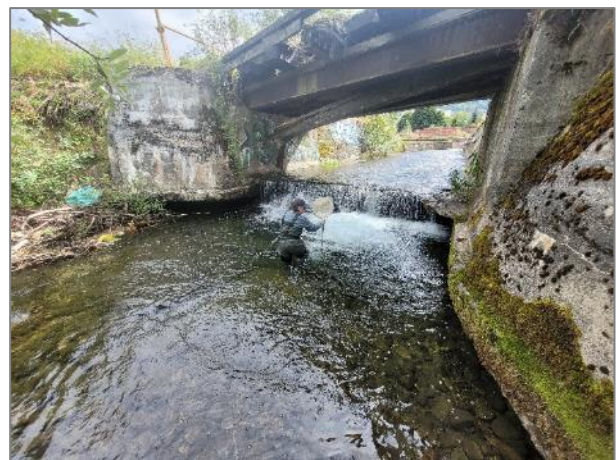
Photo 44. Drop at flume outlet.

If full replacement of the flume is not feasible, raising water levels at the outlet could mitigate the drop and reduce its barrier effect (Photo 44). Constructing a series of rock weirs leading up to the outlet can help elevate water levels effectively, and may backwater the outlet during lower flow levels. Ideally, the plunge pool habitat should be retained, as several fish were observed utilizing this pool. Concrete baffles could also be installed within the flume to enhance flow roughness and create areas of slower-moving water where fish can rest. However, these baffles should be considered temporary measures to dissipate flow energy until a more permanent solution is developed (WDFW 2003). If being considered, the installation of baffles should include a hydrological study to ensure that it would not impede the function of the flume. Adding baffles reduces hydraulic capacity, which often becomes a limit to flood capacity. The tendency for baffles to catch woody debris can also lead to reduced flow capacity. Increased riparian vegetation would also improve the habitat by providing more shade, nutrient input, and cover.

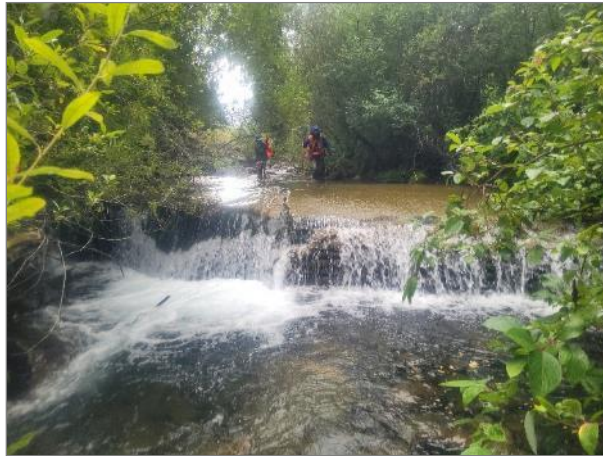
Photo 45. Constructed dam/platform proposed to be replaced with a weir.

This feature is identified as a priority for removal, as it is not associated with a stream crossing and would likely be relatively easy to remove (Photo 45). This feature should be removed and replaced with a series of rock weirs in the channel that provide fish passage over the elevation change. To the extent possible, weir installation should be done to incorporate deep pool habitat leading up to the feature.

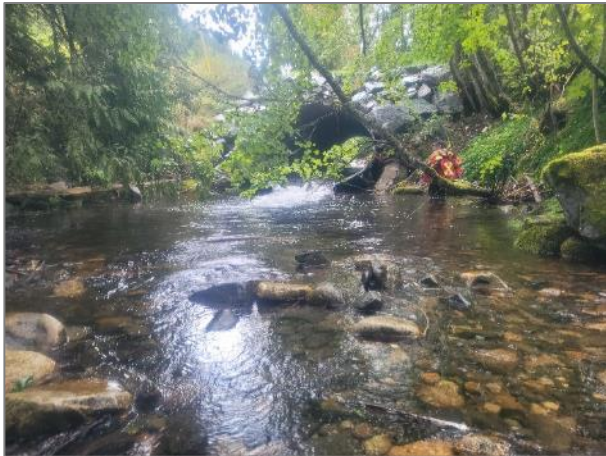
Photo 46. Proposed location for weir leading up to Kline Road culvert.

This feature currently presents a barrier to fish movement (Silvatech 2014) and prevents fish passage to higher quality rearing and potential spawning habitat upstream in R3-S2.1. Although full replacement with an open-bottom structure would be ideal, it may not be necessary. A rock weir can be constructed below the outlet to create backwater conditions at the culvert outlet, and baffles could be installed in the culvert to improve passage through the feature (Photo 46 and Photo 47). The weir should be constructed to maintain a stable water depth, ensuring that it does not obstruct flow, but allows for a gradual elevation change leading up to the culvert outlet.

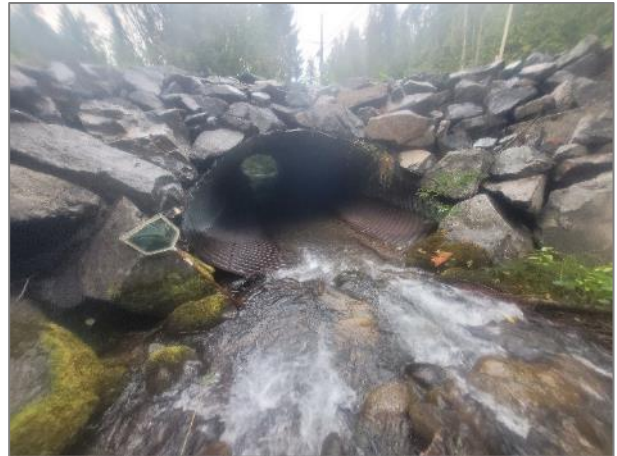
Photo 47. Kline Road culvert outlet.

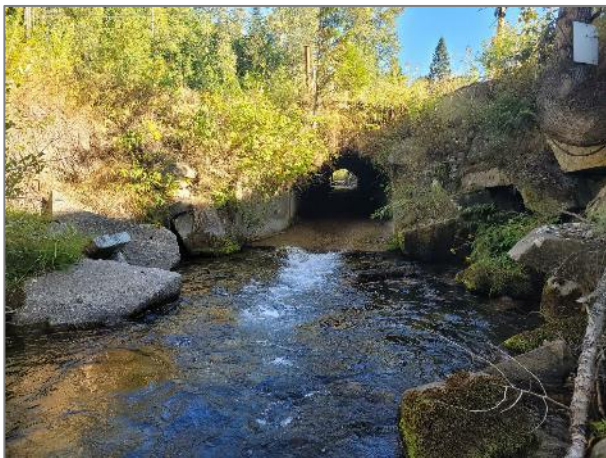
Photo 48. Proposed location for weir leading up to Highway 6 culvert.

Similar to the Kline Road culvert, full replacement of this feature with a more fish-friendly structure would be ideal, but this is complicated by costs and logistics associated with replacing a highway crossing. Full replacement may not be necessary. Construction of a weir or installation of baffles within the culvert are potential options to improve passage through the culvert (Photo 48 and Photo 49).

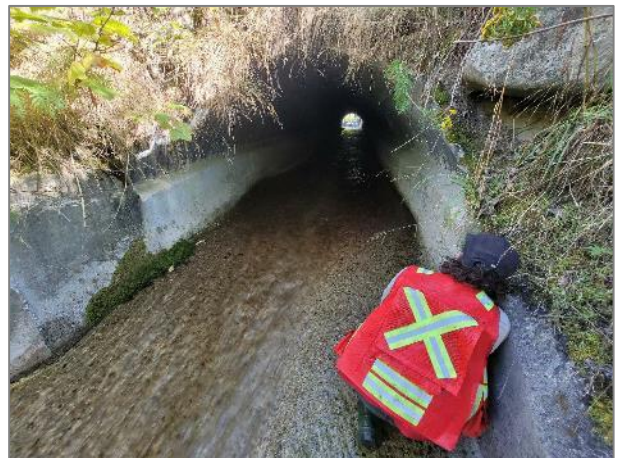
Photo 49. Highway 6 culvert.

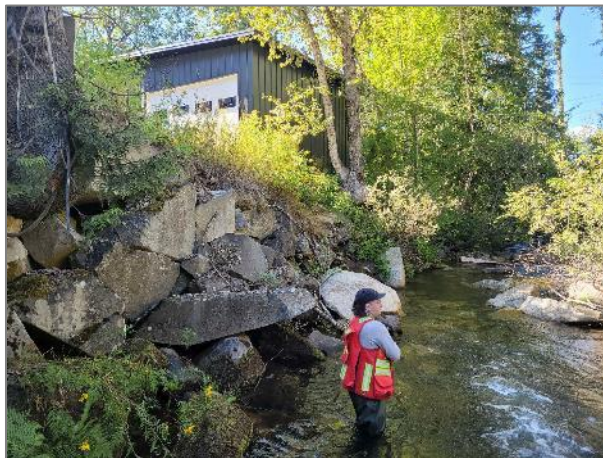
Photo 50. Example of an apparently recently constructed building located at the top of bank of Cottonwood Creek.

It is evident from this assessment that streamside development has negatively impacted both the instream and riparian habitat function of Cottonwood Creek in several areas. In many instances, these developments appear to have been completed prior to the establishment of development permit areas, and have been grandfathered in under the current OCPs. Nevertheless, some instances of recent development along top of bank were noted during our assessment, for which we could not find records of recently issued development permits (e.g., Photo 50). In order to avoid further cumulative impacts to Cottonwood Creek, it is crucial that these bylaws are properly enforced. Wherever possible, permitting for future redevelopment in riparian areas should encourage property owners to move development further from the top of bank and restore riparian areas.

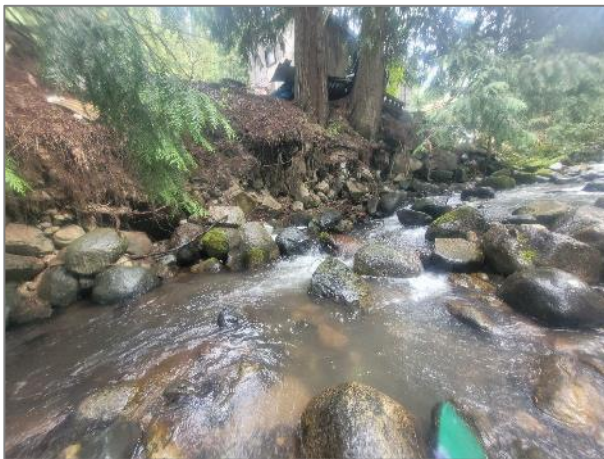
Photo 51. Example of debris and sheds on creek bank.

- **Restoration of riparian areas including replanting of riparian buffers, removal of debris and restoration of unused areas.** Several of the commercial and private properties along the creek (more particularly along sections R3-S1, R3-S2, and R3-S2.1) had minimal to no riparian vegetation, with lawns occasionally extending all the way up to the stream bank. Additionally, some properties had old debris and secondary structures (e.g. sheds, trailers) very close to top of bank that appeared to perhaps no longer be in use (Photo 51). Where possible, and where property owners are willing, we recommend removing some of these structures and debris, and replanting along the creek to a targeted *minimum* 3-5 m setback on the creek. Even a narrow strip of shrubs (e.g., willow or dogwood) along top of bank usually results in a notable increase in shade and cover (Photo 52).

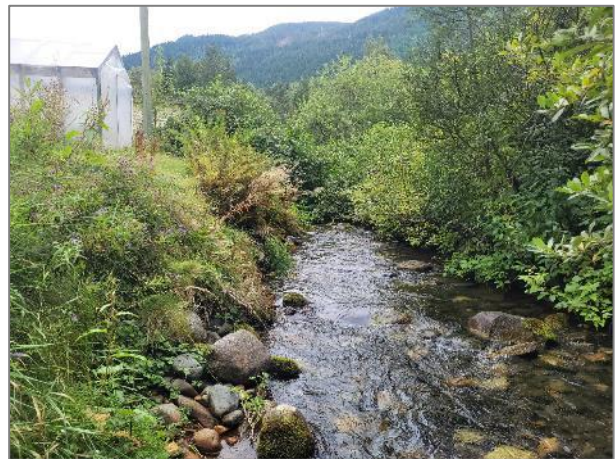
Photo 52. Comparison of cover provided by a narrow strip of shrubs (photo right) vs. a non-vegetated bank (photo left)
