Elk River Westslope Cutthroat Trout (WCT) Research Initiative: 2019 Report

Prepared by: The Elk River Alliance, Fernie, BC

Date: 28-06-2020

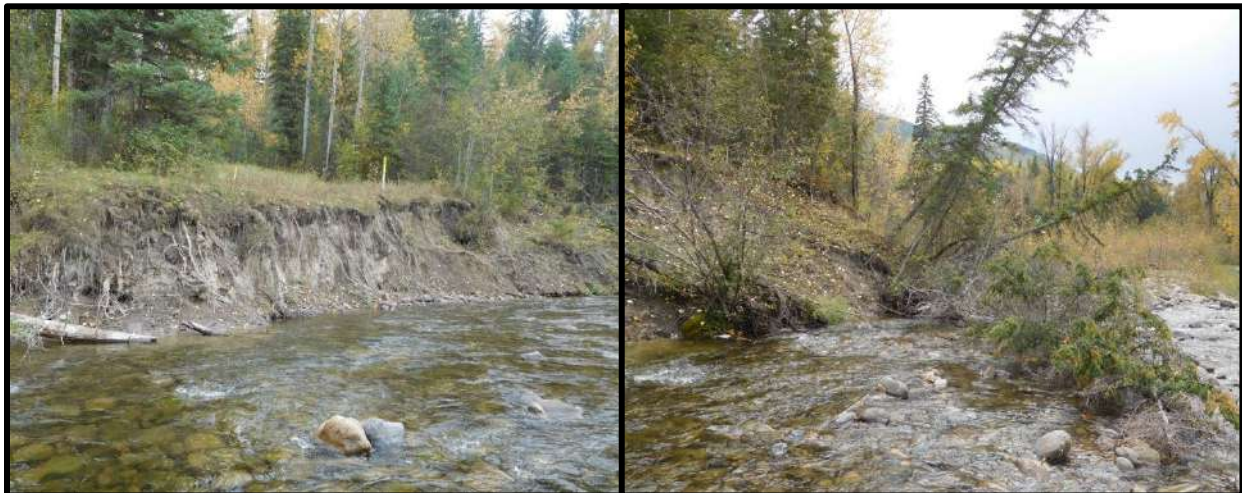
*Figure 15. Photos of HAMOR1 (Site #18) on Morrissey Creek.
Trees are seen falling into bank along a large section where the slope has failed.*

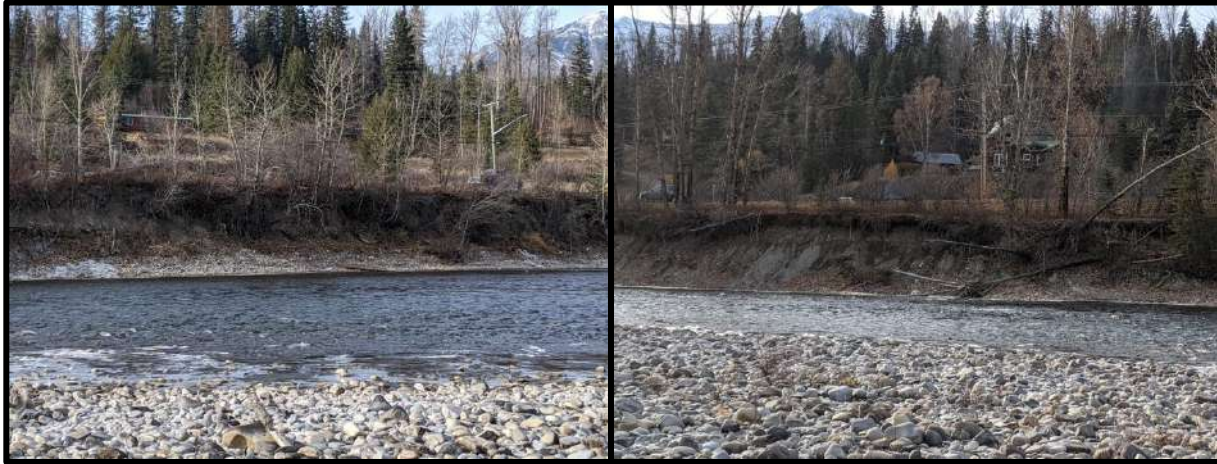
*Figure 24. Photos of HAELK03 (Site #7) on the Elk River.
These photos illustrate the long section of stream bank that is eroding into the river.*

and public outreach component. The City of Fernie may be interested in partnering on this project as a pilot project to test the viability of vegetative riprap along the Elk River.

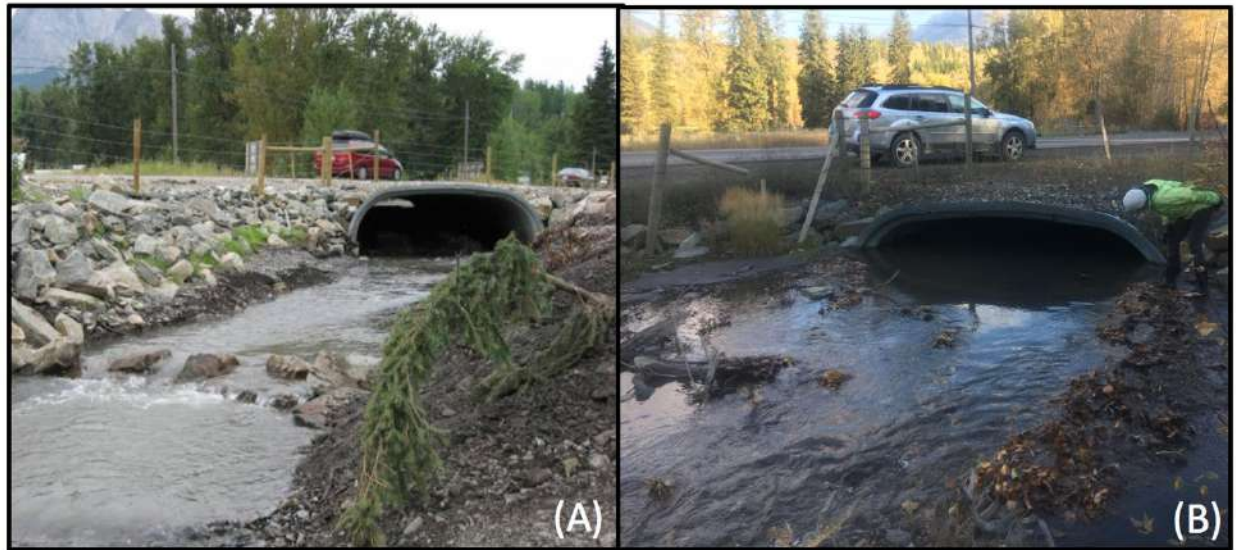
HAHAR01	Hartley Creek	49.54861	-115.01510	Culvert at site is collapsing and may pose a barrier to fish passage while being a potential hazard to the creek/highway. Rehabilitation requirements: Replacement of culvert. This would have to be done in conjunction with Ministry of Transportation/Main Roads to rectify constricted culvert.	67	23	34

Figure 25. Comparison of the Hartley Creek culvert at Highway 3 between 2007 and 2019. (A) 2007 (photo taken by Interior Reforestation Co. Ltd.) and (B) 2019. Note compression and infilling this culvert has undergone over the 12-year period.

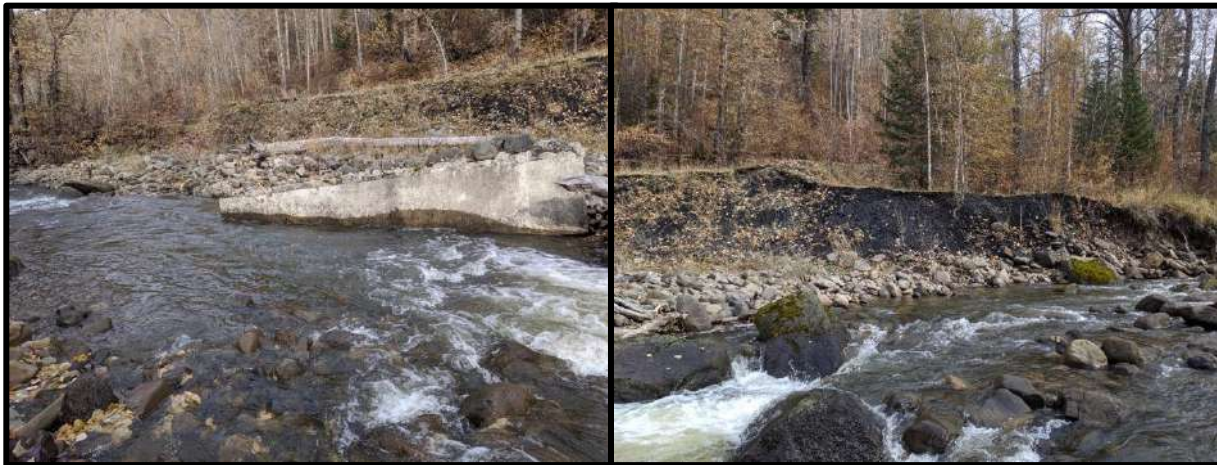
Figure 2. A historic bridge that collapsed into the stream can be seen altering the surrounding stream morphology. A failing bank can also be seen with invasive plants growing on it.

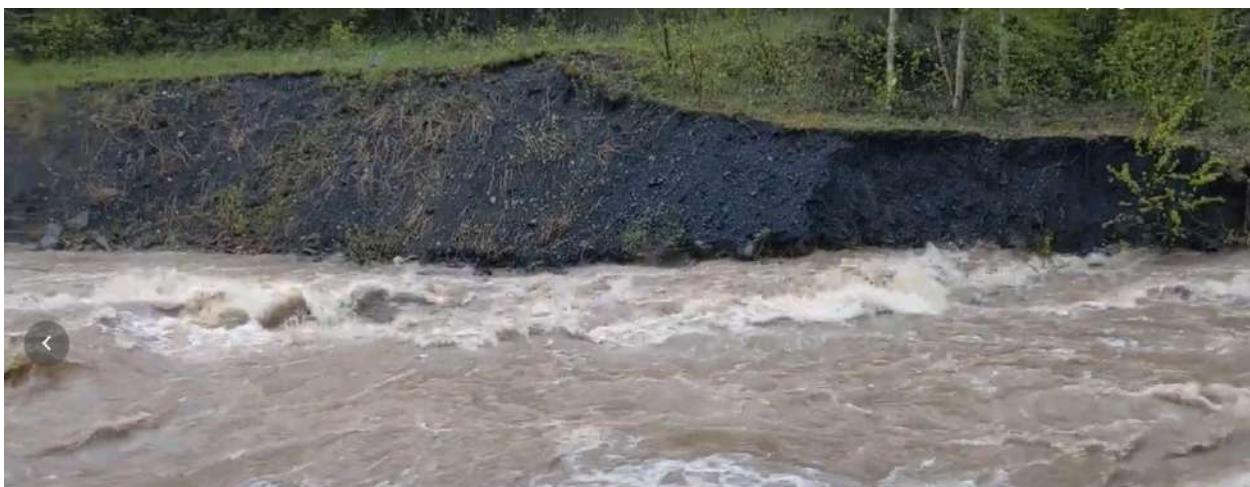
Figure 3: Same location as Figure 2 (right) during high flow event in June 2020. Note erosion at base of slope by high velocity water..

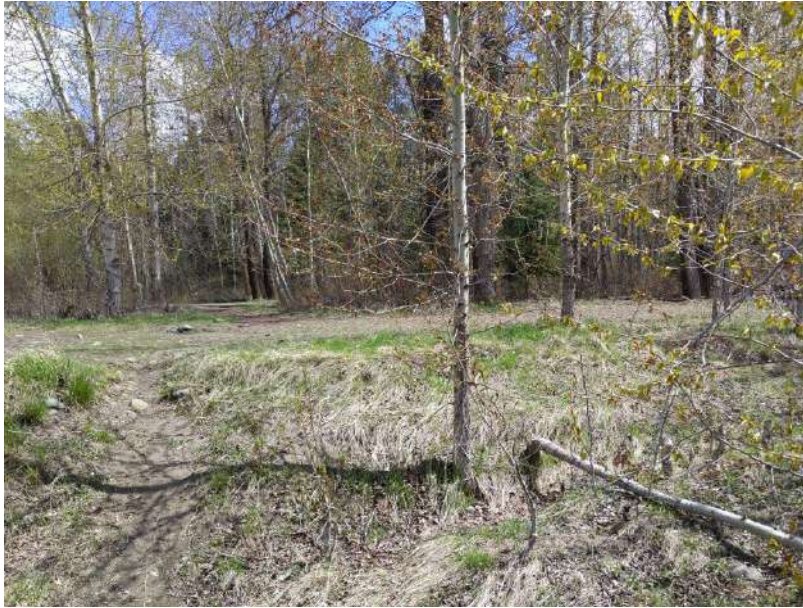
Figure 3: Riparian zone at mouth of Coal Creek. Note lack of understory vegetation and low density of cottonwood trees. Low native vegetation density encourages establishment of invasive species.

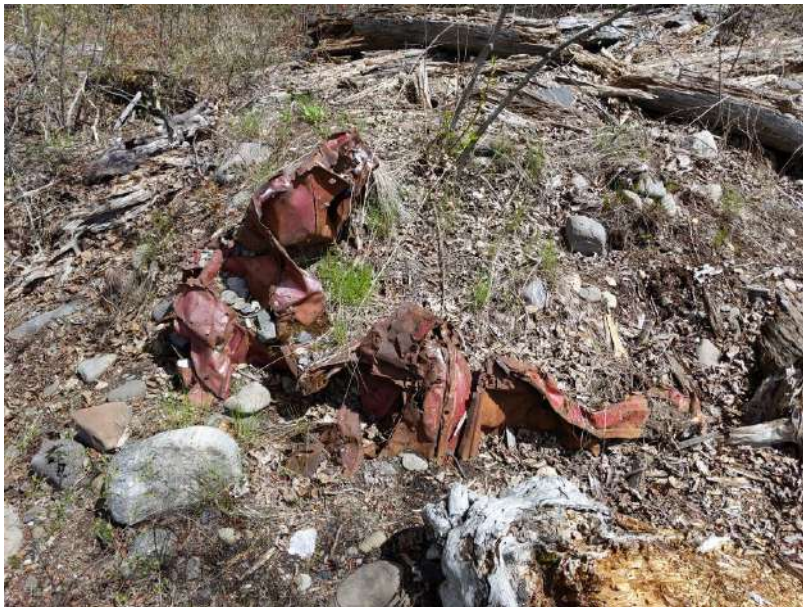
Figure 4: Large metal debris along Coal Creek.

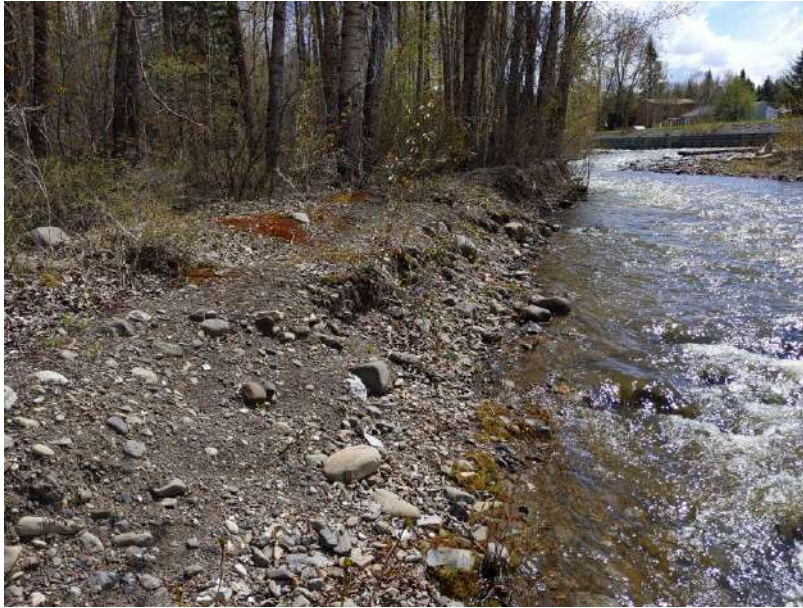
Figure 5: Bare riparian zone resulting from human access. Areas like this will likely wash out during high flow events, widening the watercourse.

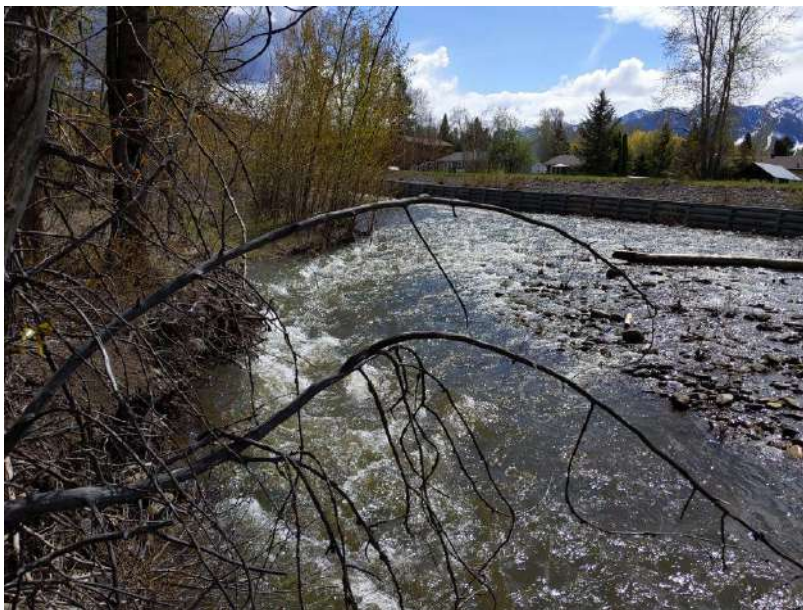
Figure 6: Rooted cut bank in adjacent to area shown in Figure 5. This bank is much more resilient to erosion, provides fish habitat, shades the water and slows water velocity during high water events.

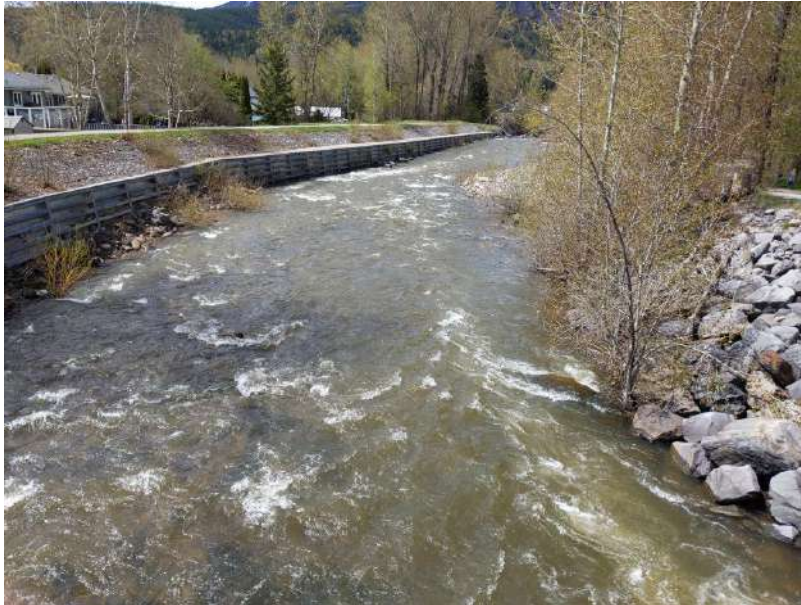
Figure 7: Metal siding (left) clads coal creek. While siding prevents erosion, it provides minimal habitat value or shading. On the right riprap can be seen, this also has minimal habitat value compared to the vegetated riparian zone seen downstream.

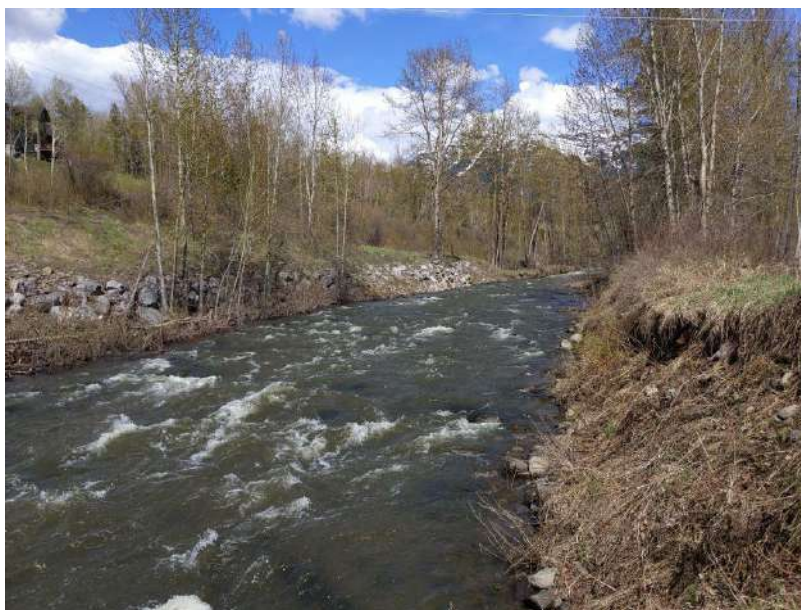
Figure 8: Weedy banks, riprap and low under/overstory vegetation on Coal Creek.

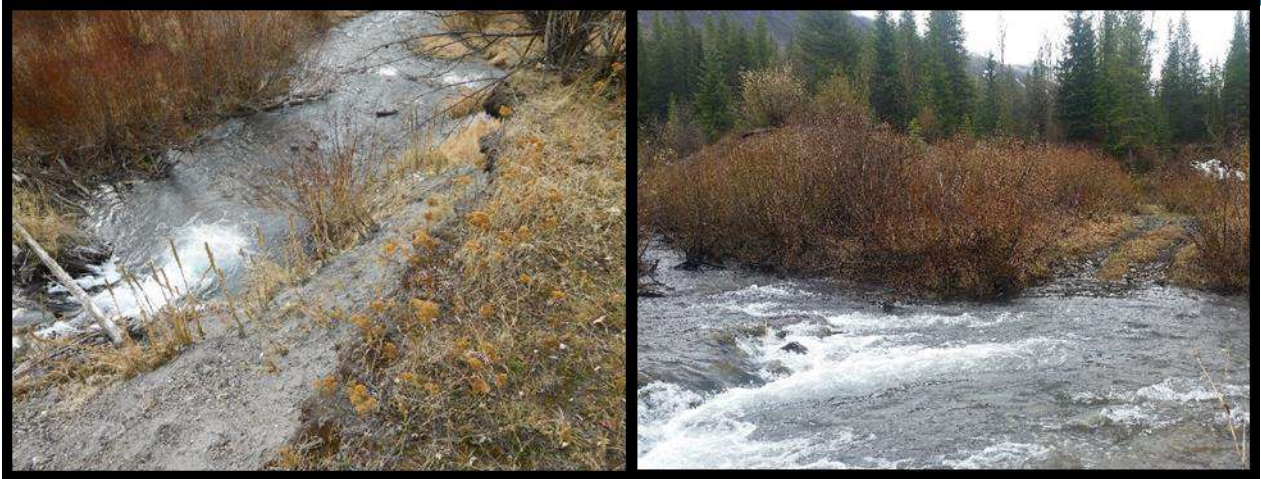
Figure 2. Photos of HACOR01 on Corbin Creek and the surrounding vegetation and nearby failing embankment.

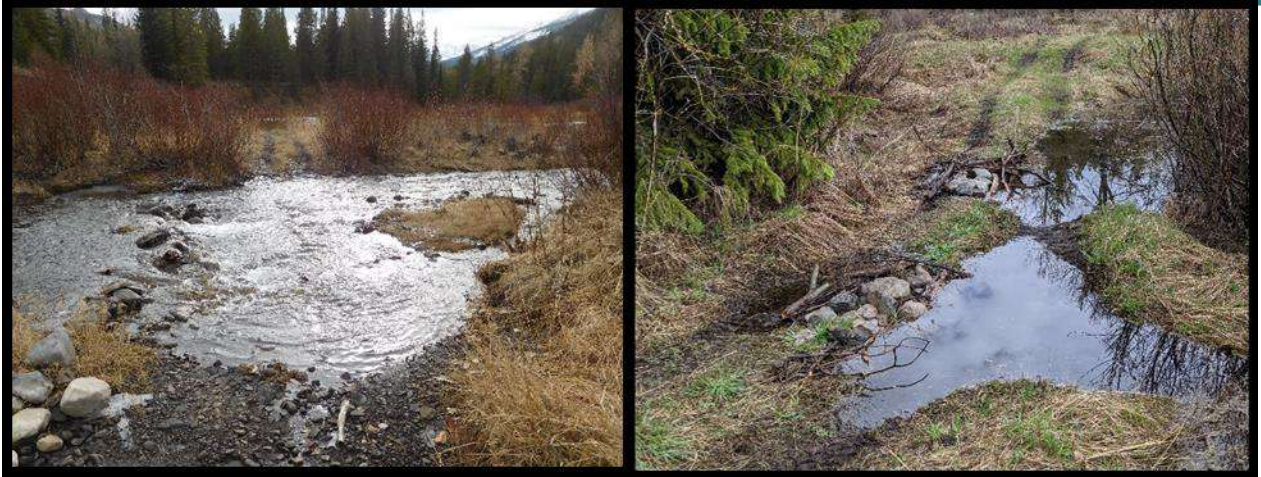
Figure 3. Photos of ATV tracks accessing and crossing Corbin Creek.

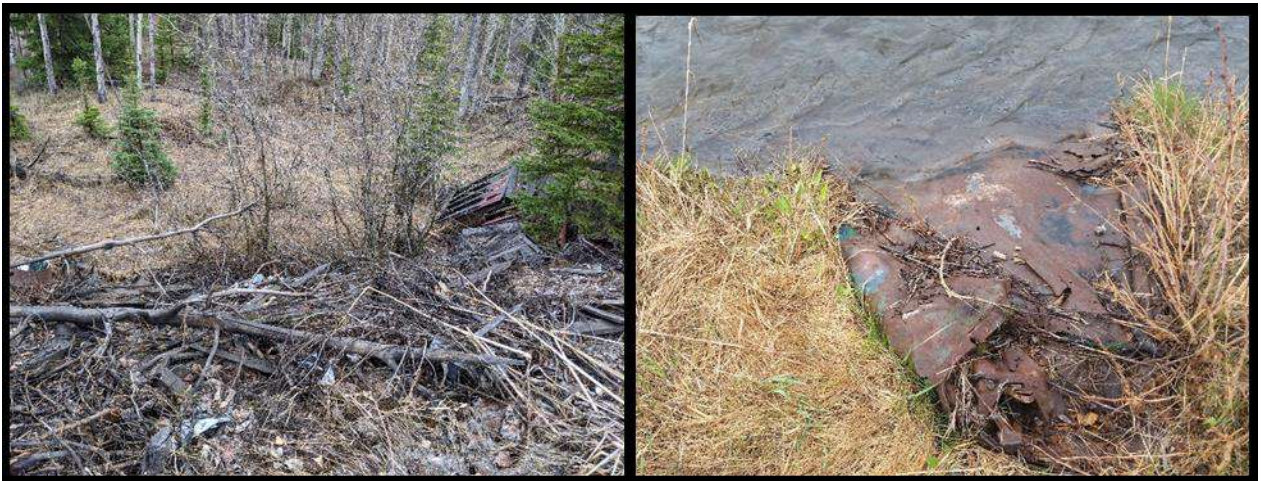
Figure 4: Metal debris at and within 50 m of HACOR01 on Corbin Creek.

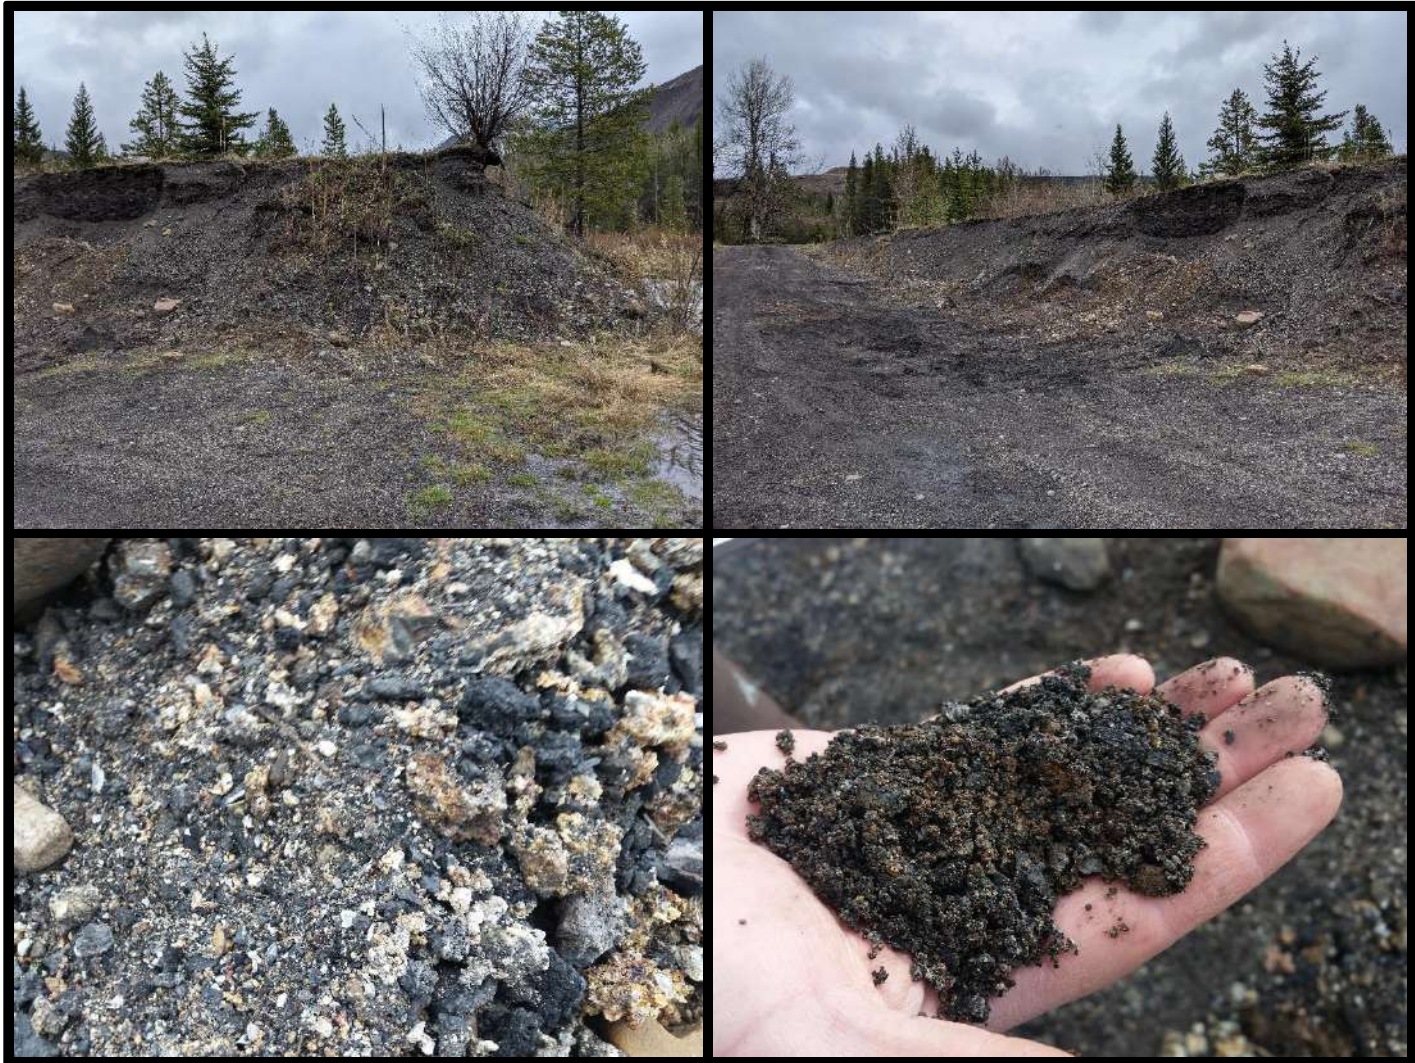
Figure 6: Failing abutment (top) and close up of abutment materials (bottom).
