**Windermere Lake
Foreshore Inventory and Mapping**

**Prepared for:
East Kootenay Integrated Lake Management
Partnership**

**Final Report
June 2007**

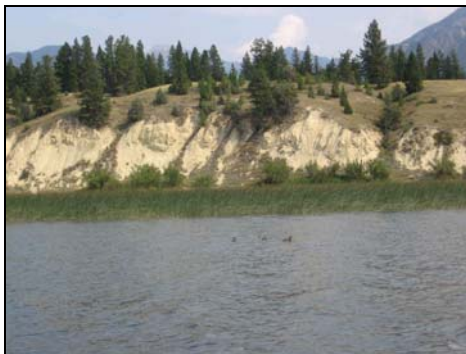
Cliff/bluff

Figure 3. Examples of predominant shore types along Windermere Lake.

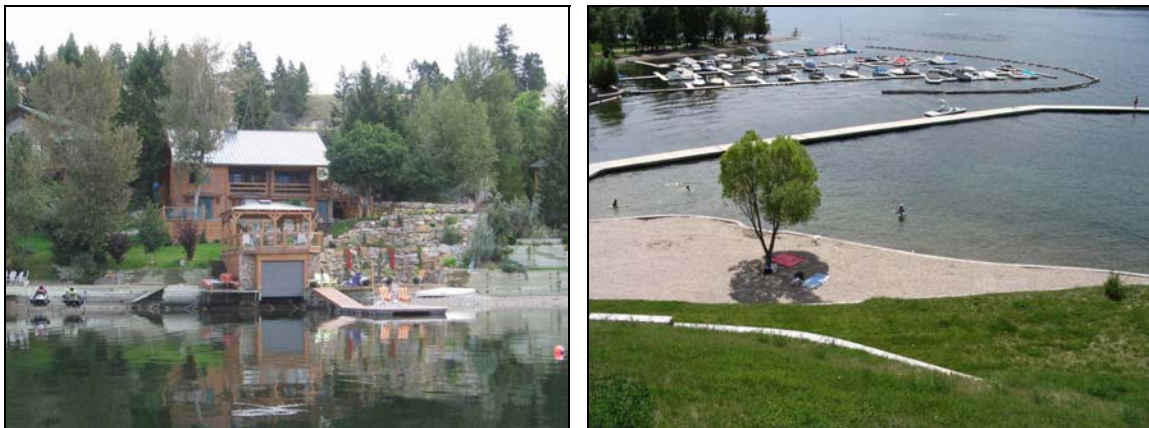
Figure 4. Examples of foreshore modifications along Windermere Lake, including boathouse, dock, retaining wall (left); and marina, dock and retaining wall (right, [photo provided by Wildsight]).

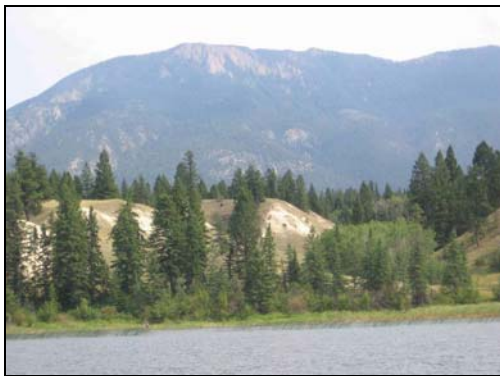
Low Level of Impact

Figure 5. Examples of low, medium and high Levels of Impact at Windermere Lake

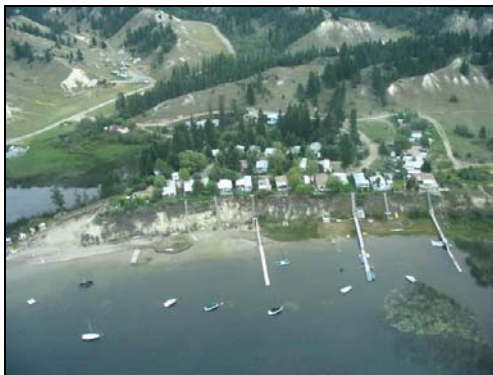
Segment 5

It is important to note that when Lol was determined for the foreshore areas of Windermere Lake, some areas were deemed to have a high disturbance level but an overall low Lol. This occurred mainly in Segments where the CPR was the primary Land Use Type, such as in Segments 11, 12 and 13. For these Segments, the railway was assessed to be a disturbance; however, the railway's presence did not affect the overall shoreline integrity to the same extent that other land uses, such as residential development would. Figure 16 portrays some examples of Segments with disturbance, but overall a low Lol.

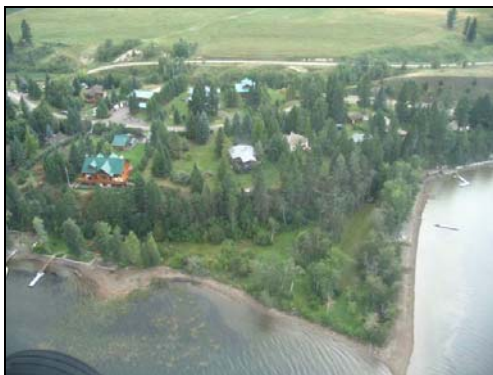
Segment 10

Segments with a medium Lol are dispersed around the lake, other than in the South East Segments. They include a variety of land use and shore types. Generally these Segments have been developed to some extent, but have not been disturbed as much (i.e. with shoreline modifications) or have not been developed as densely as those Segments rated with a high Lol. Figure 17 depicts example Segments with a medium Lol.

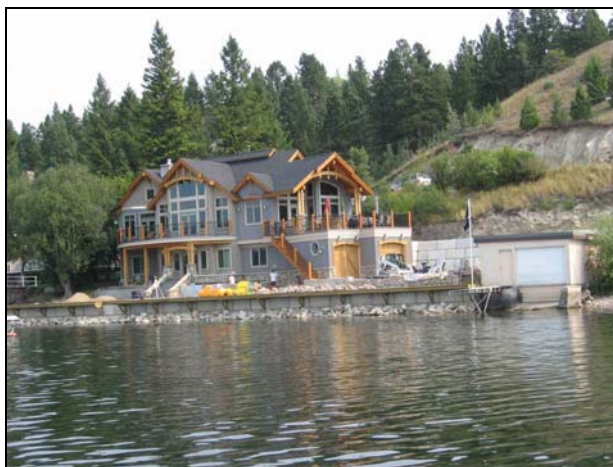
Figure 20. Foreshore modifications include removal of riparian vegetation, construction of retaining walls, docks, and boat houses.

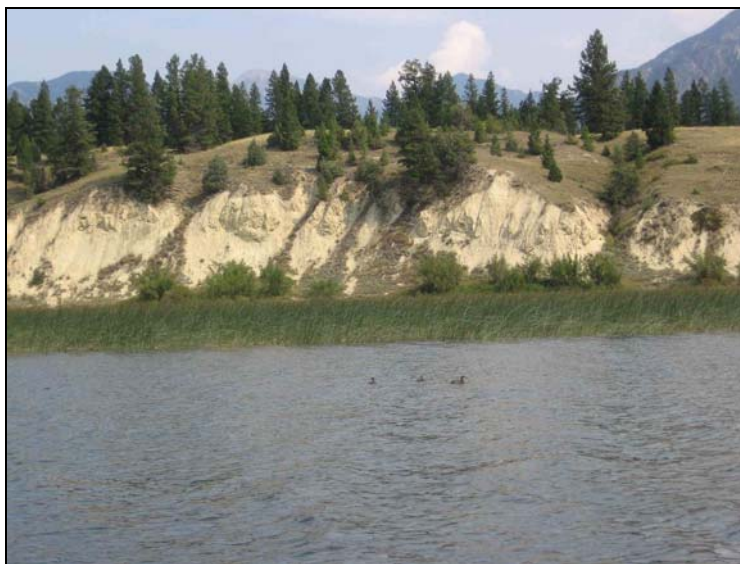
Segment 2 is located along Indian Reserve #3 and is in a natural condition. The shore type of this Segment is predominantly cliff/bluff (78%), with some vegetated shoreline area (12%). The riparian area is classified as a mixed forest, provides moderate cover, and is dominated by tall shrubs. There are some snags in this area (≥ 5). Sixty-two percent of the aquatic area contains submerged vegetation and 38% contains emergent vegetation. Swallow nests are evident in the banks, and turkey vultures and grebes were sighted during the field review.

Figure 1. Segment 2 is undisturbed, is mainly cliff/bluff shoreline, and has an abundantly vegetated littoral area.

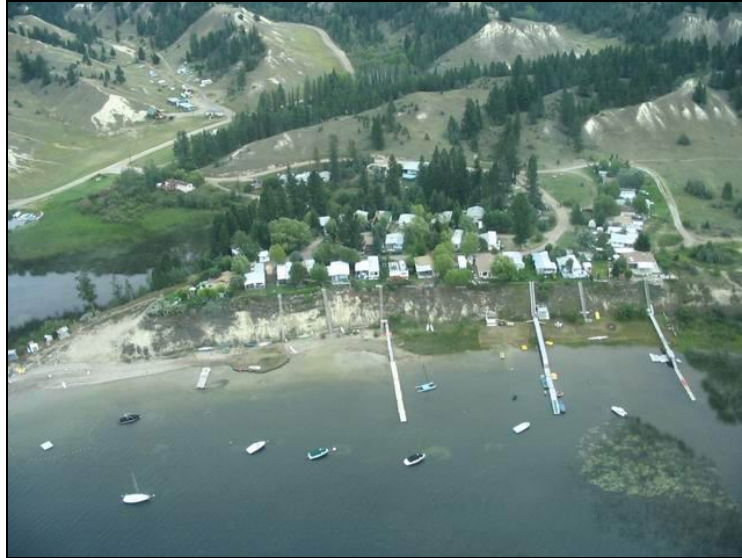
This Segment is in the Indian Reserve #3, and includes a residential area. Although approximately 50% of this shoreline Segment has urban development, the remaining 50% is in a natural condition, and the overall impact to the shoreline remains low. This site is mainly sandy beach (50%), with some cliff/bluff (20%), wetland (25%), and gravel beach (5%) shore types. Riparian vegetative cover is sparse in this Segment with the mixed mature forest providing less than 5% cover to the area. Six wood retaining walls have been constructed along the shoreline below the dwellings. Five wooden docks are also present. A high value wetland is located at the tributary mouth in this Segment with 80% of the aquatic area estimated to contain submergent vegetation and 20% emergent vegetation.

Figure 3. Urban development in Segment 5 comprises approx. 50% of the shoreline, and the remaining area is in a natural condition.

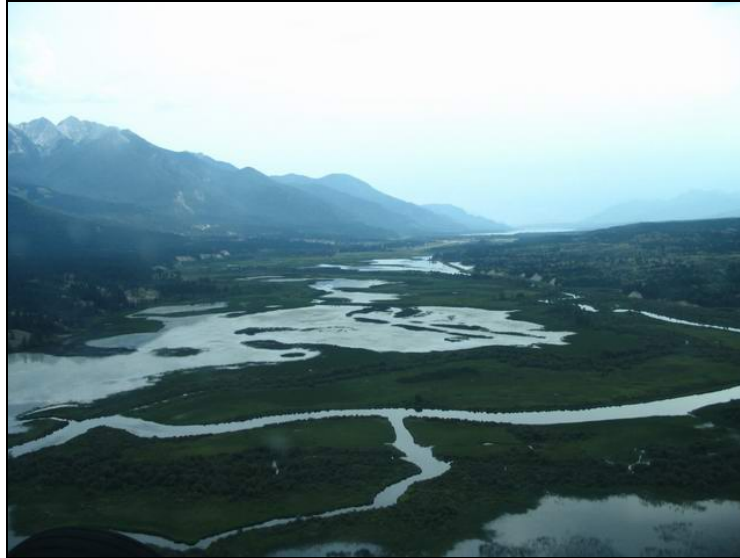
Segment 6 encompasses the southern tip of the Windermere Lake. Other than a small section (approximately 10% of area) on the western side being occupied by the Canadian Pacific Railway (CPR), most of the shoreline is in IR3 and is a natural wetland. The riparian area is aptly classified as natural wetland and riparian cover is abundant ($> 20\%$). Fifty-five percent of the aquatic area is covered by submerged vegetation and 45% by emergent vegetation.

Figure 4. Segment 6 is undisturbed wetland area.

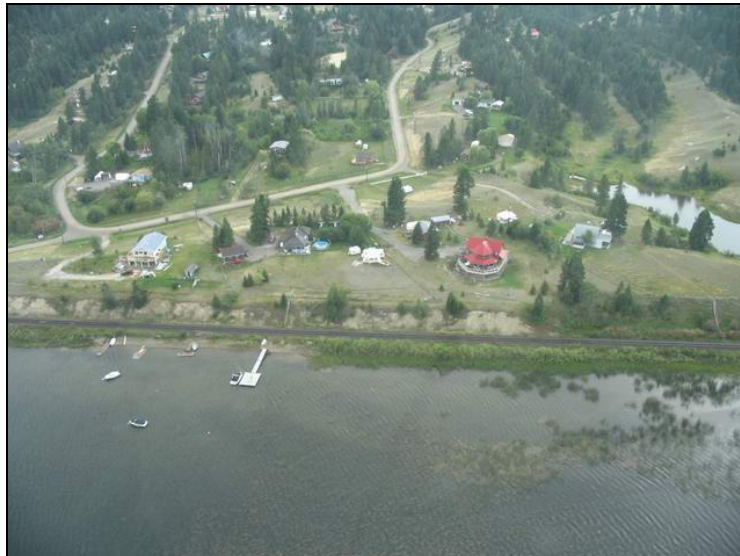
Figure 5. The CPR runs the length of Segment 7, and some residential area lies beyond (the railway) in the northern end.

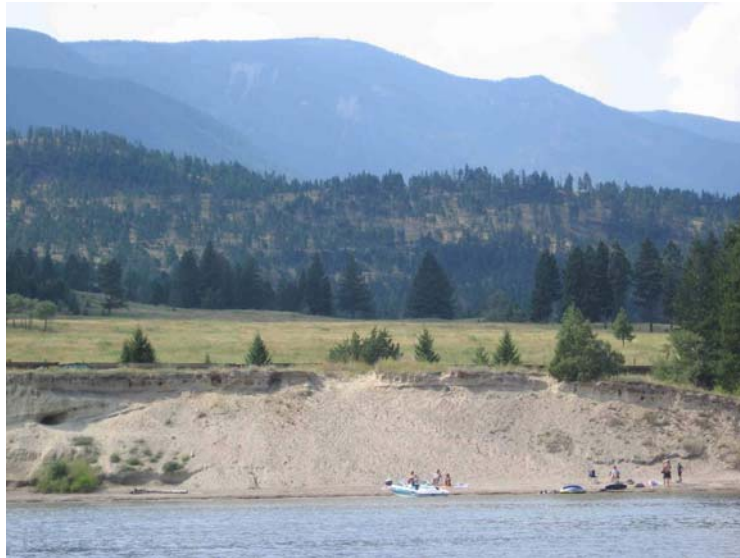
Figure 6. This portion of Segment 8 has not been disturbed by residential development, but has been impacted by the railway.

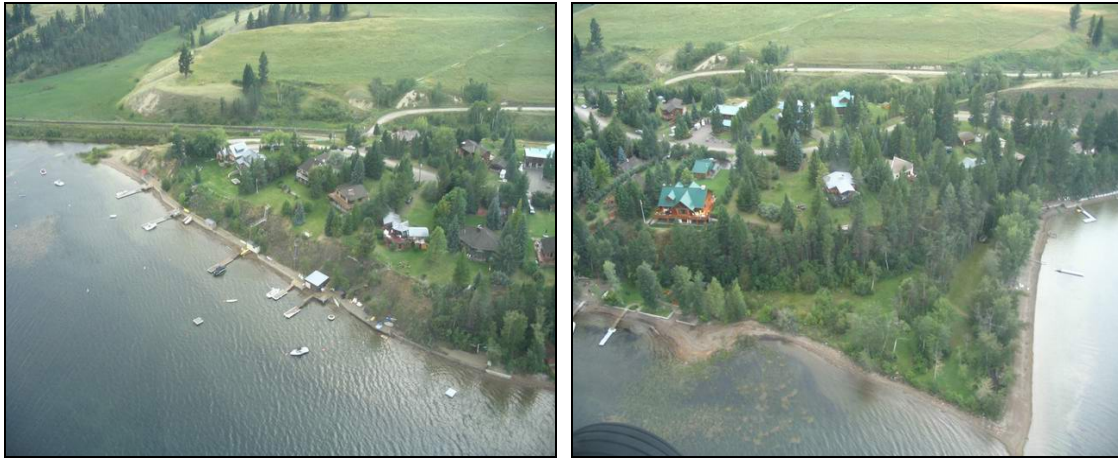
Figure 7. The attributes of Segment 10 are evident in these photos, which show moderate impacts on the shoreline as a result of residential development.

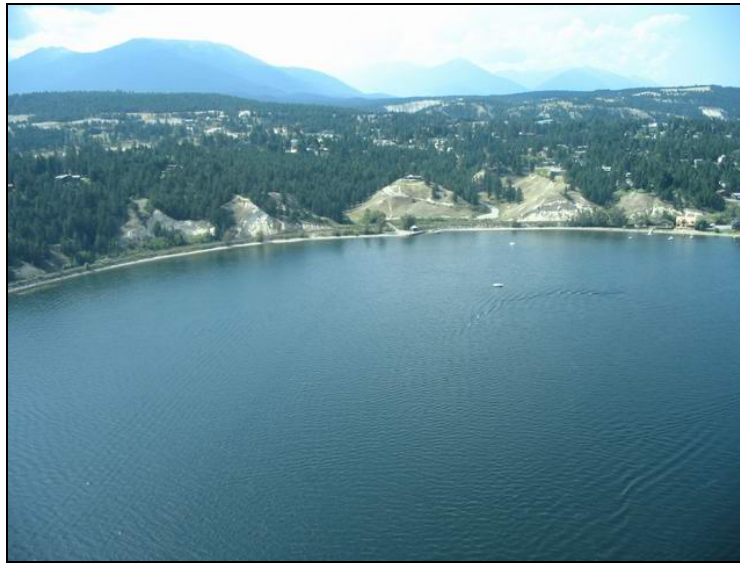
This Segment is located on private land, and is located on the southern outskirts and just within the boundaries of the District of Invermere. It is mainly low rocky shore (80%), and also includes vegetated shore type (15%) and wetland areas (5%). The CPR runs the length of this Segment and contributes to its disturbed condition (100%). The riparian area shows disturbance, and is mainly mature coniferous forest that provides moderate coverage to the foreshore. Riparian veterans and snags (≥ 5 for each) are present. Ninety-five percent of the aquatic community is vegetated with submerged plants, while 5% has emergent plants. The isolated wetland in this Segment is considered high value, and motorized impacts were noted on the upland grasslands during the survey.

Figure 8. Segment 13, showing Taynton Bay, and the railway running along the length of the shoreline.

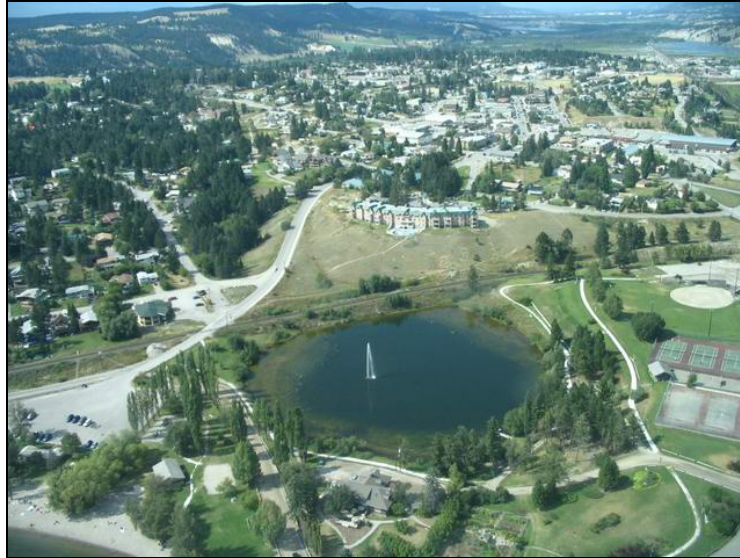
Kinsman Beach City Park is located along the shoreline of Segment 15. The park provides recreational opportunities to the public and has altered the shoreline (100%) from its natural condition. The shore type here is half sand beach and half gravel beach. The riparian area is composed of a mature broadleaf forest, which provides abundant (>20%) cover to the area. Erosion along the eastern shoreline of the park was also evident (i.e. exposed tree roots) during the field review. There is little aquatic vegetation.

Figure 9. View inland from shore of Segment 15, which includes Kinsman Beach Park.

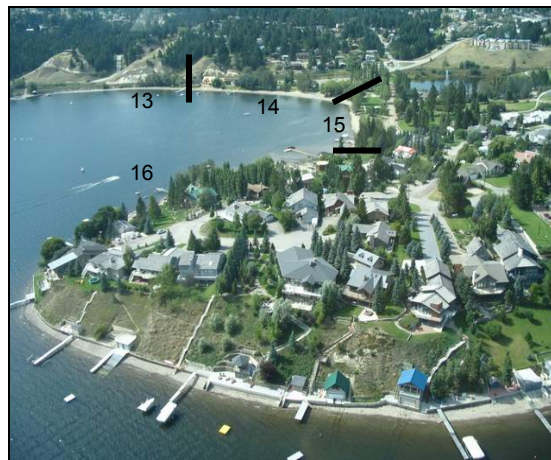
Figure 10. Urban development along the shoreline of Segment 16 includes dock and retaining wall shoreline modifications.

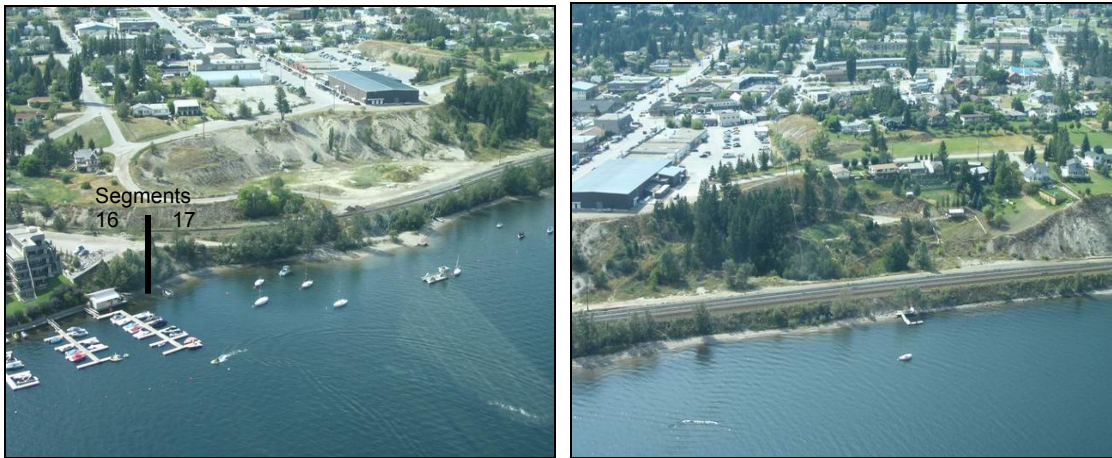
The shore type of Segment 17 is a mixture of vegetated rocky shore (40%), low rocky shore (40%), and cliff/bluff shore (20%). Approximately 70% of this site is estimated to have been disturbed. The CPR runs along 60% of this Segment, and the remainder of the shoreline (40%) is commercial development. Further disturbance to this Segment is expected since it is adjacent to downtown Invermere, and plans are in place for a resort development. Although disturbed, the

riparian area provides abundant cover to this Segment, and is primarily made up of broadleaf saplings >10m. There is little aquatic vegetation here (10% submerged). Three wooden docks and 1 concrete groyne have been built.

Figure 11. Shoreline along Segment 17, showing location for water side resort development (LHS) and downtown Invermere beyond the shoreline (RHS).

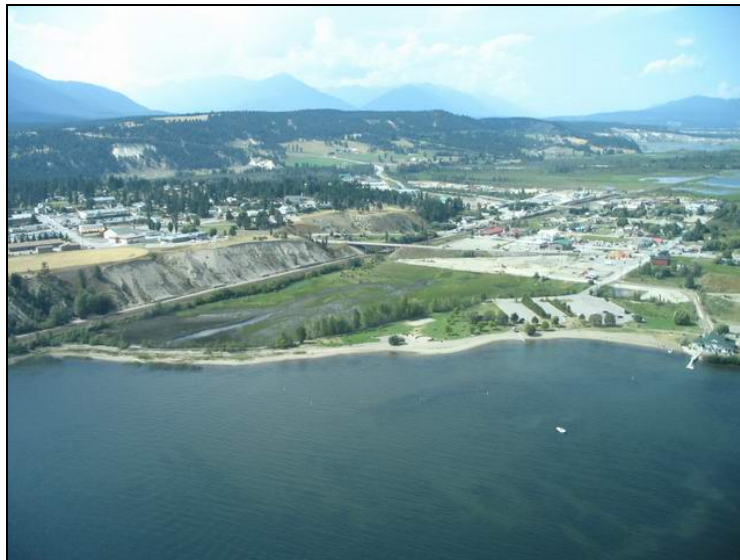
Segment 18 runs along James Chabot Provincial Park (100% park). The shoreline is mainly gravel beach (45%) and sand beach (45%) shore types. A valuable wetland area also comprises 5% of the shoreline. Approximately 40% of this Segment remains in a natural condition. The riparian area provides abundant cover of herbs/grasses (mainly low shrubs <2m). Approximately 15% of the aquatic area in this Segment contains submerged vegetation, while 10% contains emergent vegetation. There is 1 wooden dock, 1 wooden retaining wall, and a boardwalk in this Segment. An Osprey nest is located in the parking lot.

Figure 12. Segment 18 is bordered by James Chabot Provincial Park.

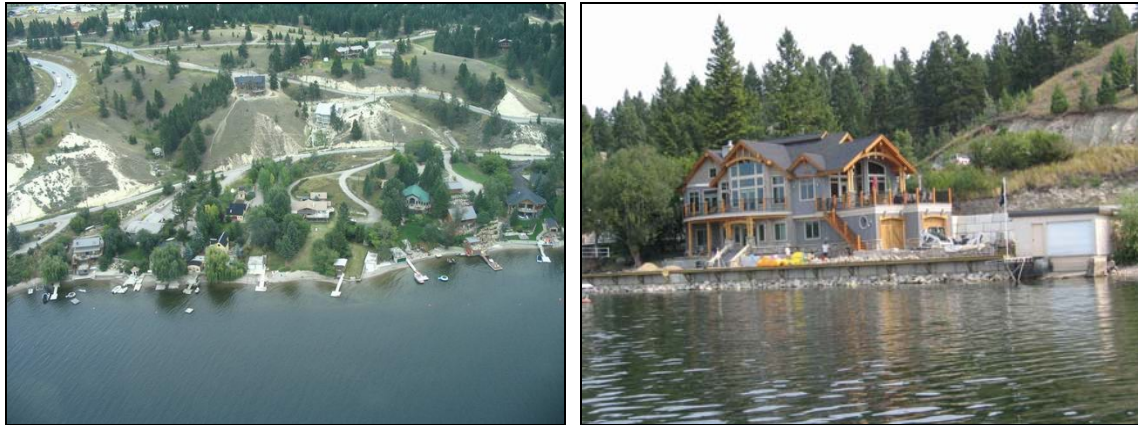
Figure 14. Most of the shoreline along Segment 20 has disturbed by residential development.

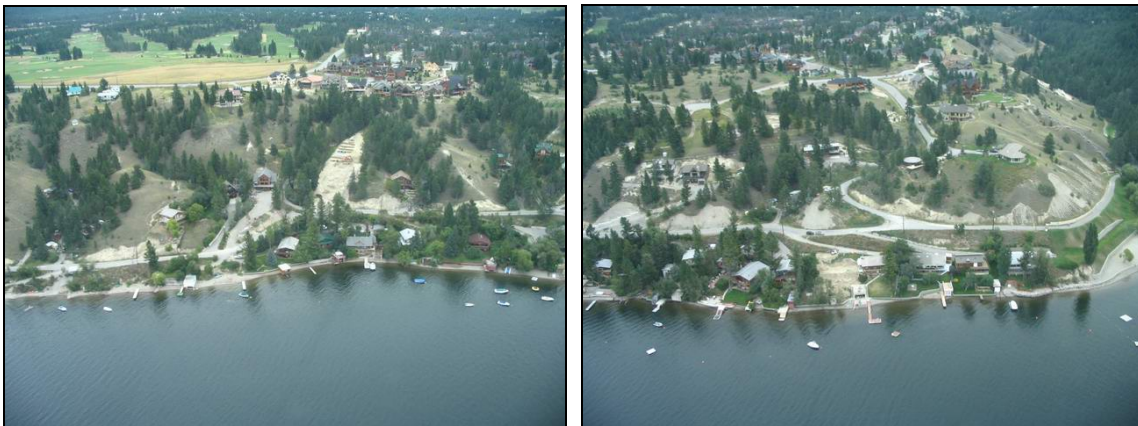
This Segment has been disturbed by residential development, which covers 100% of the area. The shore type here is predominantly vegetated (50%), although there is also a substantial amount of gravel beach (40%), as well as some cliff/bluff and low rocky shore (5% each). The riparian vegetation is composed of a mixed mature forest, which provides moderate coverage to the area. Forty percent of the aquatic area is covered with submerged aquatic vegetation. There are numerous structures built along the shoreline including 80 retaining walls (mixed construction materials), 27 wooden docks, 9 stonework groynes, and 26 boathouses.

Figure 15. Lower Lake View Road along Segment 21.

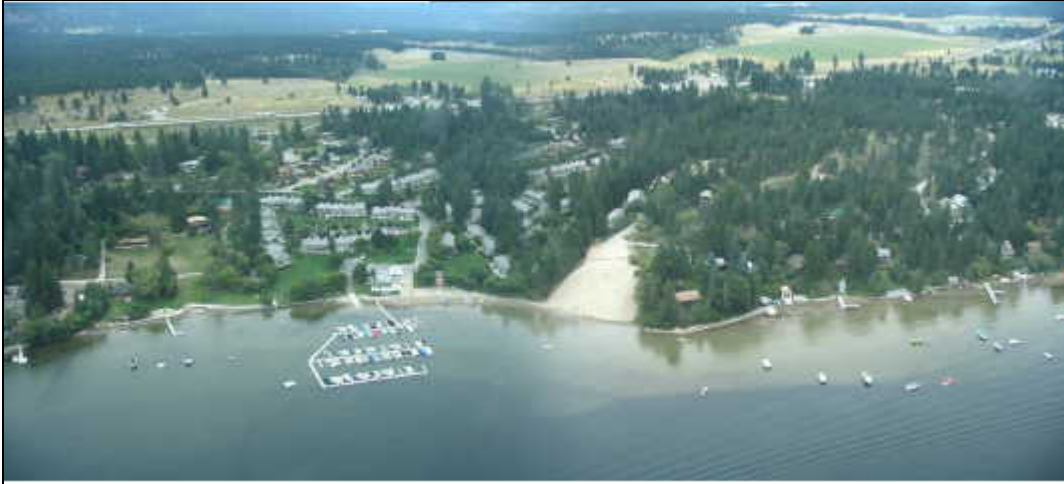
The land use of Segment 24 is composed of approximately half residential and half private recreational (50%) properties. The recreational developments include strata type complexes, such as Terra Vista, Calberley and Akiskinook resorts. These resorts are officially zoned as multi-family residential (R-3; RDEK 2007b). However, for the purposes of this review, they are described as being recreational in nature, because of their private recreational foreshore facilities such as marinas and beach access. The land uses have contributed to disturbance along most of the foreshore (95%). This Segment is mainly vegetated shore type (65%), and there is also some sand beach (20%), cliff/bluff (10%) and wetland (5%) shore types here. The riparian area

is a mixed mature forest that provides abundant cover. Riparian veteran trees are evident (≥ 5). A total of 46 retaining walls (of mixed materials), 17 wooden docks, 1 stonework groyne, 2 marinas, and 13 boathouse structures are evident along this section of shoreline. The first evidence along the eastern shore of undisturbed shoreline and intact upland forested habitat was encountered in this Segment (coming from the north).

Figure 18. Half of Segment 24 has private recreational type developments along the foreshore such as that at Terra Vista Resort and Marina and Calberley Beach (both near the centre of the photo).

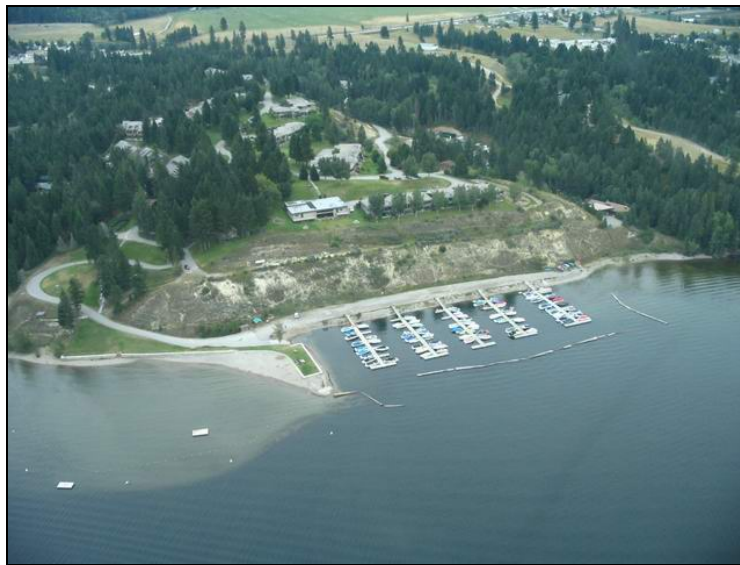
Figure 19. Segment 24 Akiskinook Resort and Marina (private), located near the south end of Segment 24, has contributed to disturbance along a large upland portion of the shoreline.

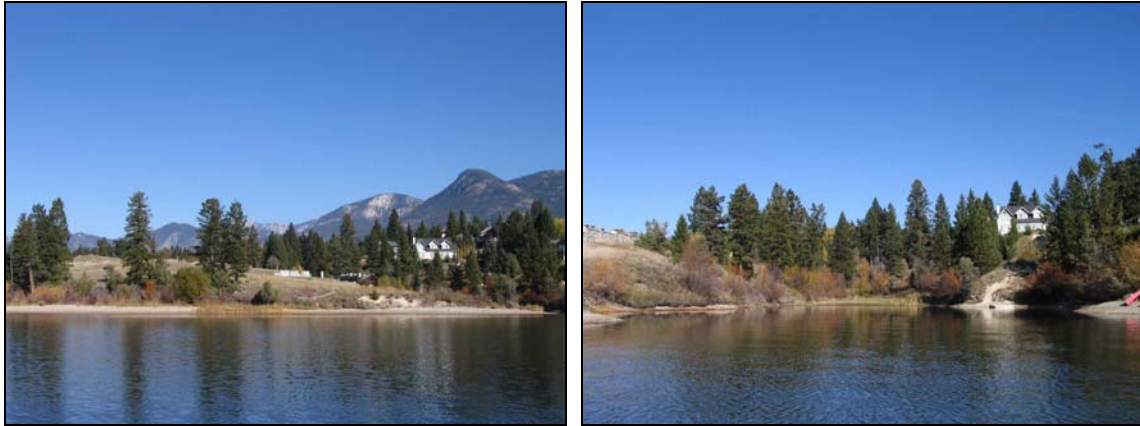
- very good natural shoreline vegetation on the point below the cemetery;
- important isolated wetland below the cemetery and at the head of the bay;
- largest natural protected bay (Hidden Bay) on eastern shore of Windermere Lake provides an important area for waterfowl refuge;
- natural plant communities in the undeveloped areas; and
- topography provides protection.

Figure 20. Segment 25 is all park and provides one of the most important habitats on the north eastern shore of Windermere Lake. The left photo shows the cemetery and the right photo shows the isolated wetland below the cemetery (photos provided by Wildsight).

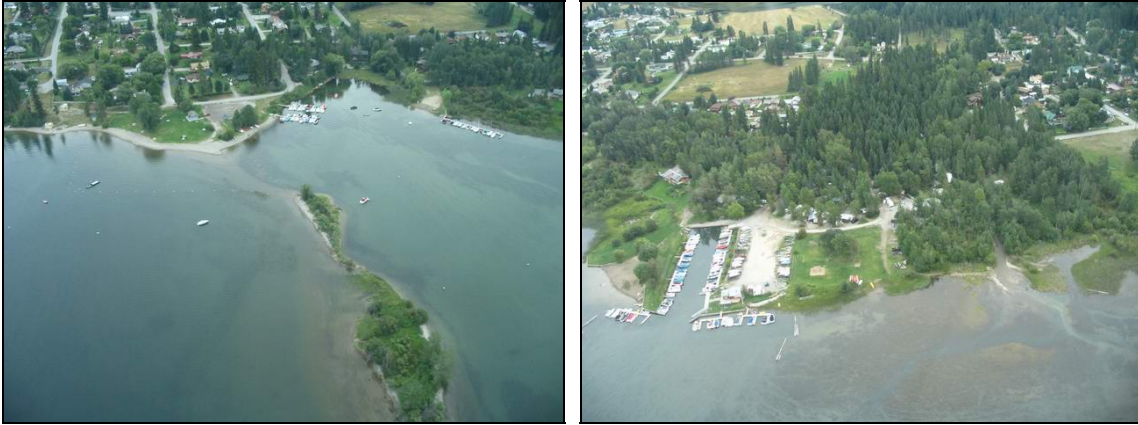
Several structures have been constructed along the foreshore including 24 retaining walls (of mixed materials), 31 wood docks, 6 stonework groynes, 4 marinas, and 8 boathouses. One non-conforming boat house structure located above the outlet of Jane Creek was identified during the field review. This structure is believed to create a barrier to fish movement upstream (Figure 33). The photos provided (Figures 32- 34) progress along the shoreline of Segment 26 in a southerly direction. The riparian habitat at the outlet of Windermere Creek is considered to be important.

Figure 21. Segment 26 - Windermere public beach and the private Cardiff Cove Marina (left); right hand photo shows Shadybrook Marina (private) and valuable riparian / foreshore habitat at outlet of Windermere Creek.

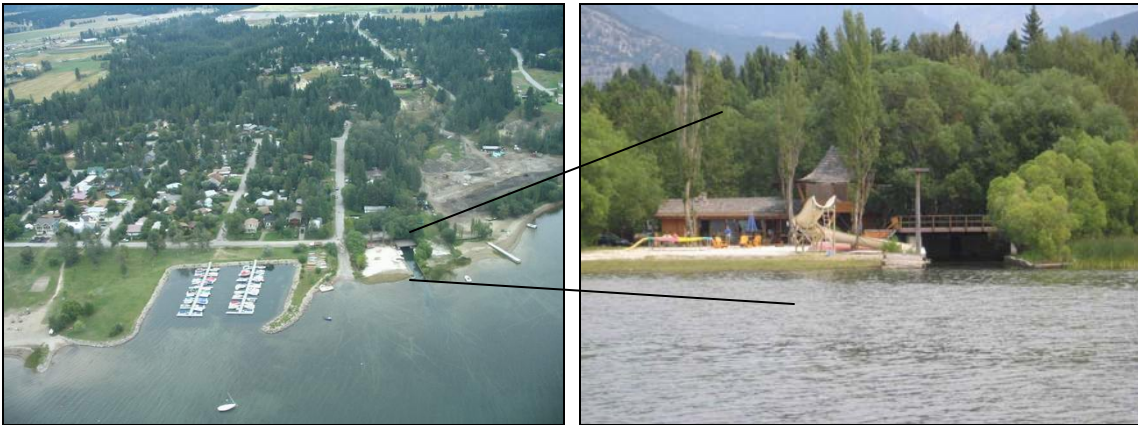
Figure 22. Segment 26 – Left photo shows Trethaway Beach Marina (private), and what was previously Coldstream campground; the right hand photo depicts a closer view of a boat house which is believed to inhibit fish access up Jane Creek.

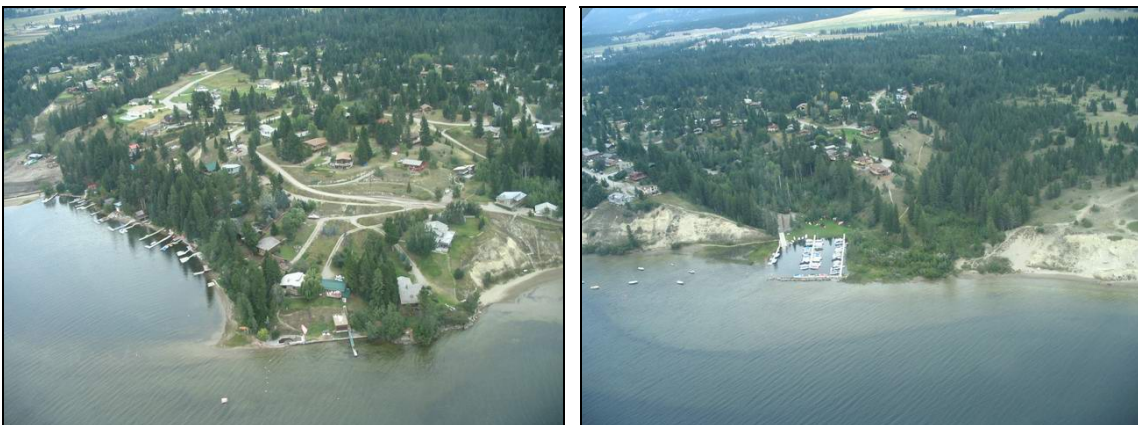
Figure 23. Southern end of Segment 26 has Indian Beach Resort and Indian Beach Marina (private).
