# Whiteswan Lake Foreshore Integrated Management Plan FINAL

**Masse Environmental Consultants Ltd.**

March 31, 2021

Project Number 2020-788

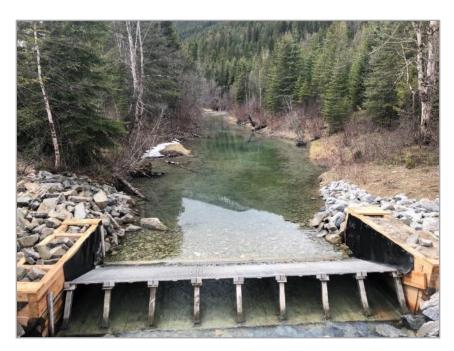
Photo 1. Outlet Creek barrier after it was refurbished in 2019 (Photo Lamson 2019).

Construction of the barrier on Outlet Creek to prevent outmigration of adult and juvenile rainbow trout into the White River and beyond to reduce the potential for hybridization of westslope cutthroat trout.

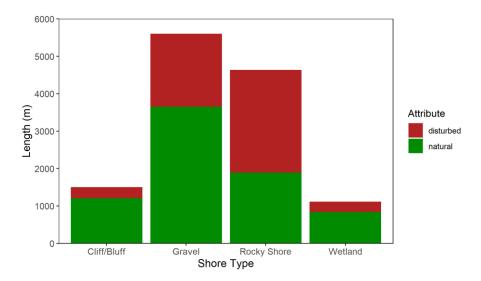
The predominant shore types consisted of gravel and rocky shores with 5.6 km (43.6%) and 4.6 km (36.1%) respectively (Table 8; Figure 2). The remainder consisted of cliff/bluff (1.5 km; 11.7%) and wetlands (1.1 km; 8.7%). Steeper shorelines were generally located along the north and south shores of the lake, as the lower gradient shorelines were located within the floodplain at the east and west ends of the lake. The greatest percentage of disturbed shoreline was found along rocky (21.4 %) and gravel (15.2%) shorelines.

Figure 2. Shore types along the Whiteswan Lake foreshore relative to the amount of natural and disturbed foreshore.

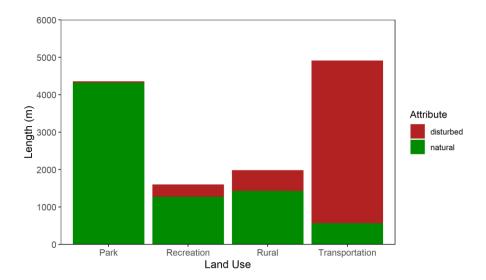
Figure 3. Land use along the Whiteswan Lake foreshore relative to the amount of natural and disturbed foreshore.

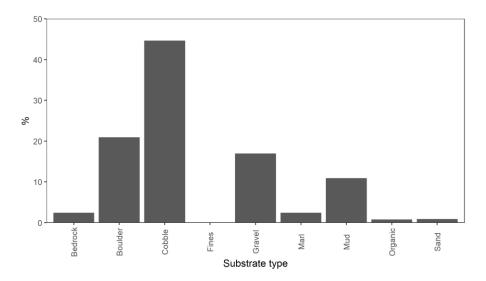
Figure 4. Substrate type along the Whiteswan Lake foreshore.

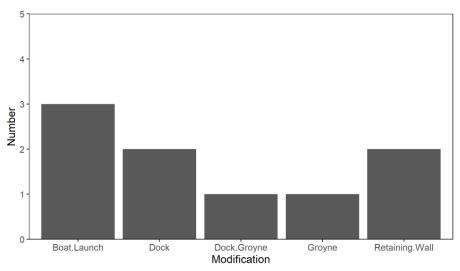
The most widespread shoreline modification was the Whiteswan Lake FSR which runs along the entire south shore of the lake for ~5.1 km (39%; Segments 1, and 16 to 22). The proximity of the road to the shoreline varied throughout with the most significant riparian buffer retained along Segment 19 (Photo 21-22). The Home Basin campground located at the northeast end of the lake provides access to recreationist to the foreshore with multiple access paths (Photo 25). Other shoreline modifications included 3 boat launches (Photo 23 and 24), 3 docks (Photo 26), 2 retaining walls (Photo 27) and 1 groyne (Photo 28). Riparian vegetation removal was also observed at the east end of the lake where agricultural fields were created (Photo 29).

Impacts from the use of motor boats was most prominent in the shallow littoral zones at either end of the lake with disturbance of the littoral substrate from propellers dragging along the bottom which may be affecting aquatic vegetation growth in some areas (Photo 30). ATV tracks were also observed on the foreshore at the east end of the lake (Photo 31), which may have gained access through the agricultural fields.

Figure 5. Foreshore modifications in Whiteswan Lake.

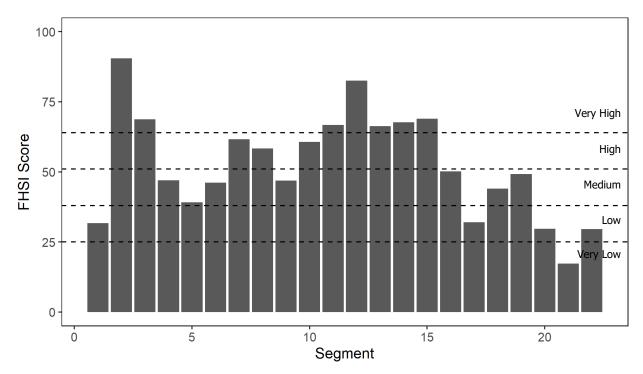
Rating	Range	Shoreline Length (m)	Shoreline %	Segments
Very High	>64	3530.8	27.4	2, 3, 11, 12, 13, 14, 15
High	51-64	2037.9	13.2	7, 8, 10
Medium	38-51	4248.2	35.7	4, 5, 6, 9, 16, 18, 19
Low	25-38	2747.7	21.4	1, 17, 20, 22
Very Low	<25	298.9	2.3	21

Figure 6. Plot of FHSI scores for each segment based on the criteria used in Table 3.
