Lake Windermere 2011 Water Quality Monitoring Results

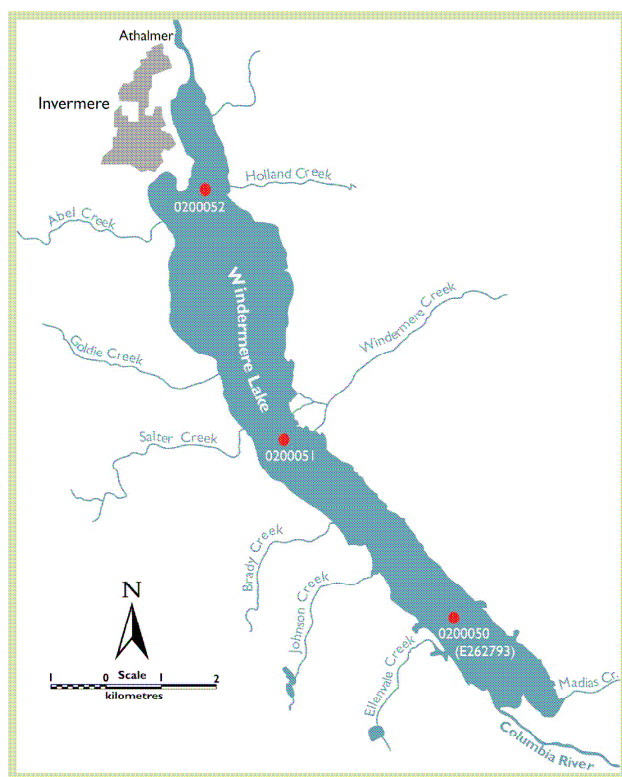
Sampling Sites = Red Dots

In 2011 Lake Windermere Ambassadors' volunteers and staff sampled lake water at three locations established by the Ministry of Environment and sampled over the previous 5 years by the Lake Windermere Project. The sites cover the north and south end and center of the lake.

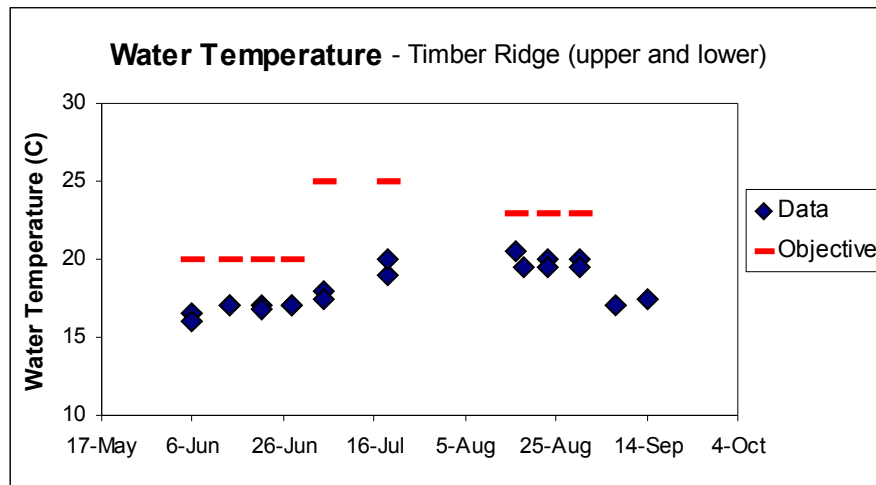
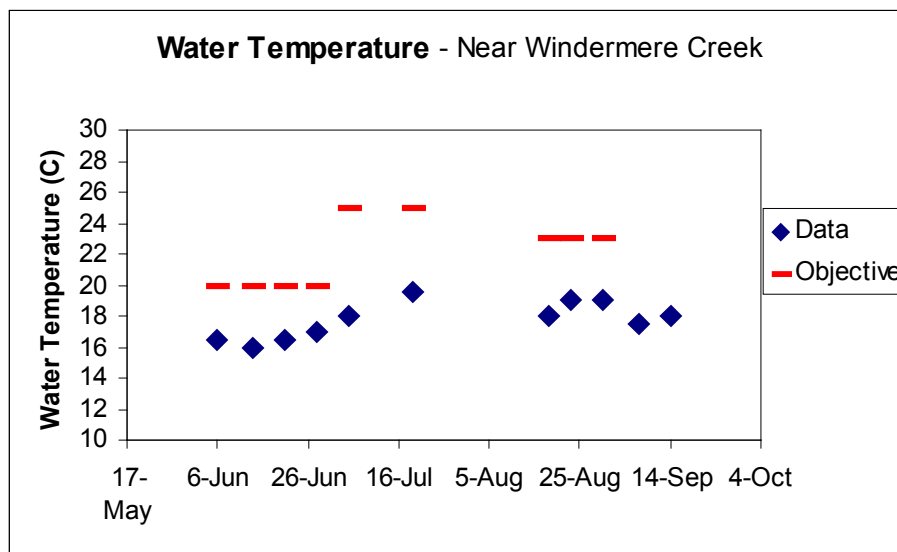
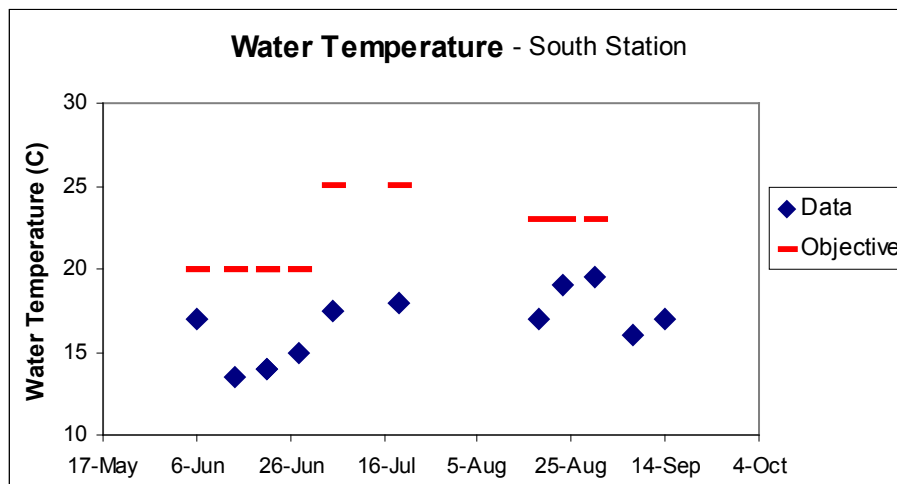
In the summer of 2011, temperature at all three water monitoring stations were below the maximum recommended temperature, and therefore the lake met water quality objectives.

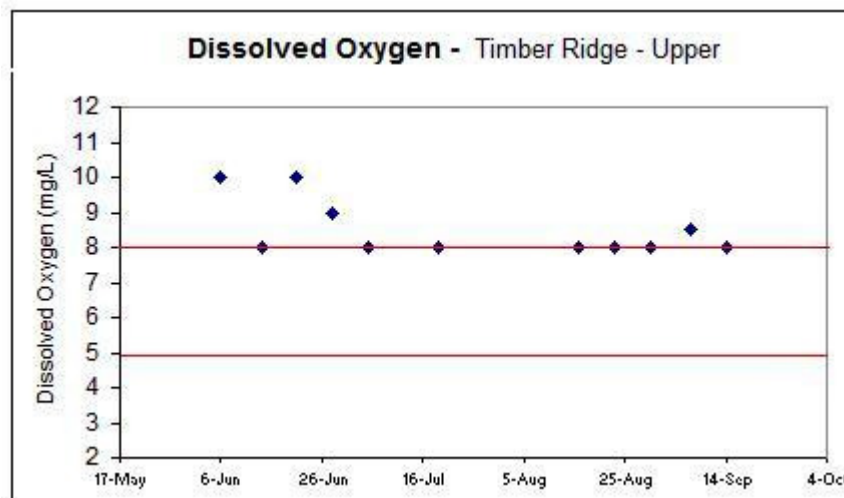
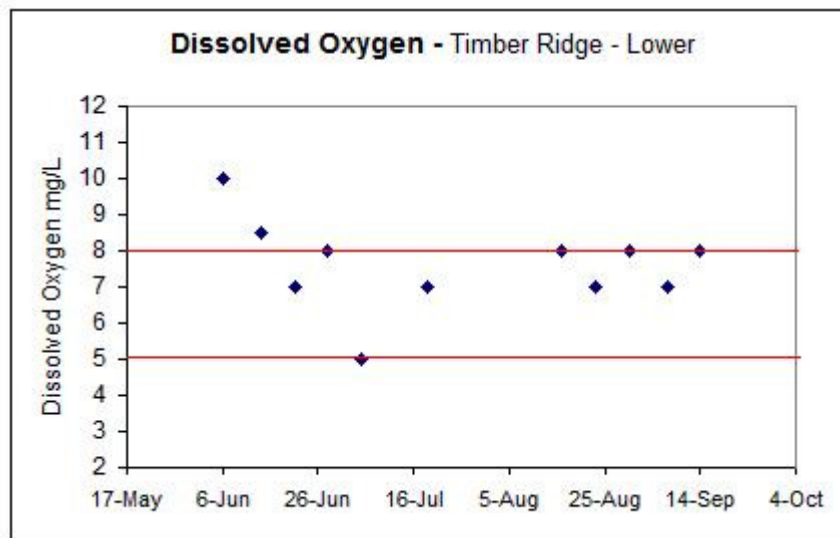
At the Timber Ridge station on the north end of the lake, mean oxygen levels at the lake surface were always at or above the objective to protect aquatic life (8 mg/L). The instantaneous minimum oxygen level (5 mg/L) was not detected during the sampling period.

One meter above the lake bottom, however, there was less oxygen. The mean oxygen levels were below the objective to protect aquatic life, and the instantaneous minimum oxygen level was detected once during the sampling period.

Given that there was sufficient oxygen near the surface during this time period, it is not likely that the lower oxygen levels down low were a threat to aquatic life. Nonetheless, historic water quality data show higher oxygen levels at this site (7 -14 mg/L), so further monitoring of this site should be undertaken to determine if a trend towards lower oxygen is occurring in this section of the lake.

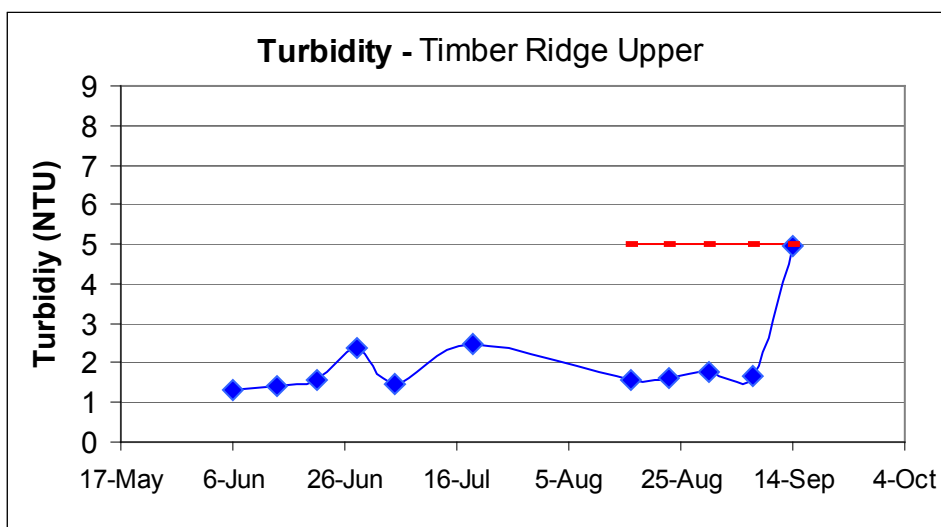
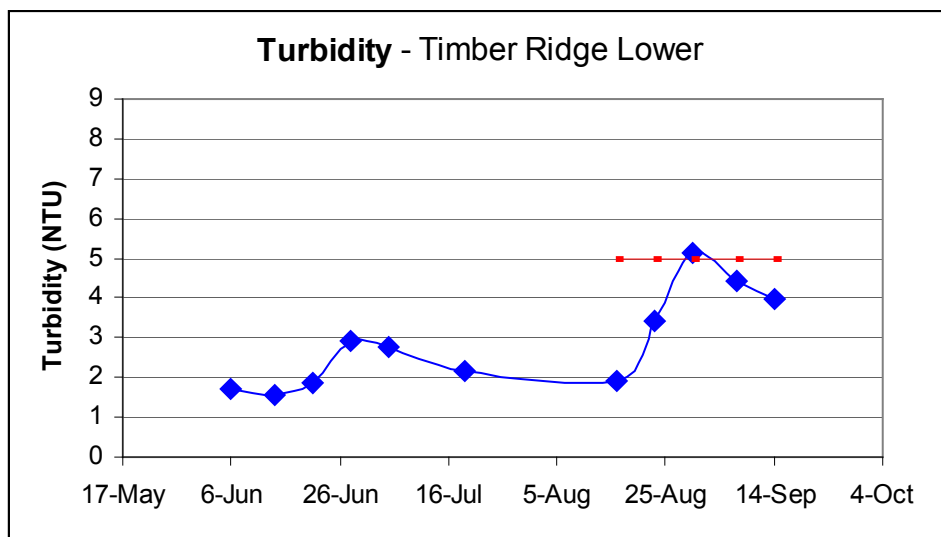
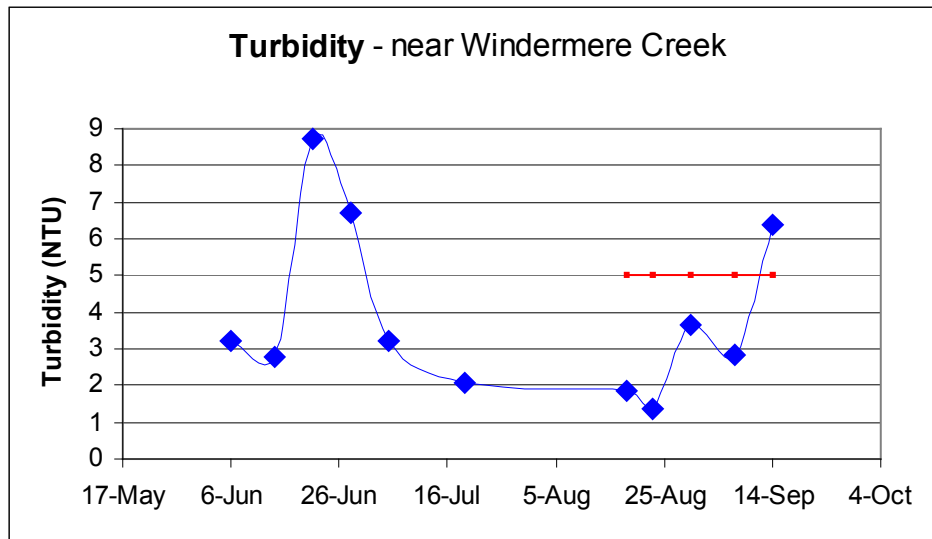
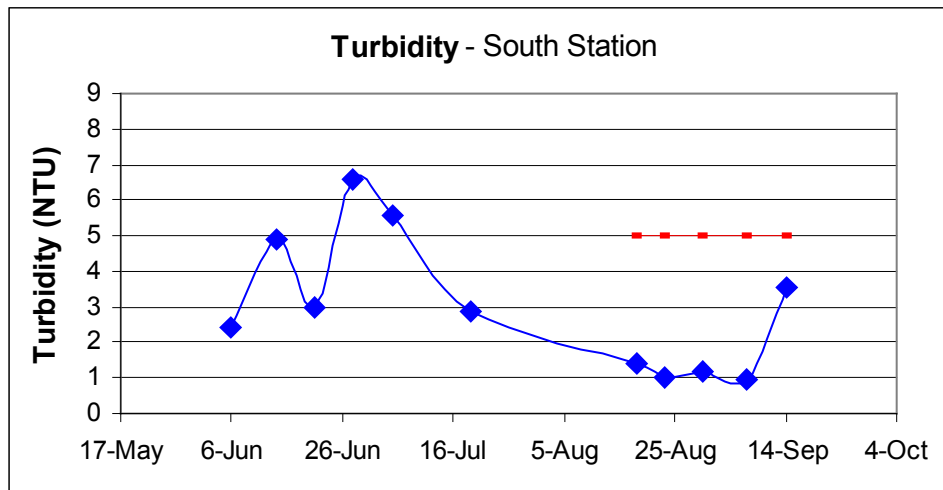
In 2011, the turbid flow objective was exceeded at the Windermere Creek station and the South station. Field observations and information about a landslide in Windermere Creek substantiate this finding for the station near Windermere Creek. Field notes from the south station documented turbid inflow from the Columbia River during this time.

In 2011, the clear flow objective of 5 NTU maximum was exceeded once at the north site where the sample was taken 1 meter above the lake bottom (station = Timber Ridge Lower). Field notes from that day indicate that surface conditions were choppy and the distance to the bottom could not accurately be gauged. Thus, it is possible that the sample was taken very close to the lake bottom.

The clear flow objective for average turbidity over 30 days exceeded the recommended 1 NTU at all stations, indicating that conditions in 2011 were more turbid than both historically (1970s and 1980s) and recently (2006-2009).

Note: lines added to ease interpretation only – no continuous data were taken.
Red line indicates the “clear flow” objective.

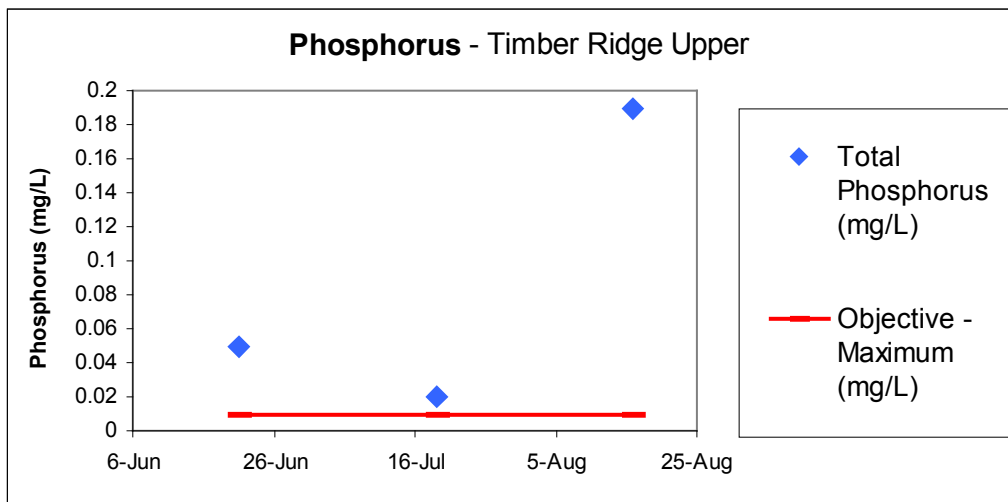
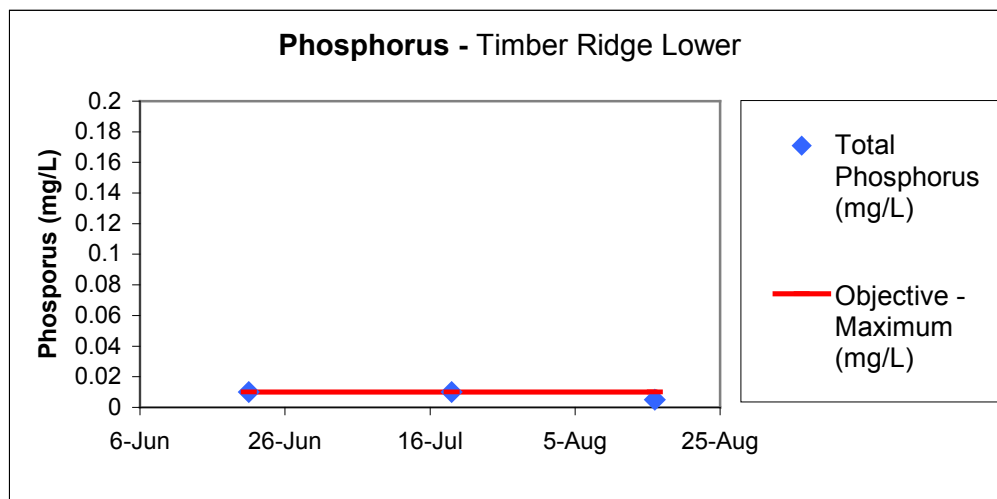
The measured phosphorus concentration at the Timber Ridge station (average of phosphorus near the lake surface and near the bottom) was found to be higher than the recommended level during all three sampling events. In August it was 10 times higher than the recommended levels. The type of phosphorus present gives some insight into what might have been occurring at that

time. Since total phosphorus (typically bound to sediments) was much higher than dissolved phosphorus in that sample, the results may indicate the presence of particulates in the sample. Ministry of Environment scientists suggest that since Lake Windermere is a “riverine” system (a widening of the Columbia River) and there is more flow through it than in typical lakes, the mixing of nutrients, especially when they are bound to sediment, may be highly variable.

Compared to historic data, the 2011 Timber Ridge results appear to be an exception to the conditions typical of Lake Windermere. Nonetheless, the high results indicate that future monitoring at this site is warranted in order to determine if there might be an increase in phosphorus occurring.

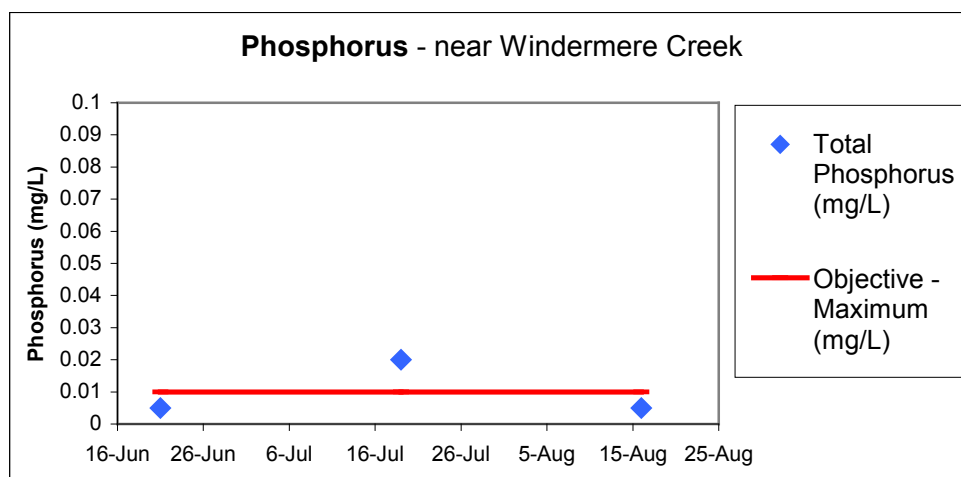
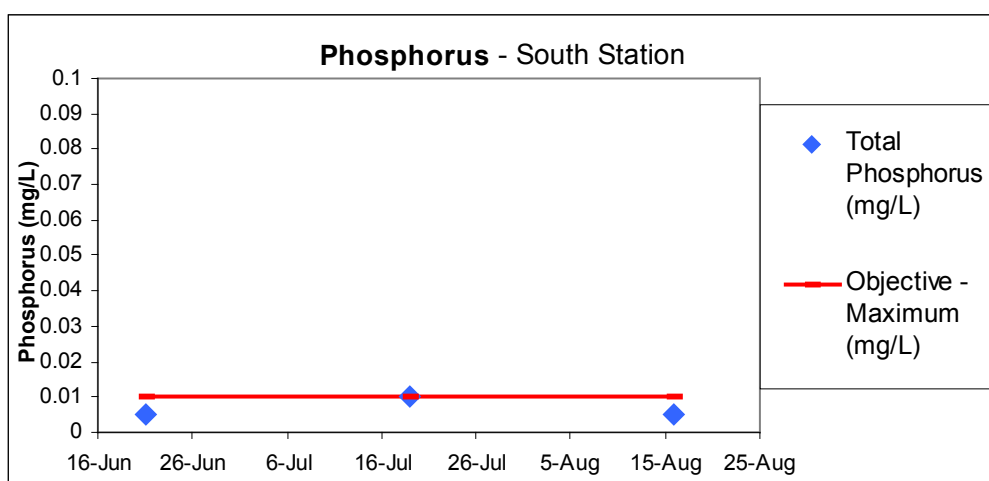
Phosphorus concentration near Windermere Creek was higher than the objective in July. All of the phosphorus detected that day was in the dissolved form.

At the South station, phosphorus was always at or below the recommended level.

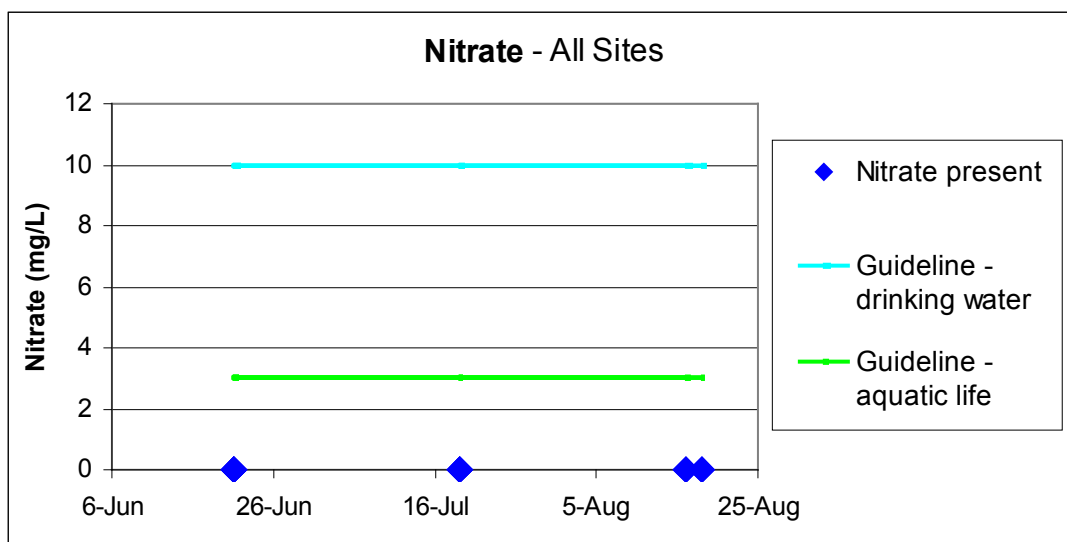
Total nitrogen and nitrate levels were consistently well below guidelines at all sites throughout the monitoring season. These results are consistent with historic data.
