**LAKE KOOCANUSA
FORESHORE INVENTORY AND MAPPING AND AQUATIC HABITAT
INDEX**

East Kootenay Integrated Lake
Management Partnership

VAST Resource Solutions Inc.

Oct 17, 2017

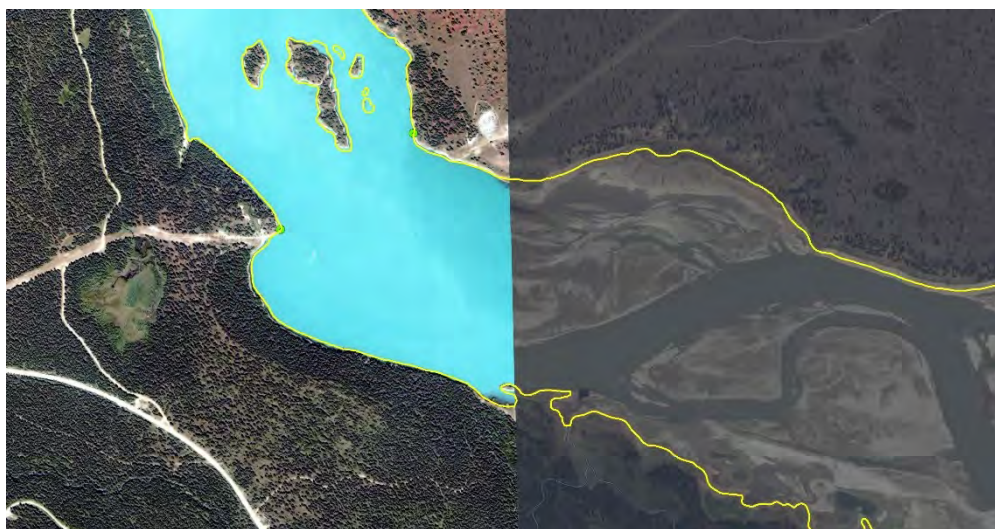
Figure 1. Orthophoto view of Lake Kooconusa, showing full-pool (left) and low-pool (right). The BC Freshwater Atlas shoreline is shown in yellow.

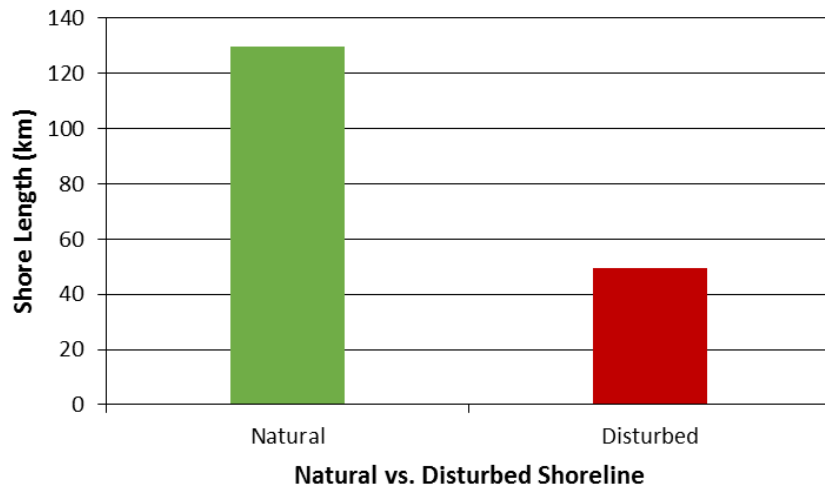
Figure 3. Extent of Natural and Disturbed shoreline along Lake Kocanusa.

Overall, results indicate that 72% of the foreshore is in a natural condition and that 28% has been disturbed (Table 3). Lake Kooconusa is an altered ecosystem; it was a riverine ecosystem and is now a reservoir ecosystem. The shoreline is considered to have stabilized over the past 43 years; therefore, it is considered natural at full-pool for the purposes of the FIM analysis (Mac Donald pers. Comm.). The land use types and their extent along the shoreline are depicted in Figure 2. The extent of disturbed and natural foreshore areas for the entire shoreline are provided in Figure 3. Figure 4 provides an example of a natural and disturbed shoreline found along Lake Kooconusa.

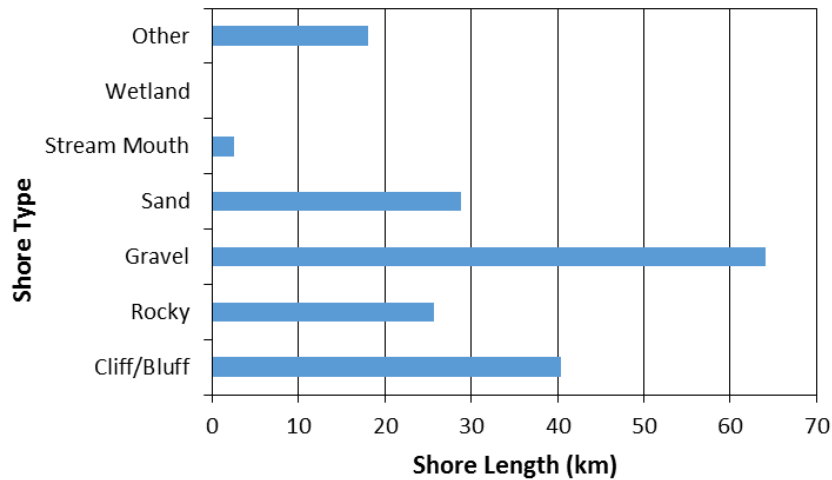
Figure 5. Total length of each Shore Type along Lake Koochanusa.

The foreshore of Lake Koochanusa is diverse consisting of cliff/bluff, rocky, gravel, sand, stream mouth, and other shore types. A breakdown of the lengths of each of these foreshore types along the perimeter of the lake is provided in Figure 5. The foreshore is primarily Gravel Beach Shore Type (64 km or 36% of the shoreline). Cliff/bluff and Sand Shore Types also make up substantial lengths of the shore (22% and 16% respectively), while Stream Mouth Shore Type makes up the smallest extent of foreshore (1%). Wetlands are not present along the foreshore. Figure 6 depicts the two dominant shorelines along Lake Koochanusa.

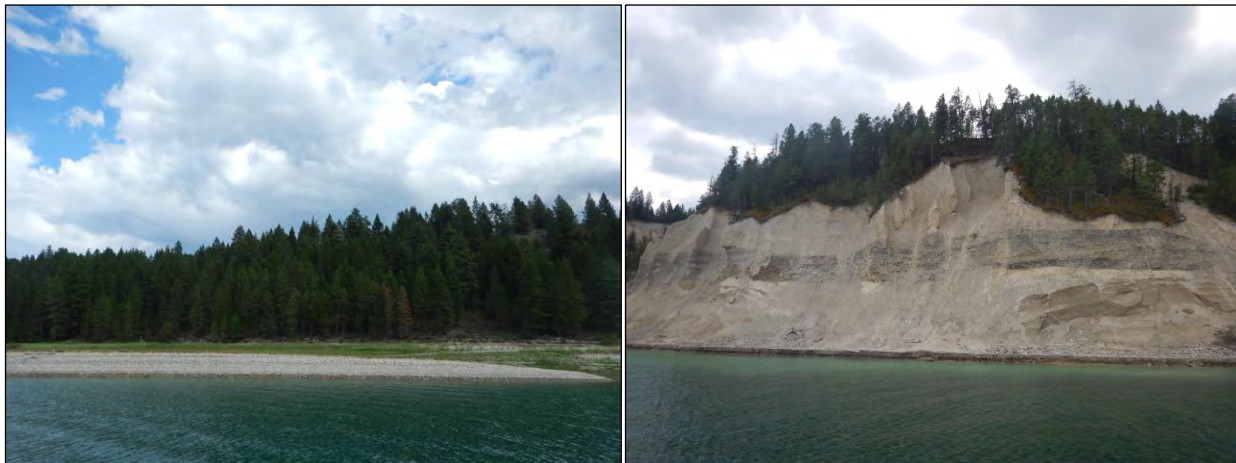
Figure 6. Gravel beach shore type (left photo) and Cliff/Bluff shore type (right photo). Photos taken by Heather Leschied (EKILMP), July 2015.

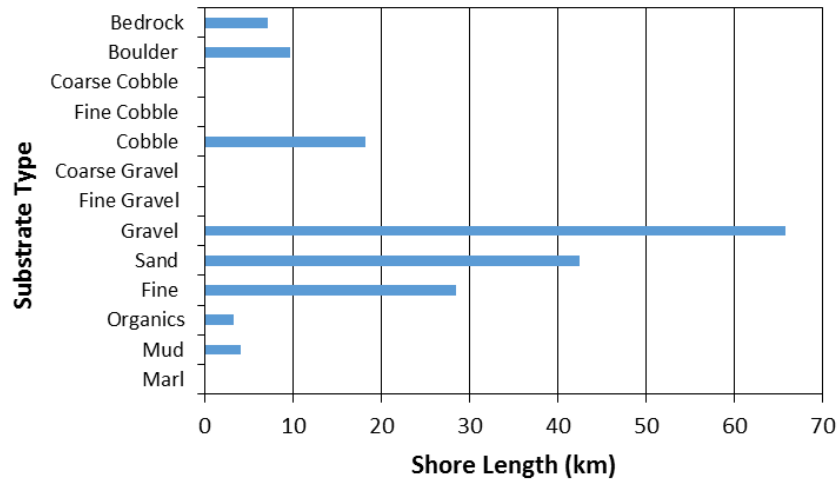
Figure 7. Substrate types observed along the foreshore of Lake Kocanusa.

The dominant lake substrate is gravel, which comprises 66 km (37%) of the shoreline, followed by sand (24%) and fines (16%). Fines including silt, mud and organic substrates were rare at full-pool, 749.5 m (2459 feet), but they were much more common at low-pool, and very productive (Mac Donald pers. comm.). Mud and organic substrates are least abundant along the shoreline (each making up 2% of the shoreline). A breakdown of the lengths of each of the substrate types along the perimeter of the lake is provided in Figure 7.

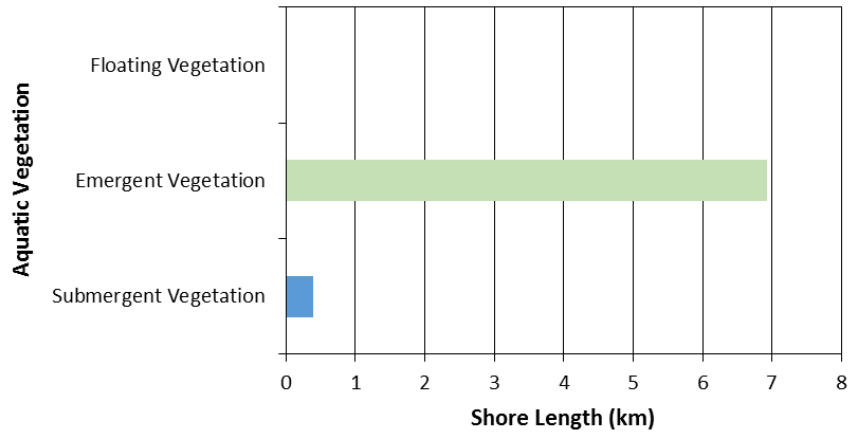
Figure 8. Aquatic Vegetation types along Lake Koochanusa.

Aquatic vegetation describes the portion of the shoreline that comprises emergent, submergent, or floating vegetation (Schleppe and Mason, 2009). The dominant type of aquatic vegetation observed along the lake is emergent vegetation, comprising about 4.0% of the total shoreline (Figure 8). Submergent vegetation is less abundant representing only 0.2% of the shoreline. Floating vegetation was not observed along the shoreline. Figure 9 is an example of a segment that has emergent vegetation.

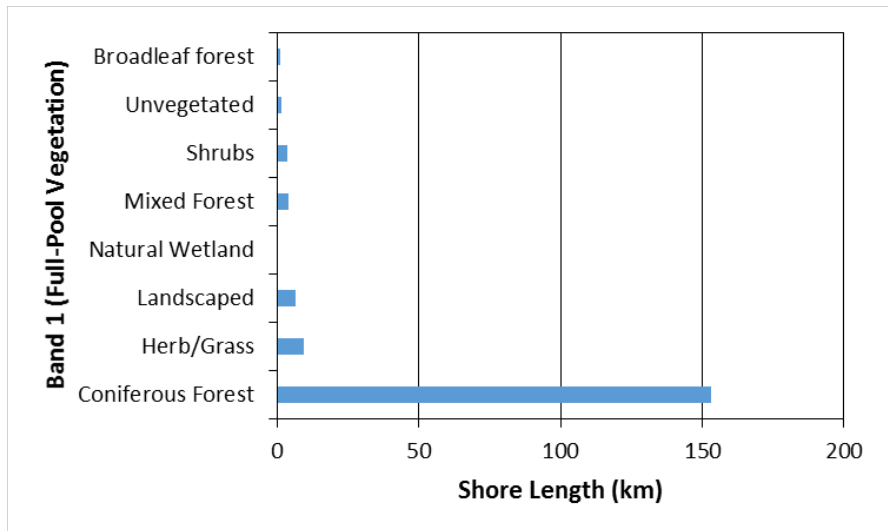
Figure 10. Full-Pool vegetation along the shoreline of Lake Kocanusa.

The dominant full-pool vegetation is coniferous forest (147 km; 82%), while unvegetated areas (0.9%) and broadleaf forests (0.6%) are less abundant (Figure 10). An example of coniferous forest vegetation is shown in Figure 11. Mature forest is the predominant full-pool vegetation stage of the lake, encompassing 127 km (71%) of the shoreline. Overhanging vegetation occurs in only about 2% (3 km) of the shoreline (Figure 12). Most of the shoreline has sparse shrub cover (114 km; 63%) and moderate tree cover (78 km; 43%).

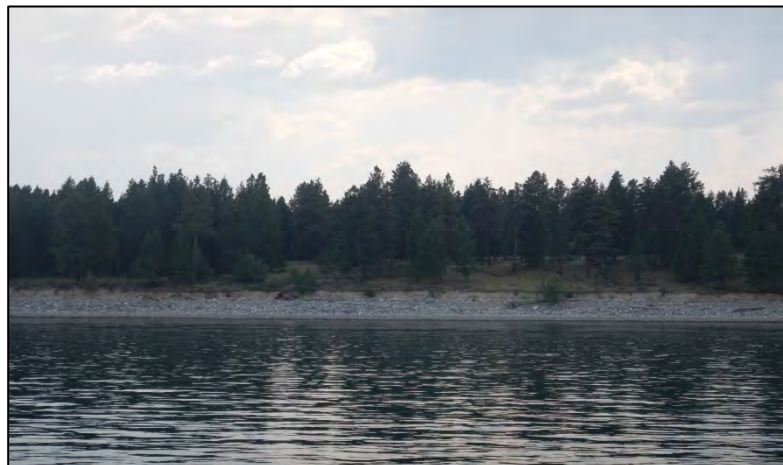
Figure 11. Coniferous forest vegetation along Segment 5. Photo by Heather Leschied (EKILMP), July 2015.

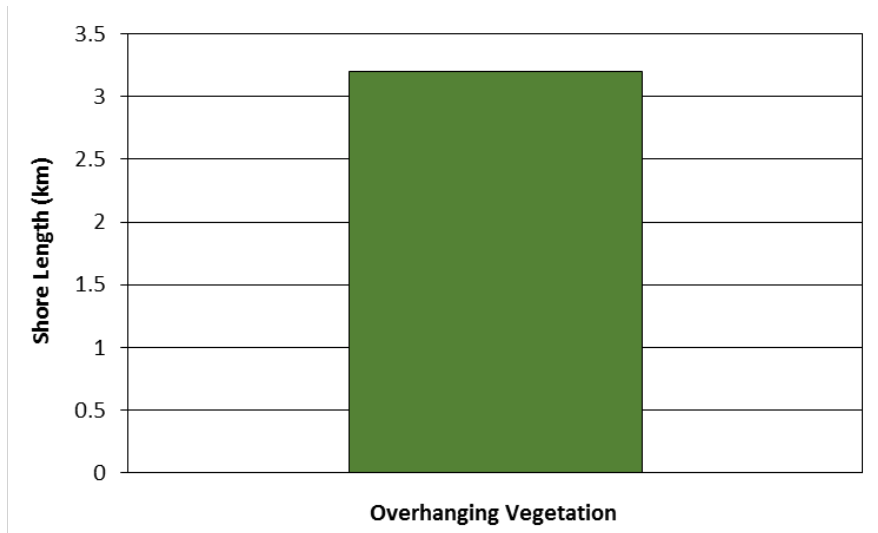
Figure 12. Total overhanging vegetation along Lake Kooanusua.

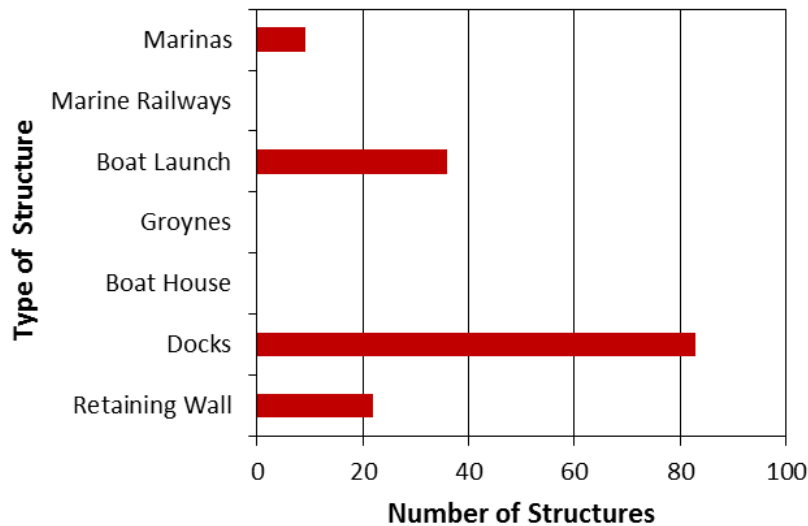
Figure 13. Number and type of modification structures along Lake Kooanusua.

Lake Kooanusua shoreline modifications include retaining walls, docks, boat launches, and marinas (Figure 13). The most common form of shoreline modification are docks, with a total of 83 observed. Boat launches are the next most common type of modification with 36 recorded. Retaining walls and marinas also occur along the lake shoreline (22 and 9, respectively). There are no boat houses, groynes or marine railways along the lake shoreline. Figure 14 provides examples of shoreline modifications observed along Lake Kooanusua.

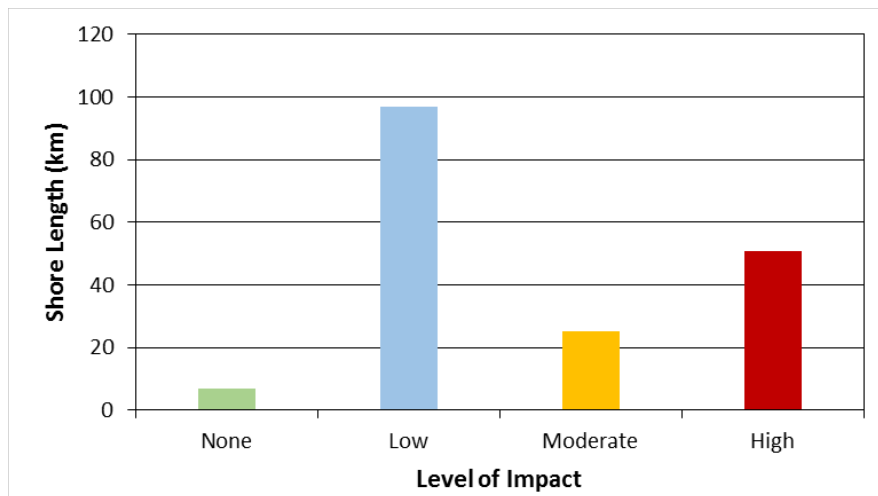
Figure 15. Level of impact along Lake Kooconusa.

Level of Impact (LoI) provides a qualitative indication of the overall health of the foreshore and considers the land use, level of disturbance, and modification information provided. Generally a High LoI refers to a segment with >40% alteration along its shoreline, a Moderate LoI is between 10 and 40% alteration, and a Low LoI segment is mainly natural with <10% alteration. Figure 15 provides a summary of the LoI ratings for Lake Kooconusa, and reveals that 28% (51 km) of the foreshore has a High LoI, 14% (25 km) has a Moderate LoI, 54% (97 km) has a Low LoI and 4% (7 km) has no level of disturbance.

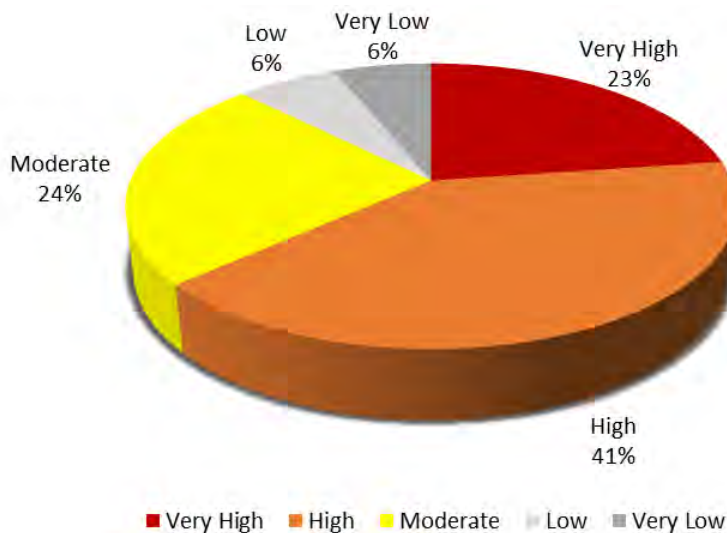
Ecological Value	Current Ecological Value		
	Total Segments	Total Shoreline Length	
		(%)	(km)
Very High	10	23	40.9
High	21	41	73.0
Moderate	17	24	43.3
Low	4	6	11.4
Very Low	5	6	11.0
			179.6

Figure 16. Current Ecological Value rankings and associated percentage (%) of shoreline.

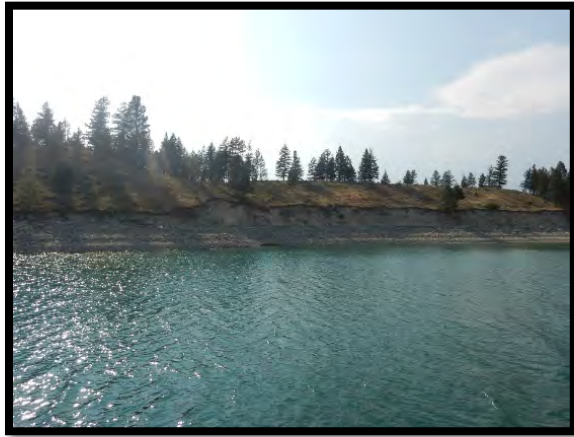
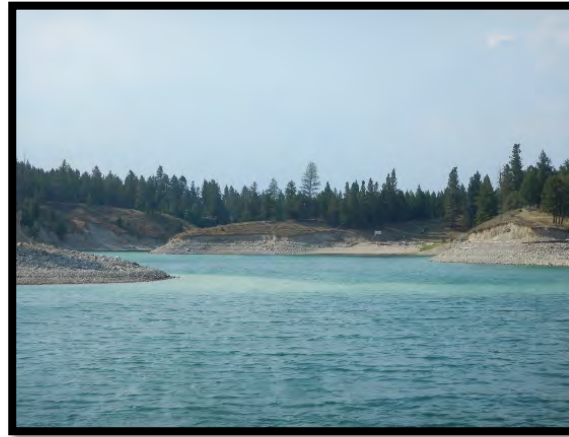
Lake Kocanusa Segment No. 1

Segment Length (km)	Shore Type	Shore Type Mod.	Slope	Land Use	Level of Impact	Livestock Access	Disturbed	Natural
2.8	Cliff/bluff	None	Very Steep (60+)	Forestry	Low (<10%)	Yes	10	90
<i>Comments:</i>

Retain Walls	% Ret. Wall	Ret. Wall Material	Docks	Docks per km	Boat Launch	% Rail Modifier	% Road Modifier	Marinas	Substrate Mod.	% Substrate Mod.
0	0	0	0	0	2	0	1	0	No	0
<i>Comments:</i> 23 mooring buoys, 14 boats

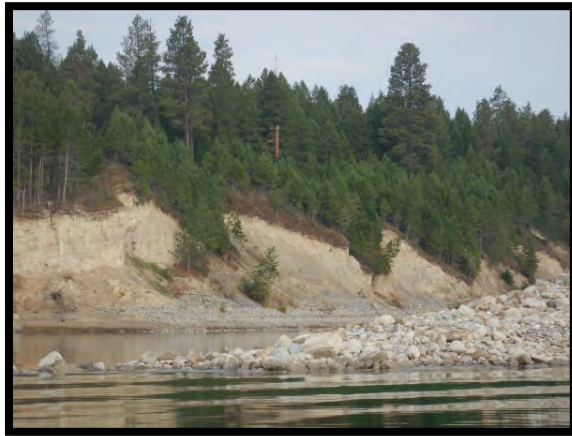
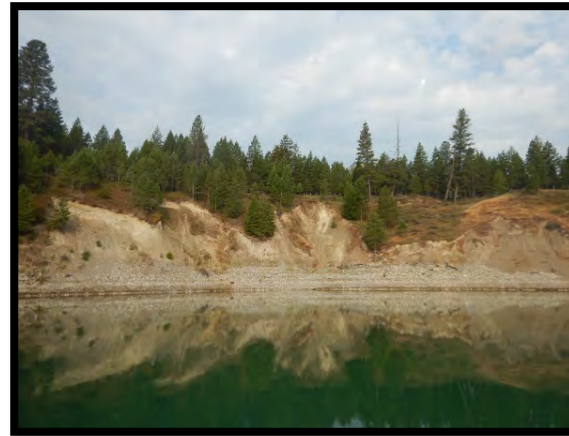
Lake Koocanusa Segment No. 2

Segment Length (km)	Shore Type	Shore Type Mod.	Slope	Land Use	Level of Impact	Livestock Access	Disturbed	Natural
3	Stream Mouth	Other	Steep (20-60)	Forestry	Low (<10%)	Yes	5	95
Comments: some low gradient areas, grassy, 1 private home, fields at top of bank

Retain Walls	% Ret. Wall	Ret. Wall Material	Docks	Docks per km	Boat Launch	% Rail Modifier	% Road Modifier	Marinas	Substrate Mod.	% Substrate Mod.
0	0	0	0	0	0	0	0	0	No	0
Comments: 1 moored boat

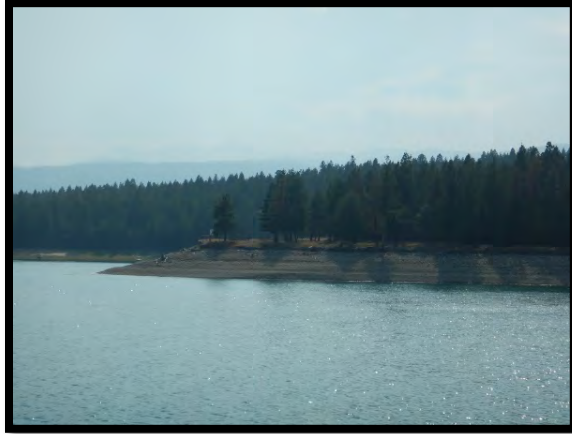
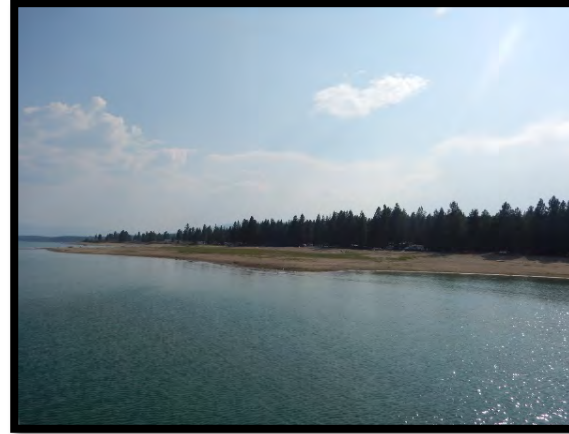
Lake Koochanusa Segment No. 3

Segment Length (km)	Shore Type	Shore Type Mod.	Slope	Land Use	Level of Impact	Livestock Access	Disturbed	Natural
4.2	Sand	None	Low (0-5)	Recreation	High (>40%)	Yes	80	20
Comments:		sandy shores campground

Retain Walls	% Ret. Wall	Ret. Wall Material	Docks	Docks per km	Boat Launch	% Rail Modifier	% Road Modifier	Marinas	Substrate Mod.	% Substrate Mod.
0	0	0	0	0	2	0	10	0	No	0
Comments:		gravel boat launches

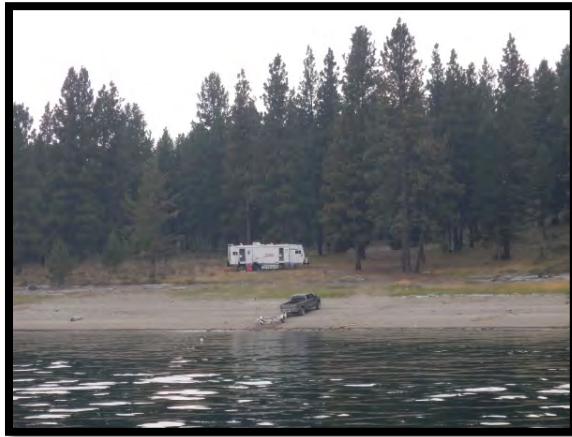
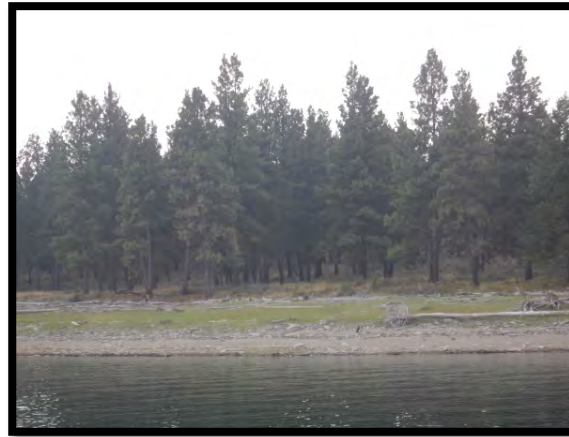
Lake Koocanusa Segment No. 4

Segment Length (km)	Shore Type	Shore Type Mod.	Slope	Land Use	Level of Impact	Livestock Access	Disturbed	Natural
1.6	Gravel	None	Low (0-5)	Natural Area	Low (<10%)	Yes	1	99
Comments: camping, boat access

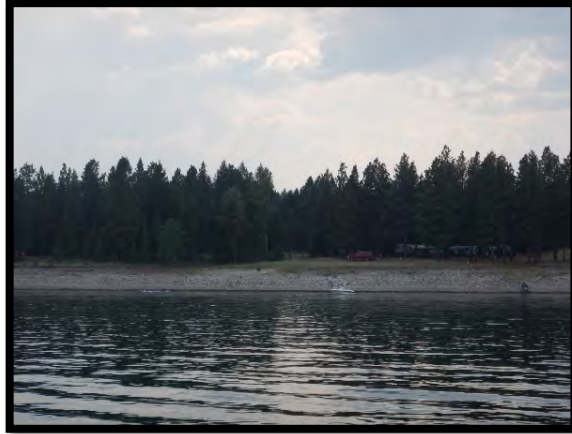
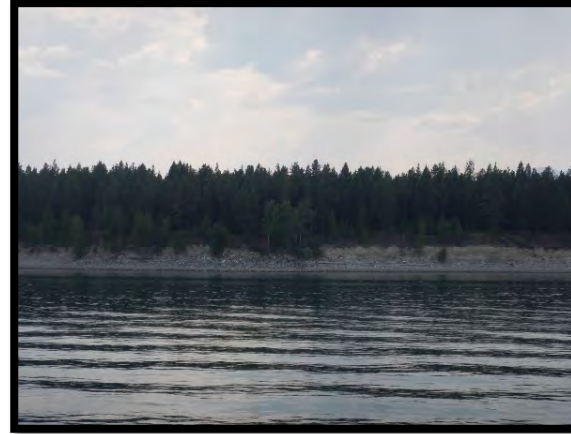
Lake Koocanusa Segment No. 5

Segment Length (km)	Shore Type	Shore Type Mod.	Slope	Land Use	Level of Impact	Livestock Access	Disturbed	Natural
2.5	Rocky Shore	Other	Steep (20-60)	Forestry	Low (<10%)	Yes	5	95
Comments:		camping, boat access

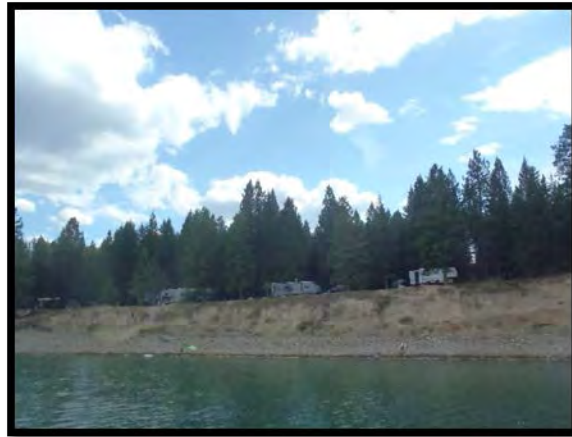
Lake Koocanusa Segment No. 6

Segment Length (km)	Shore Type	Shore Type Mod.	Slope	Land Use	Level of Impact	Livestock Access	Disturbed	Natural
3.7	Cliff/Bluff	Marina large (20+)	Very Steep (60+)	Single Family	High (>40%)	Yes	40	60
Comments: private/commercial/recreation

Retain Walls	% Ret. Wall	Ret. Wall Material	Docks	Docks per km	Boat Launch	% Rail Modifier	% Road Modifier	Marinas	Substrate Mod.	% Substrate Mod.
2	1	Concrete	1	0	0	0	10	1	No	0
Comments: 250 m floating breakwater, cattle fence

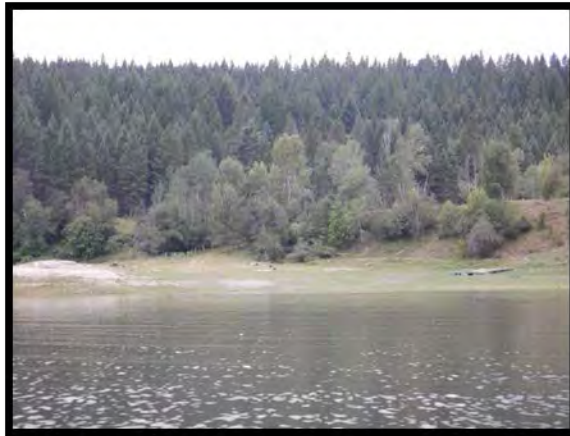
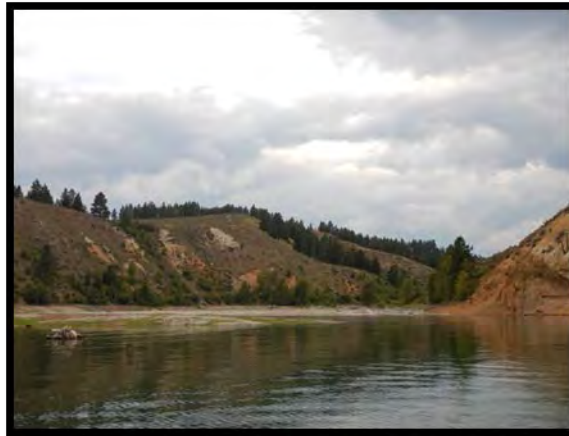
Lake Koocanusa Segment No. 7

Segment Length (km)	Shore Type	Shore Type Mod.	Slope	Land Use	Level of Impact	Livestock Access	Disturbed	Natural
1.4	Stream Mouth	Road	Low (0-5)	Natural Area	Low (<10%)	Yes	10	90
Comments: gold cr fan /outlet shallow bay

Retain Walls	% Ret. Wall	Ret. Wall Material	Docks	Docks per km	Boat Launch	% Rail Modifier	% Road Modifier	Marinas	Substrate Mod.	% Substrate Mod.
0	0	0	1	1	1	0	35	0	No	0
Comments: orv access/truck access

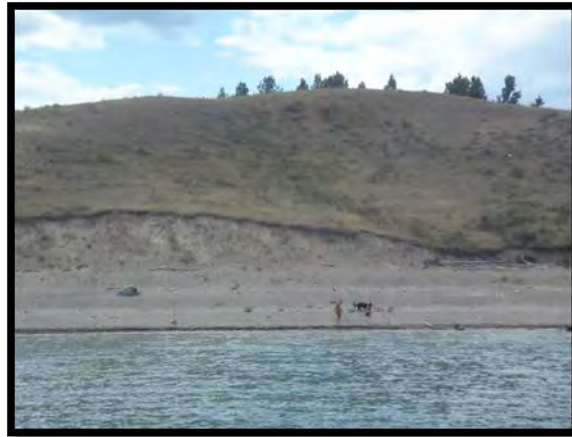
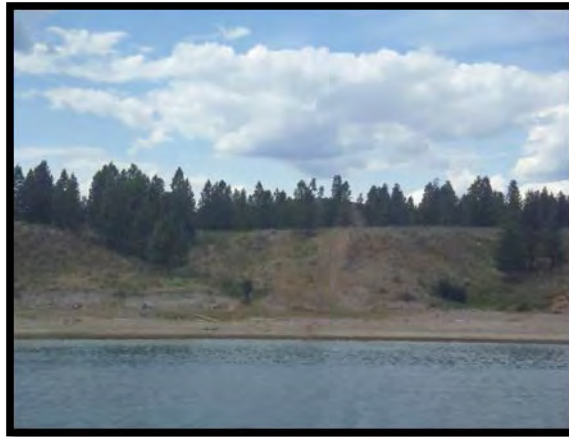
Lake Koochanusa Segment No. 8

Segment Length (km)	Shore Type	Shore Type Mod.	Slope	Land Use	Level of Impact	Livestock Access	Disturbed	Natural
2.1	Cliff/Bluff	None	Very Steep (60+)	Natural Area	Low (<10%)	Yes	10	90
Comments:		hoodoos

Retain Walls	% Ret. Wall	Ret. Wall Material	Docks	Docks per km	Boat Launch	% Rail Modifier	% Road Modifier	Marinas	Substrate Mod.	% Substrate Mod.
0	0	Other	0	0	0	0	0	0	No	0
Comments:		2 sailboats, cattle fence

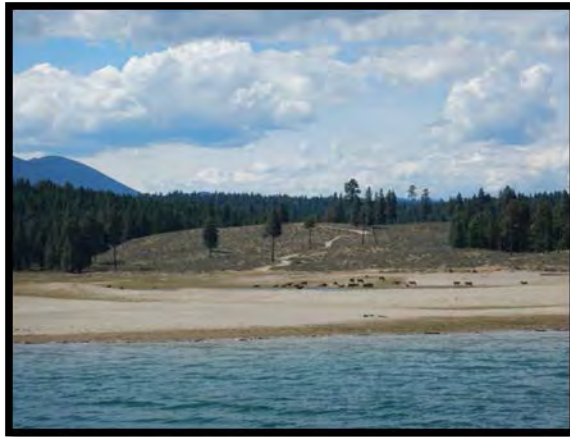
Lake Koocanusa Segment No. 9

Segment Length (km)	Shore Type	Shore Type Mod.	Slope	Land Use	Level of Impact	Livestock Access	Disturbed	Natural
2	Sand	Road	Moderate (5-20)	Natural Area	High (>40%)	Yes	80	20
Comments: sandy beach

Retain Walls	% Ret. Wall	Ret. Wall Material	Docks	Docks per km	Boat Launch	% Rail Modifier	% Road Modifier	Marinas	Substrate Mod.	% Substrate Mod.
0	0	Other	0	0	0	0	10	0	No	0
Comments: 25 cattle, 3 trailers, 8 boats, 2 house boats , 1 tent, dogs

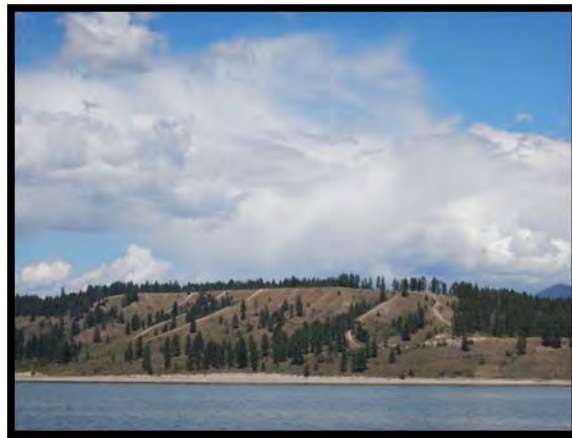
Lake Koocanusa Segment No. 10

Segment Length (km)	Shore Type	Shore Type Mod.	Slope	Land Use	Level of Impact	Livestock Access	Disturbed	Natural
7.4	Rocky Shore	Road	Very Steep (60+)	Forestry	Medium (10-40%)	Yes	25	75
<i>Comments:</i>

Retain Walls	% Ret. Wall	Ret. Wall Material	Docks	Docks per km	Boat Launch	% Rail Modifier	% Road Modifier	Marinas	Substrate Mod.	% Substrate Mod.
0	0	Other	0	0	2	0	0	0	No	0
<i>Comments:</i> 1 cattle fence, 4 docks, camping, roads/trails, 2 pocket beaches, swim platform

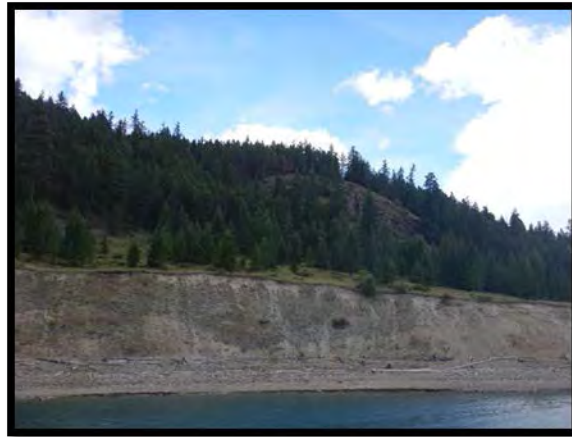
Lake Koocanusa Segment No. 11

Segment Length (km)	Shore Type	Shore Type Mod.	Slope	Land Use	Level of Impact	Livestock Access	Disturbed	Natural
3.7	Cliff/Bluff	None	Very Steep (60+)	Forestry	Low (<10%)	Yes	0	100
Comments:		wisa - wha

Retain Walls	% Ret. Wall	Ret. Wall Material	Docks	Docks per km	Boat Launch	% Rail Modifier	% Road Modifier	Marinas	Substrate Mod.	% Substrate Mod.
0	0	Other	0	0	0	0	0	0	No	0
Comments:		1 cattle fence, old skid road/forry road

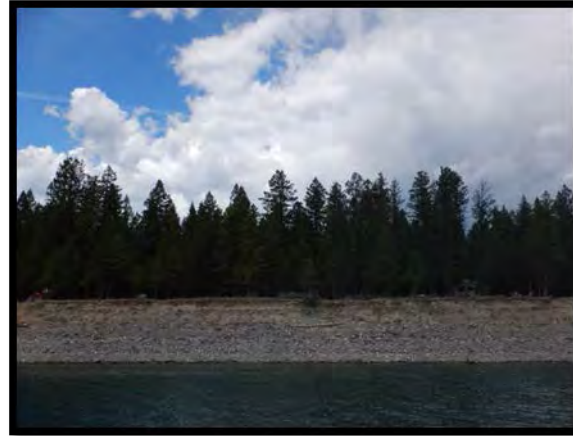
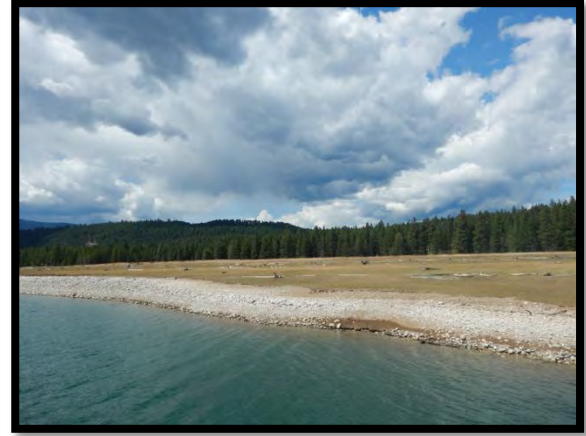
Lake Koochanusa Segment No. 12

Segment Length (km)	Shore Type	Shore Type Mod.	Slope	Land Use	Level of Impact	Livestock Access	Disturbed	Natural
2	Rocky Shore	Other	Steep (20-60)	Recreation	Medium (10-40%)	No	40	60
Comments:		steep gravel/boulder banks

Retain Walls	% Ret. Wall	Ret. Wall Material	Docks	Docks per km	Boat Launch	% Rail Modifier	% Road Modifier	Marinas	Substrate Mod.	% Substrate Mod.
0	0	Other	1	1	1	0	30	0	No	0
Comments:		gravel launch, 3 boats on shoreline

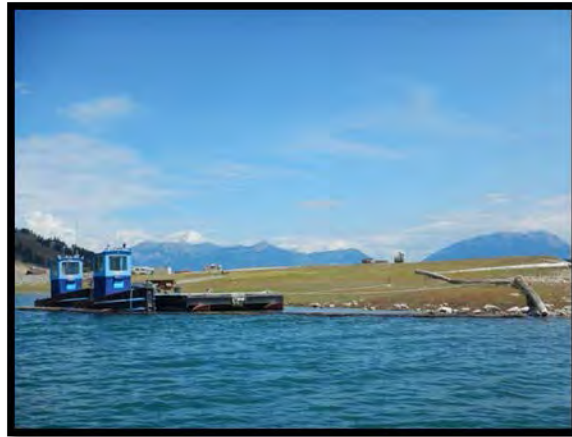
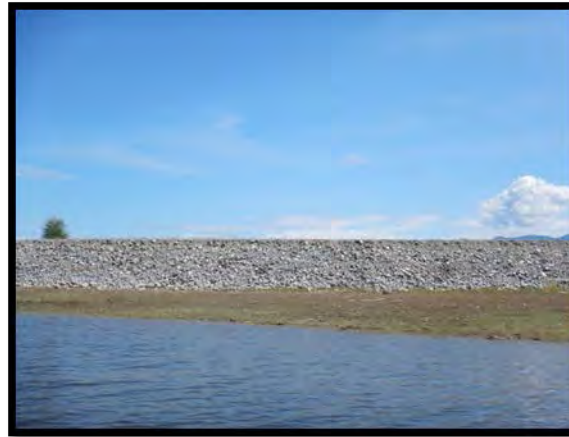
Lake Koocanusa Segment No. 13

Segment Length (km)	Shore Type	Shore Type Mod.	Slope	Land Use	Level of Impact	Livestock Access	Disturbed	Natural
1	Rocky Shore	Other	Moderate (5-20)	Industrial	Medium (10-40%)	Yes	50	50
Comments: shallow mud/grass bay adjacent Sweetwater s breakwater

Retain Walls	% Ret. Wall	Ret. Wall Material	Docks	Docks per km	Boat Launch	% Rail Modifier	% Road Modifier	Marinas	Substrate Mod.	% Substrate Mod.
0	0	Other	1	1	0	0	30	0	No	0
Comments: 5 marker buoys, 2 log breakwater, 1 propane tank, 2 tugs

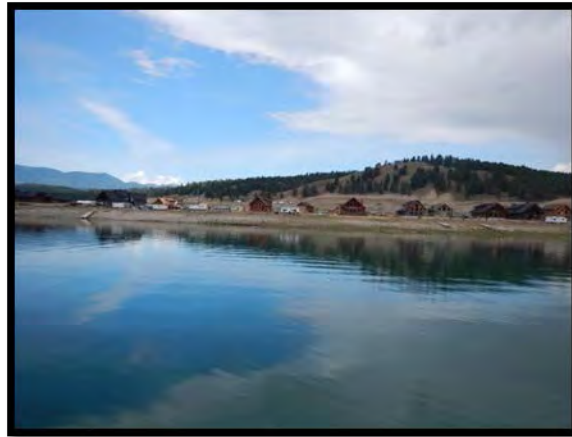
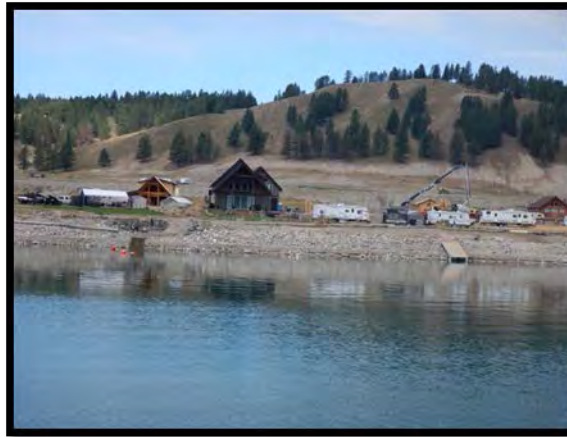
Lake Koocanusa Segment No. 14

Segment Length (km)	Shore Type	Shore Type Mod.	Slope	Land Use	Level of Impact	Livestock Access	Disturbed	Natural
2.7	Gravel	Marina large (20+)	Bench	Single Family	High (>40%)	No	100	0
Comments:		Sweetwater

Retain Walls	% Ret. Wall	Ret. Wall Material	Docks	Docks per km	Boat Launch	% Rail Modifier	% Road Modifier	Marinas	Substrate Mod.	% Substrate Mod.
3	1	Mixed	20	10	1	0	100	1	Yes	1
Comments:		30 mooring buoys, 9 stairs, 4 swimming platforms, 4 log booms - 800 m, 1 boat basin n end

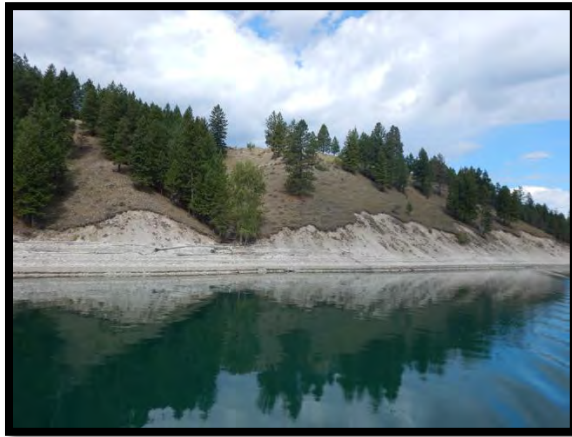
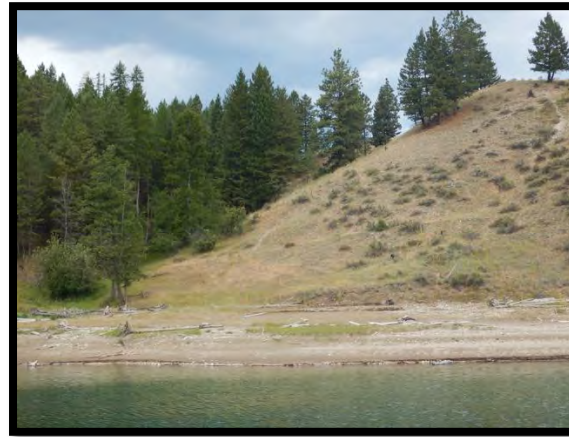
Lake Koocanusa Segment No. 15

Segment Length (km)	Shore Type	Shore Type Mod.	Slope	Land Use	Level of Impact	Livestock Access	Disturbed	Natural
1.3	Cliff/Bluff	Road	Very Steep (60+)	Forestry	Low (<10%)	Yes	5	95
Comments:		1 private home with landscaping, active bank erosion

Retain Walls	% Ret. Wall	Ret. Wall Material	Docks	Docks per km	Boat Launch	% Rail Modifier	% Road Modifier	Marinas	Substrate Mod.	% Substrate Mod.
1	1	Stonework	1	1	0	0	10	0	No	0
Comments:		4 pilings , 1 mooring buoy

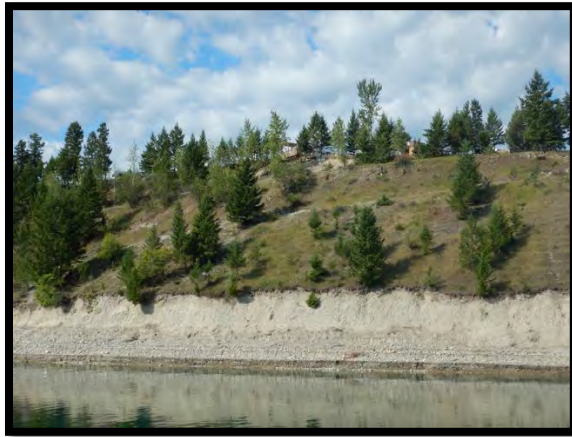
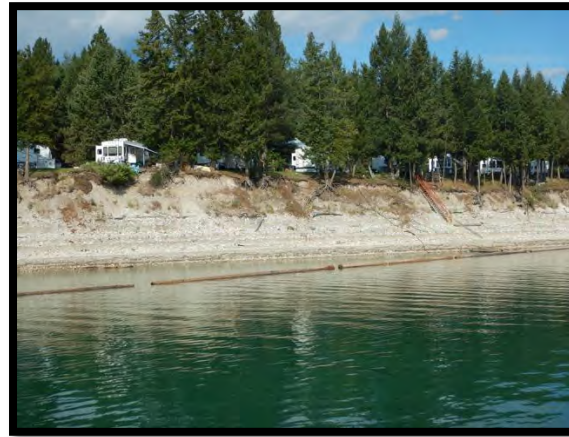
Lake Koochanusa Segment No. 16

Segment Length (km)	Shore Type	Shore Type Mod.	Slope	Land Use	Level of Impact	Livestock Access	Disturbed	Natural
1.8	Cliff/Bluff	Marina large (20+)	Very Steep (60+)	Commercial	High (>40%)	No	100	0
Comments: extensive development on steep banks/bluffs

Retain Walls	% Ret. Wall	Ret. Wall Material	Docks	Docks per km	Boat Launch	% Rail Modifier	% Road Modifier	Marinas	Substrate Mod.	% Substrate Mod.
0	0	0	2	2	1	0	100	3	Yes	5
Comments: 1 concrete boat launch, 8 stairs, 2 trails, 4 swimming platform platforms, 2 mooring buoys, fences

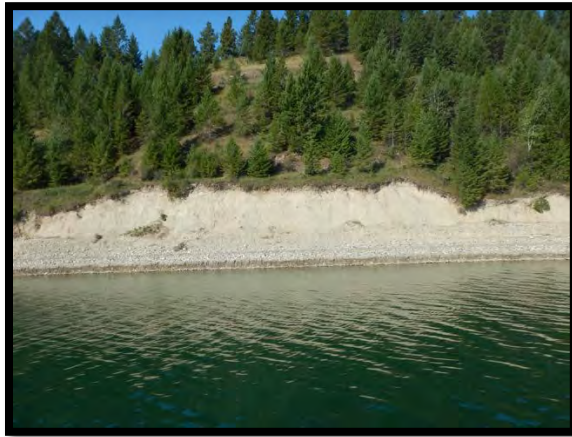
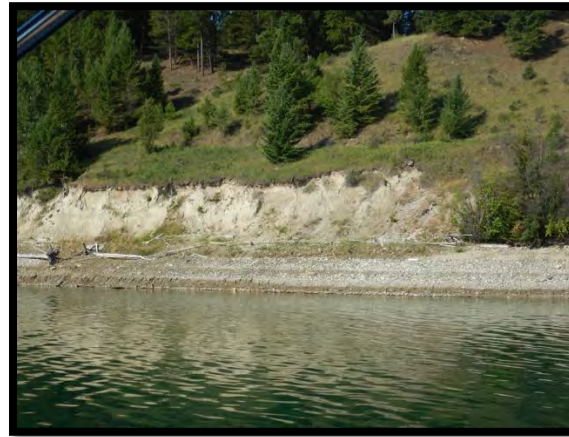
Lake Koochanusa Segment No. 17

Segment Length (km)	Shore Type	Shore Type Mod.	Slope	Land Use	Level of Impact	Livestock Access	Disturbed	Natural
2.4	Cliff/Bluff	None	Very Steep (60+)	Forestry	Low (<10%)	Yes	5	95
Comments: significant steep eroding clay/sand bluffs

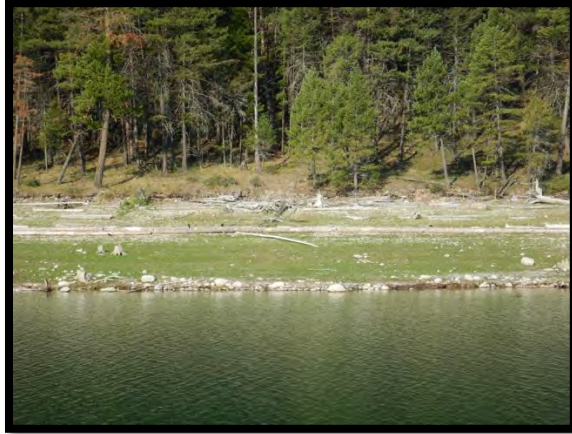
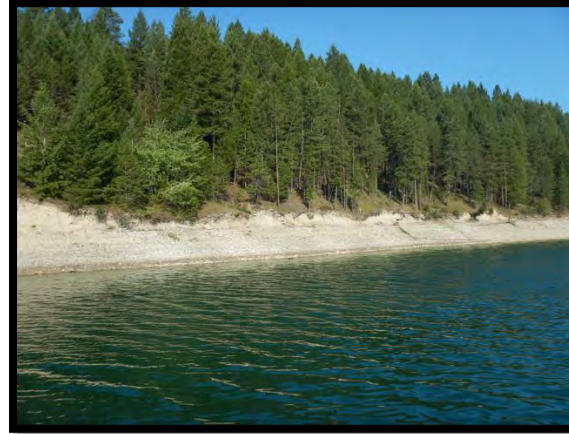
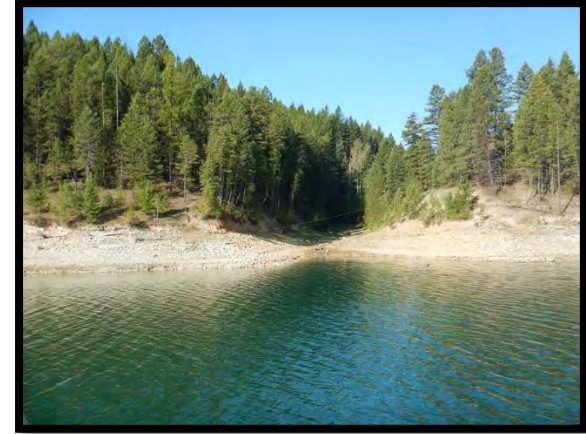
Lake Koocanusa Segment No. 18

Segment Length (km)	Shore Type	Shore Type Mod.	Slope	Land Use	Level of Impact	Livestock Access	Disturbed	Natural
3.7	Gravel	None	Steep (20-60)	Forestry	Low (<10%)	Yes	0	100
Comments:

Retain Walls	% Ret. Wall	Ret. Wall Material	Docks	Docks per km	Boat Launch	% Rail Modifier	% Road Modifier	Marinas	Substrate Mod.	% Substrate Mod.
0	0	0	0	0	0	0	0	0	No	0
Comments: 1 mooring buoy, 500m log boom/breakwater at north end, 1 rope swing

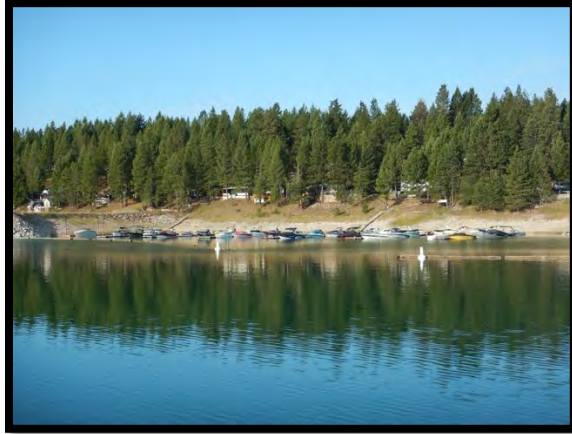
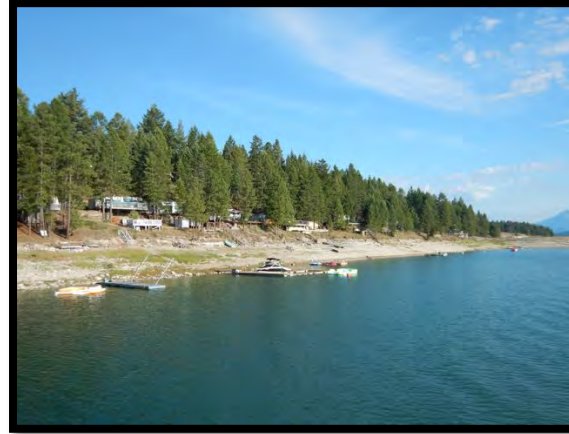
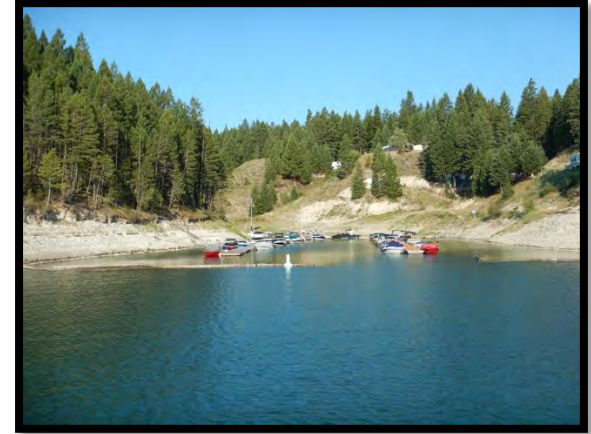
Lake Koocanusa Segment No. 19

Segment Length (km)	Shore Type	Shore Type Mod.	Slope	Land Use	Level of Impact	Livestock Access	Disturbed	Natural
0.9	Sand	Marina large (20+)	Moderate (5-20)	Commercial	High (>40%)	No	100	0
Comments:		Cutts marinas and rv park

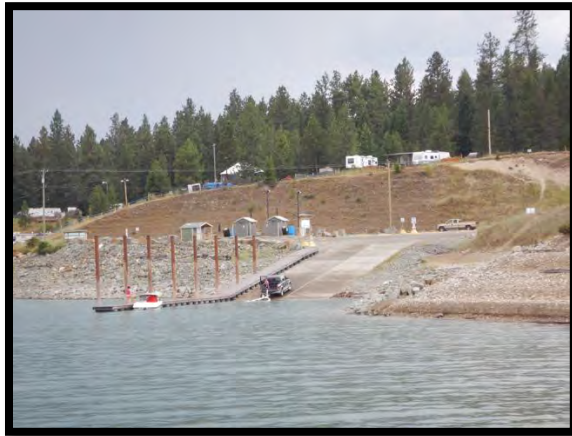
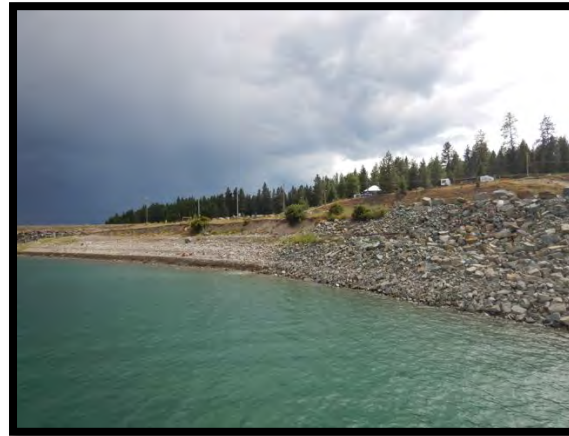
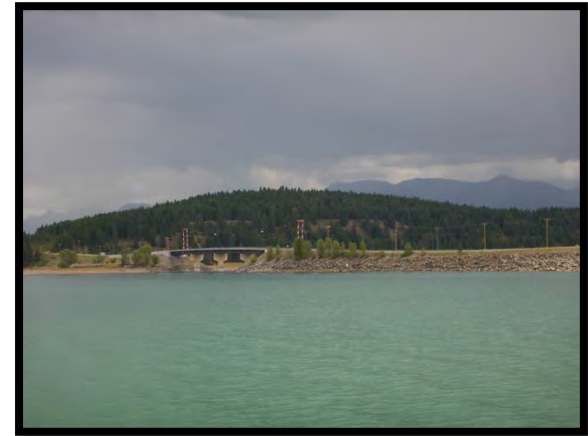
Lake Koochanusa Segment No. 20

Segment Length (km)	Shore Type	Shore Type Mod.	Slope	Land Use	Level of Impact	Livestock Access	Disturbed	Natural
1.6	Other	Road	Steep (20-60)	Industrial	High (>40%)	No	98	2
Comments: large boat launch/riprap causeway /highway

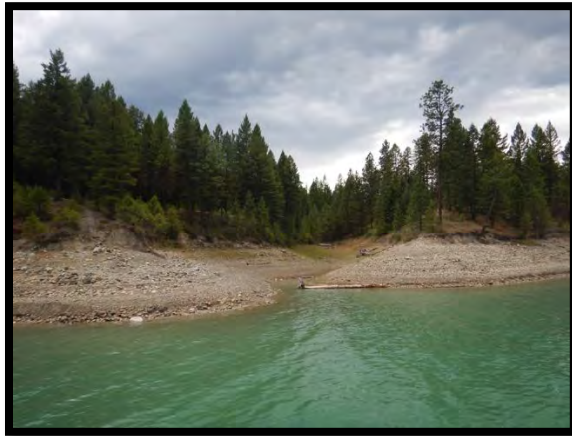
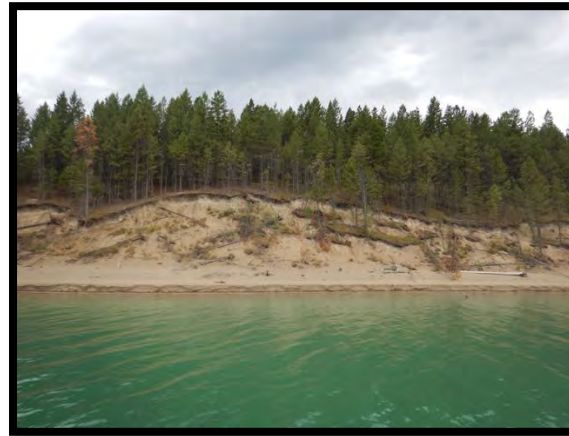
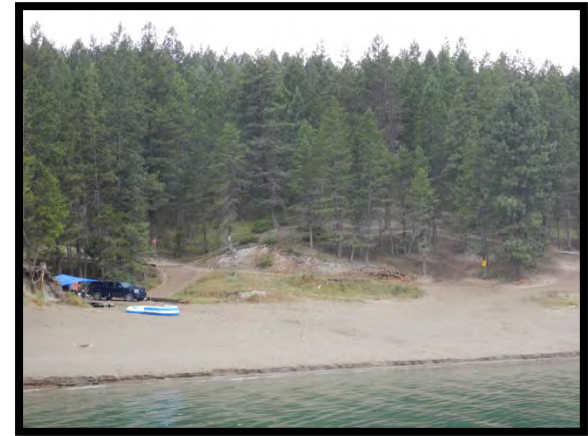
Lake Koocanusa Segment No. 21

Segment Length (km)	Shore Type	Shore Type Mod.	Slope	Land Use	Level of Impact	Livestock Access	Disturbed	Natural
3.5	Gravel	Road	Low (0-5)	Forestry	Low (<10%)	Yes	2	98
Comments: In end gravel/rocky s end eroding sandy cliffs

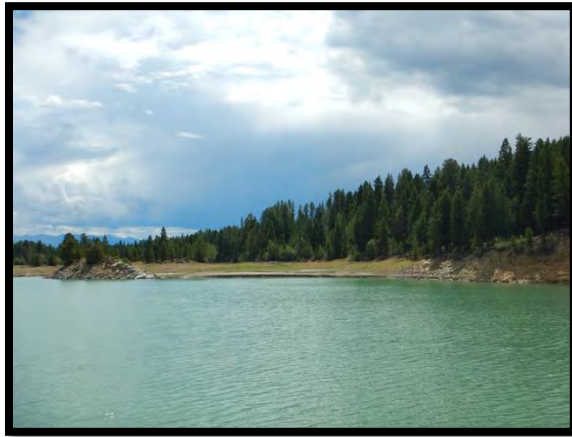
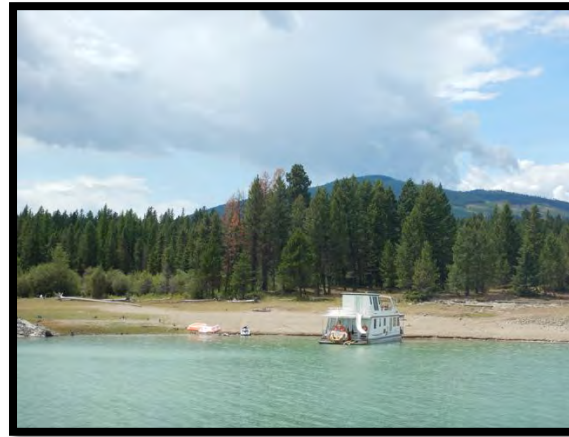
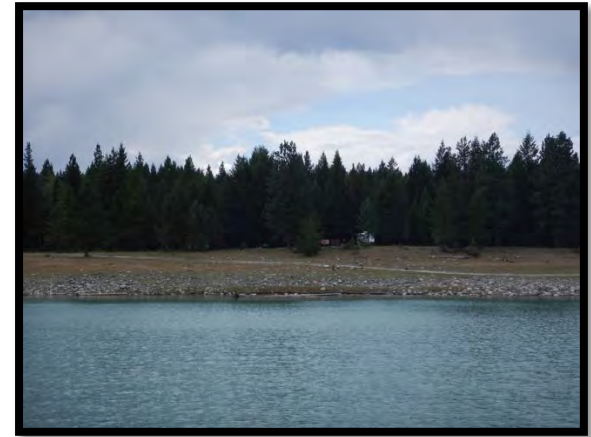
Lake Kocanusa Segment No. 22

Segment Length (km)	Shore Type	Shore Type Mod.	Slope	Land Use	Level of Impact	Livestock Access	Disturbed	Natural
5	Rocky Shore	Road	Moderate (5-20)	Forestry	High (>40%)	Yes	50	50
Comments: bedrock/rubble/boulder/sand-gravel, steep at start 600 m then low bench

Mud	Organics	Fine	Sand	Gravel	Cobble	Boulder	Bedrock
0	0	5	10	20	5	20	40
Comments: broken bedrock common

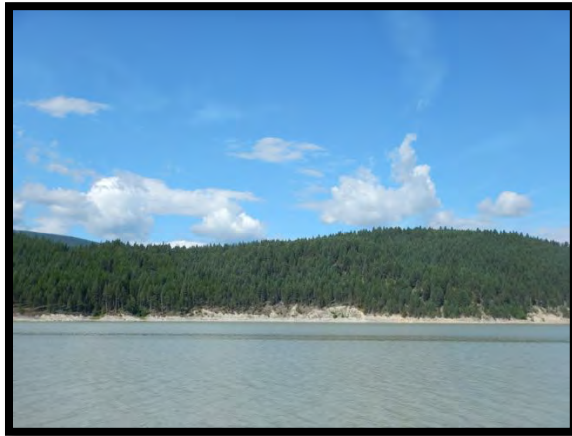
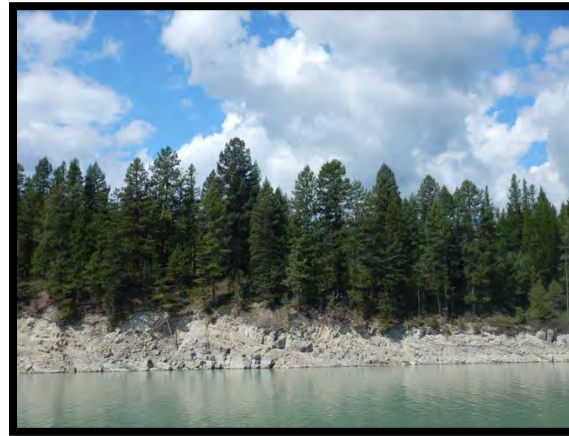
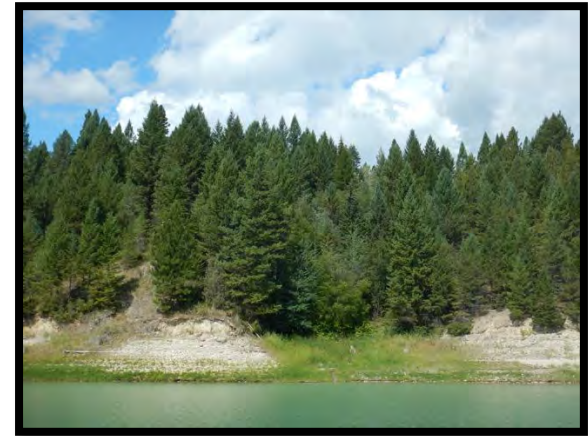
Lake Koocanusa Segment No. 23

Segment Length (km)	Shore Type	Shore Type Mod.	Slope	Land Use	Level of Impact	Livestock Access	Disturbed	Natural
11.5	Rocky Shore	Road	Steep (20-60)	Forestry	Low (<10%)	Yes	5	95
Comments:		bedrock much more prevalent than east shore

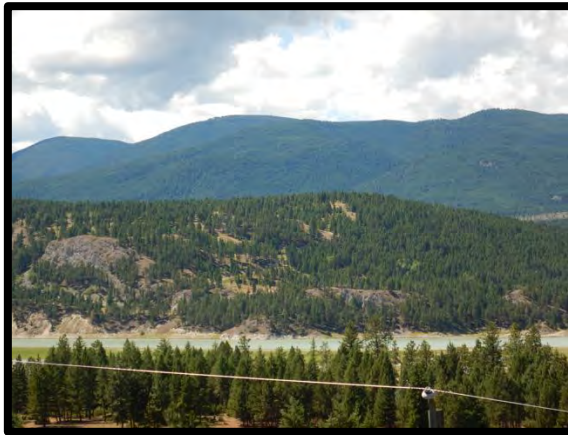
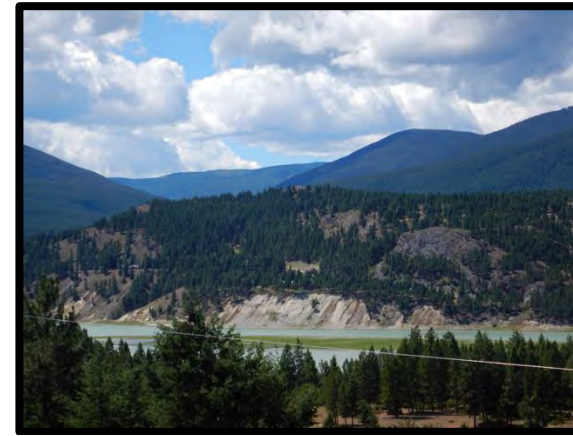
Lake Koocanusa Segment No. 24

Segment Length (km)	Shore Type	Shore Type Mod.	Slope	Land Use	Level of Impact	Livestock Access	Disturbed	Natural
2.5	Cliff/Bluff	Road	Very Steep (60+)	Natural Area	Low (<10%)	No	1	99
Comments: south of wardner town site-osprey landing

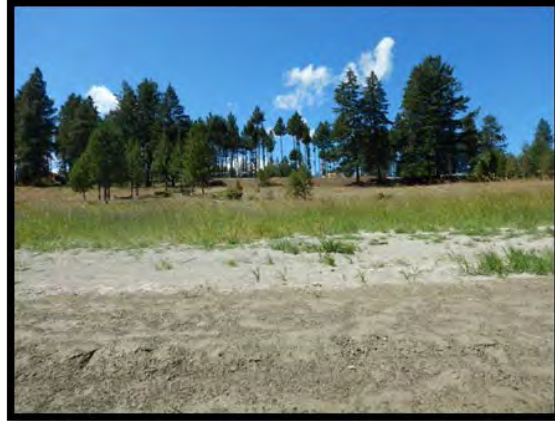
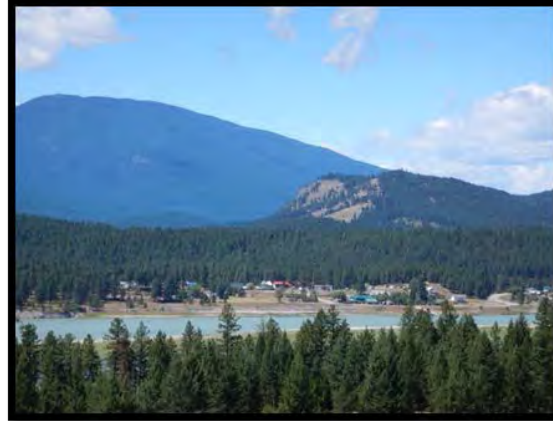
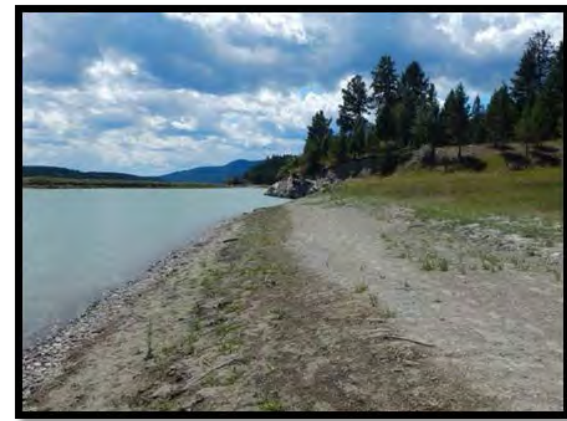
Lake Koocanusa Segment No. 25

Segment Length (km)	Shore Type	Shore Type Mod.	Slope	Land Use	Level of Impact	Livestock Access	Disturbed	Natural
3.7	Gravel	Road	Moderate (5-20)	Single Family	High (>40%)	No	90	10
Comments:		wardner town site
