**LAKE KOOCANUSA
FORESHORE INVENTORY AND MAPPING AND AQUATIC HABITAT
INDEX**

East Kootenay Integrated Lake
Management Partnership

VAST Resource Solutions Inc.

Oct 17, 2017

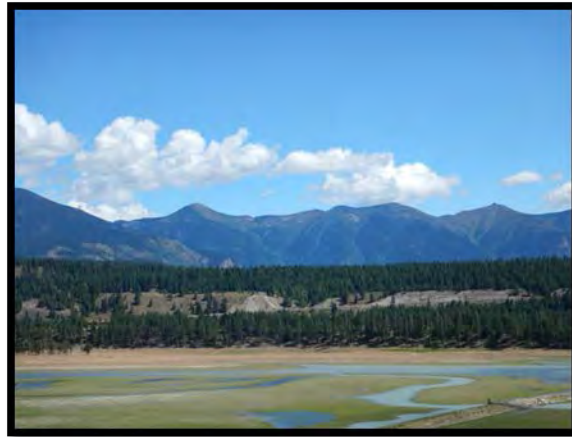
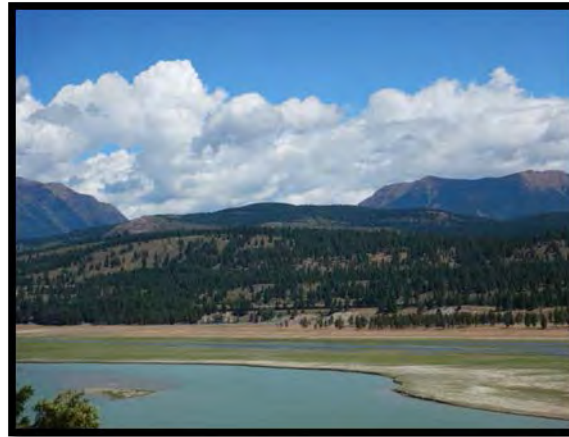
Lake Koocanusa Segment No. 26

Segment Length (km)	Shore Type	Shore Type Mod.	Slope	Land Use	Level of Impact	Livestock Access	Disturbed	Natural
6.5	Other	Road	Low (0-5)	Agriculture	High (>40%)	Yes	50	50
Comments: grazing fields

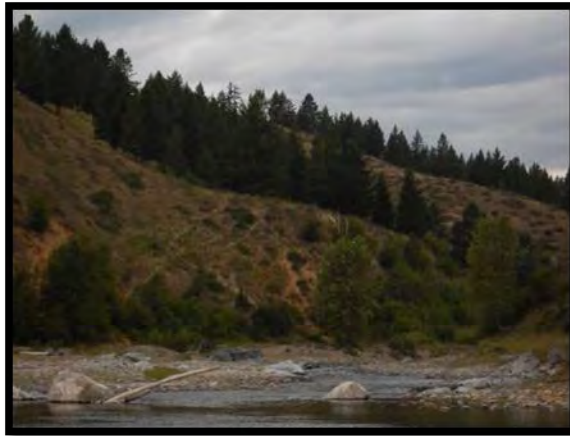
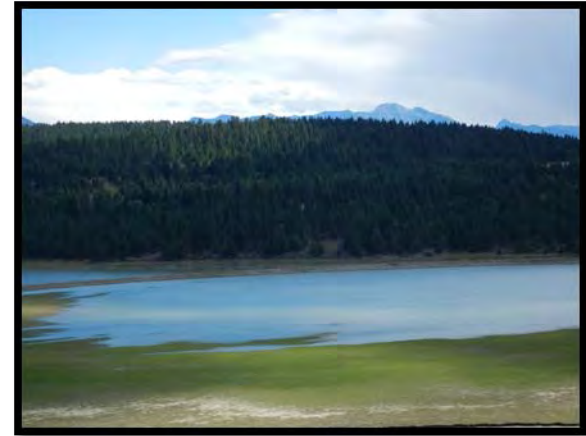
Lake Koochanusa Segment No. 27

Segment Length (km)	Shore Type	Shore Type Mod.	Slope	Land Use	Level of Impact	Livestock Access	Disturbed	Natural
3.4	Gravel	Road	Moderate (5-20)	Rural	None	Yes	20	80
Comments: frontage old rail line

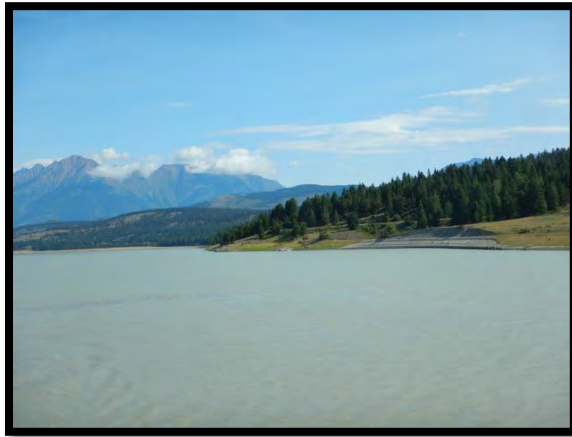
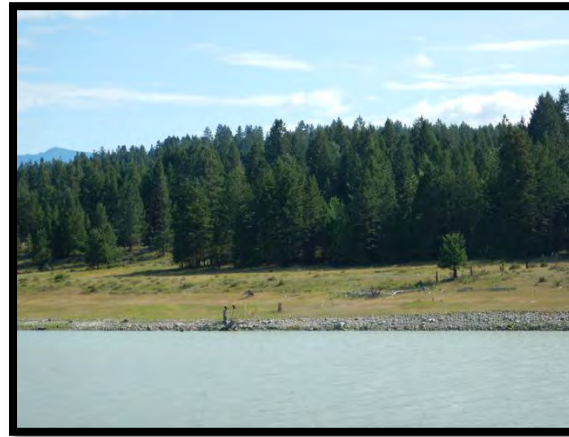
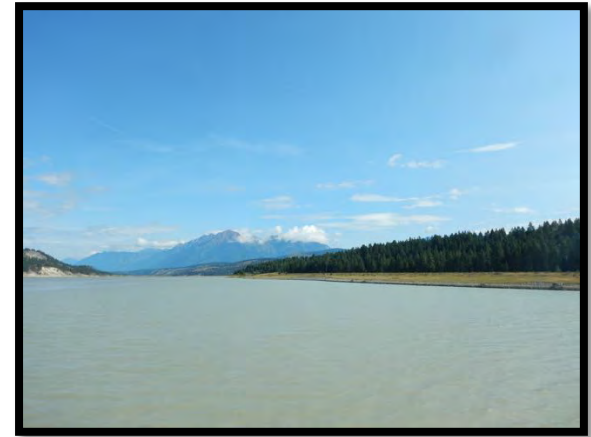
Lake Koochanusa Segment No. 28

Segment Length (km)	Shore Type	Shore Type Mod.	Slope	Land Use	Level of Impact	Livestock Access	Disturbed	Natural
1.2	Gravel	Railway	Moderate (5-20)	Agriculture	Medium (10-40%)	Yes	50	50
Comments: 90 percent low grassy bench, stopped short 200m of end of segment water too shallow

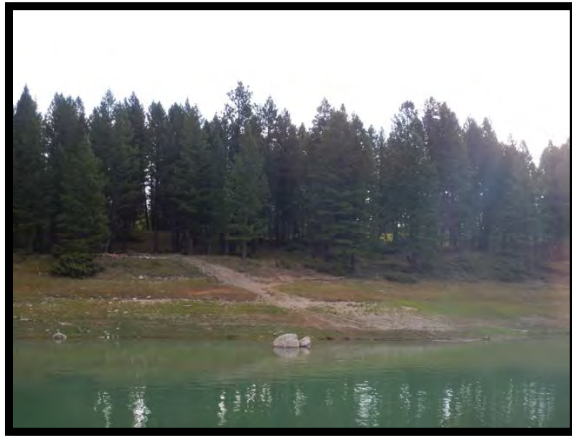
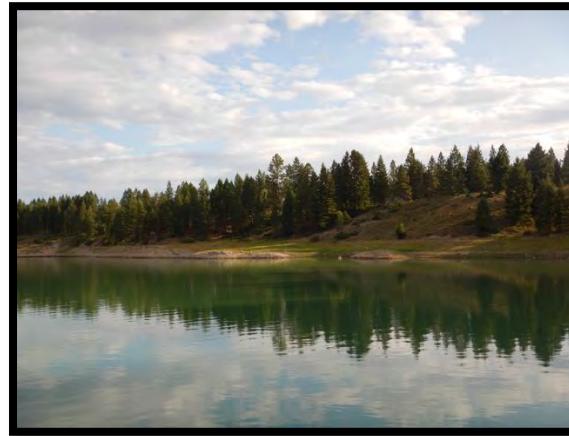
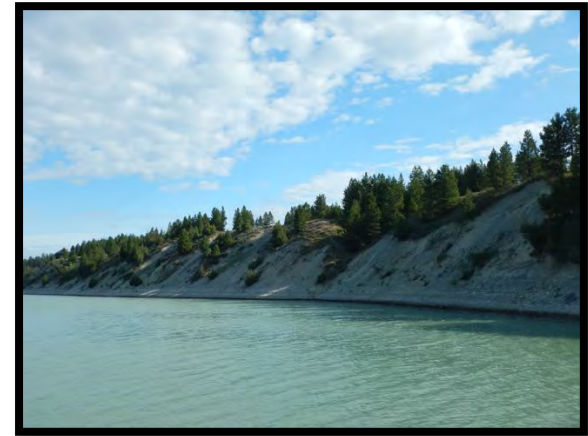
Lake Koocanusa Segment No. 29

Segment Length (km)	Shore Type	Shore Type Mod.	Slope	Land Use	Level of Impact	Livestock Access	Disturbed	Natural
11	Gravel	Road	Very Steep (60+)	Forestry	Low (<10%)	Yes	5	95
Comments: predominantly steep, 1 short section 800-1,000m of low and moderate gradient,

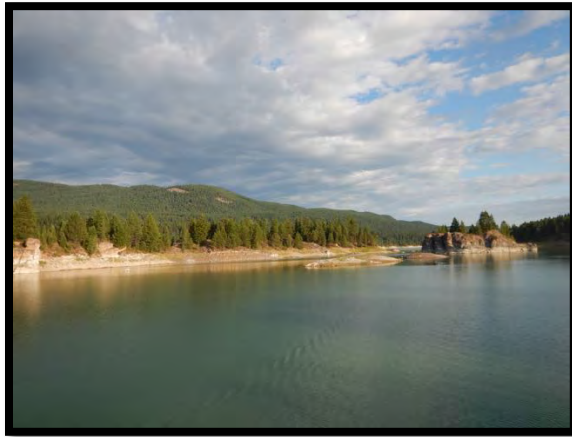
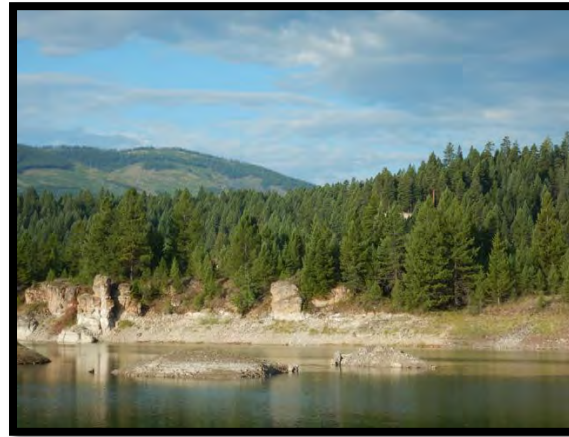
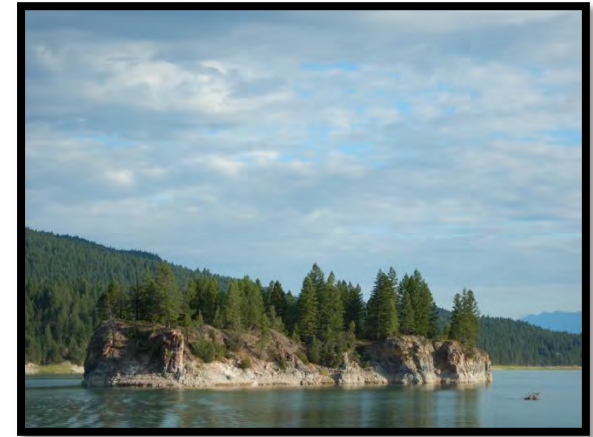
Lake Koochanusa Segment No. 30

Segment Length (km)	Shore Type	Shore Type Mod.	Slope	Land Use	Level of Impact	Livestock Access	Disturbed	Natural
2	Cliff/Bluff	None	Very Steep (60+)	Forestry	Low (<10%)	No	1	99
Comments: bedrock/broken bedrock /rubble piles- islands 3 large, several small

Mud	Organics	Fine	Sand	Gravel	Cobble	Boulder	Bedrock
0	0	10	0	10	0	20	60
Comments: angular broken rock

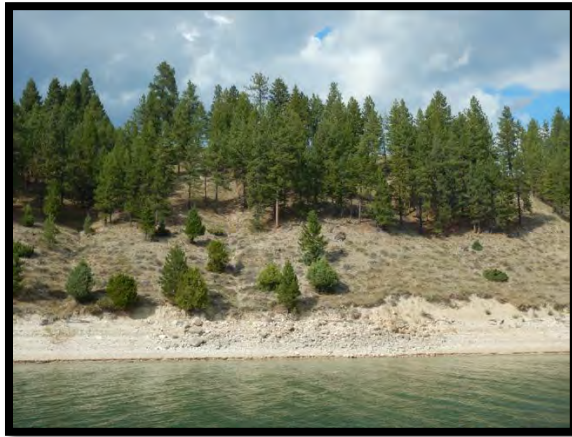
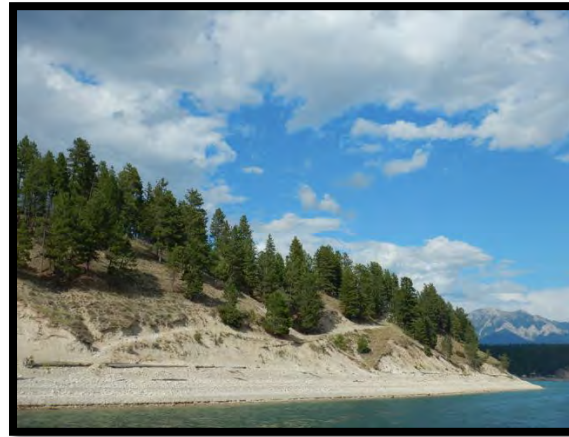
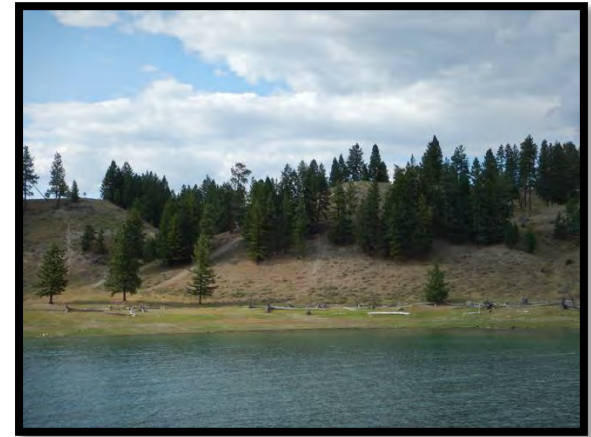
Lake Koocanusa Segment No. 31

Segment Length (km)	Shore Type	Shore Type Mod.	Slope	Land Use	Level of Impact	Livestock Access	Disturbed	Natural
4.1	Gravel	None	Very Steep (60+)	Forestry	Low (<10%)	Yes	5	95
Comments:	cliff bluffs

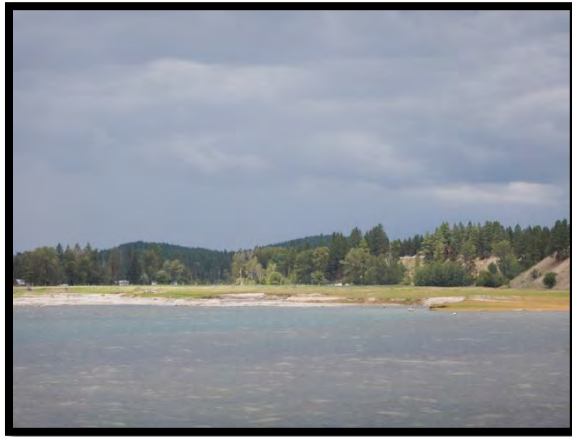
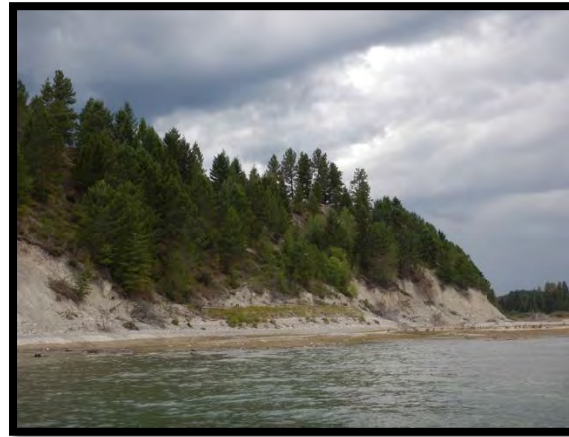
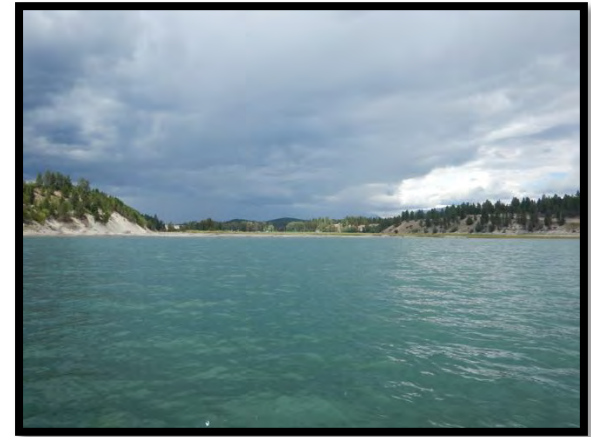
Lake Koochanusa Segment No. 32

Segment Length (km)	Shore Type	Shore Type Mod.	Slope	Land Use	Level of Impact	Livestock Access	Disturbed	Natural
1.8	Stream Mouth	None	Low (0-5)	Natural Area	Low (<10%)	Yes	10	90
Comments:		sand creek outlet fan/braided channels

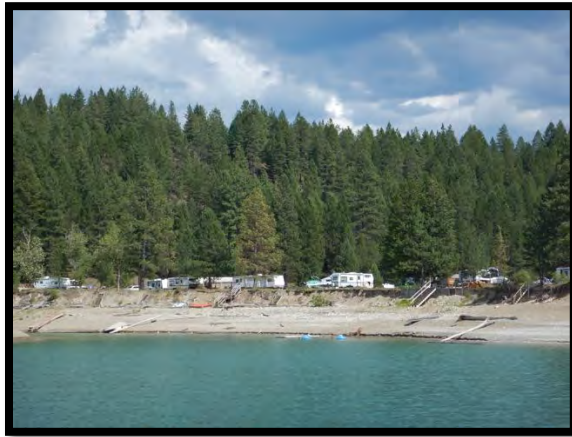
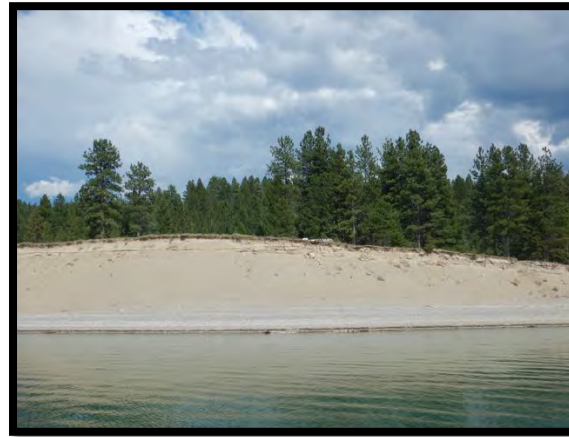
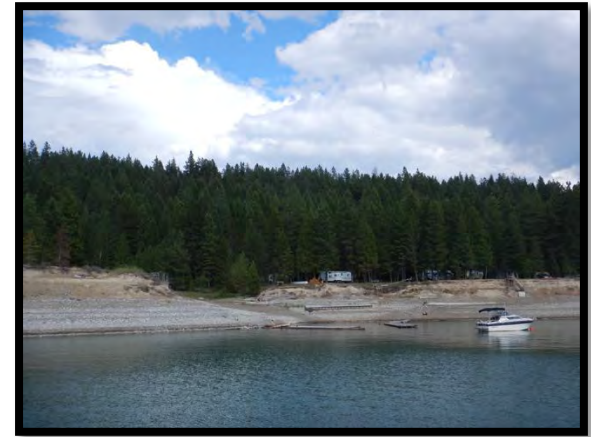
Lake Koochanusa Segment No. 33

Segment Length (km)	Shore Type	Shore Type Mod.	Slope	Land Use	Level of Impact	Livestock Access	Disturbed	Natural
3.9	Gravel	Road	Steep (20-60)	Recreation	High (>40%)	No	80	20
Comments:		gravel, some sand banks

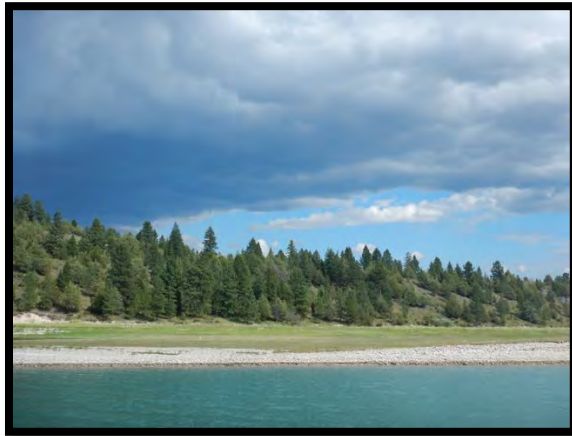
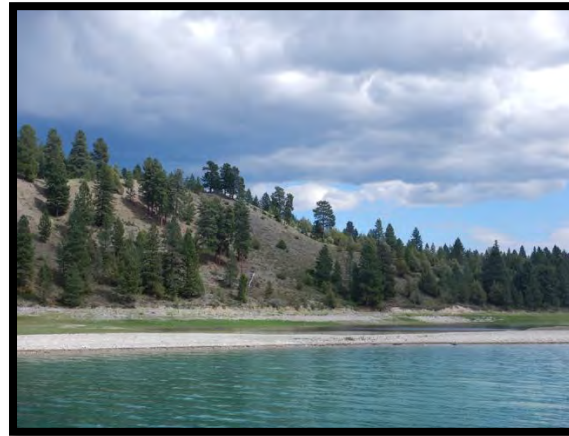
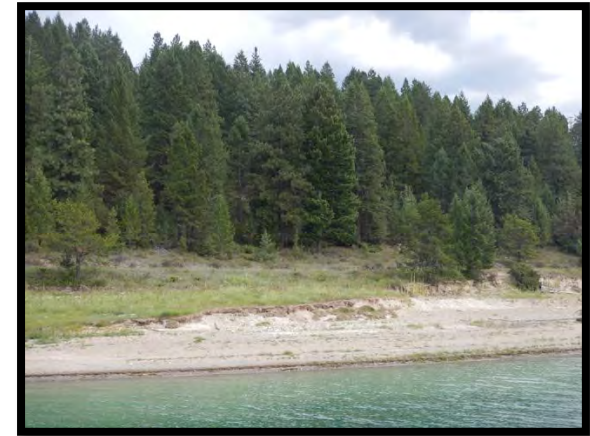
Lake Koocanusa Segment No. 34

Segment Length (km)	Shore Type	Shore Type Mod.	Slope	Land Use	Level of Impact	Livestock Access	Disturbed	Natural
3.1	Gravel	Road	Steep (20-60)	Forestry	High (>40%)	Yes	50	50
Comments: gravel shoreline with variable width 20 - 100 m grassy benches below full pool

Retain Walls	% Ret. Wall	Ret. Wall Material	Docks	Docks per km	Boat Launch	% Rail Modifier	% Road Modifier	Marinas	Substrate Mod.	% Substrate Mod.
0	0	0	0	0	0	0	50	0	No	0
Comments: orv trails to water

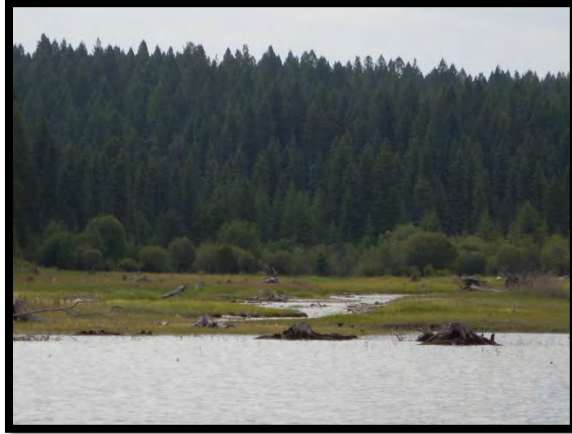
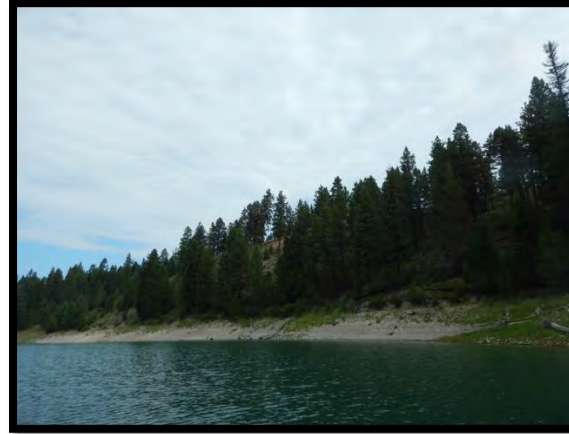
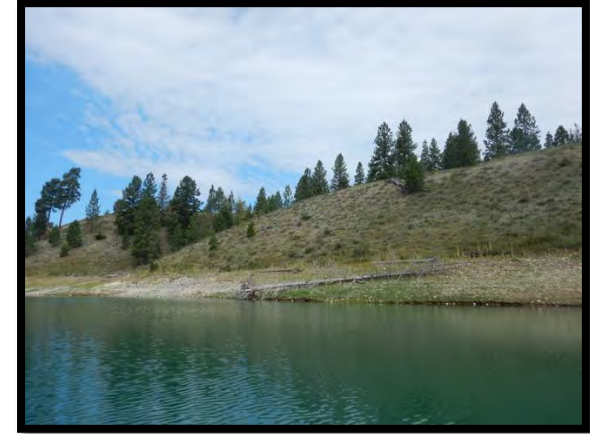
Lake Koochanusa Segment No. 35

Segment Length (km)	Shore Type	Shore Type Mod.	Slope	Land Use	Level of Impact	Livestock Access	Disturbed	Natural
2.2	Gravel	Road	Steep (20-60)	Forestry	Low (<10%)	Yes	2	98
Comments:		Kikomun inlet road at western entrance

Retain Walls	% Ret. Wall	Ret. Wall Material	Docks	Docks per km	Boat Launch	% Rail Modifier	% Road Modifier	Marinas	Substrate Mod.	% Substrate Mod.
0	0	0	0	0	0	0	0	0	No	0
Comments:		2 orv trails to water

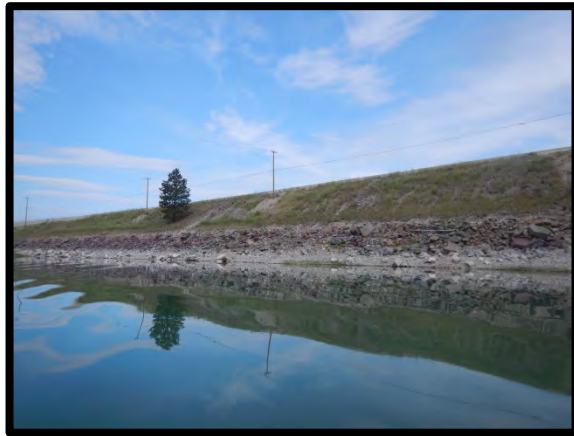
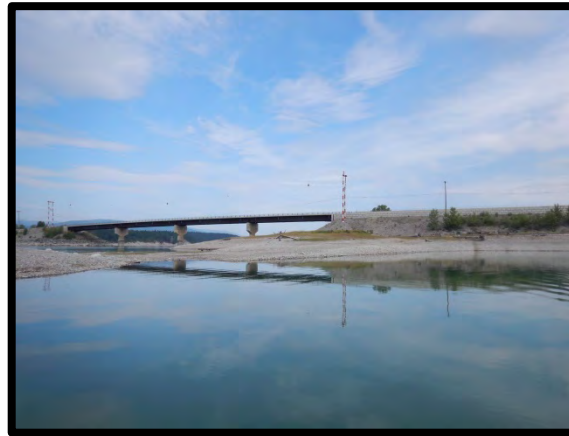
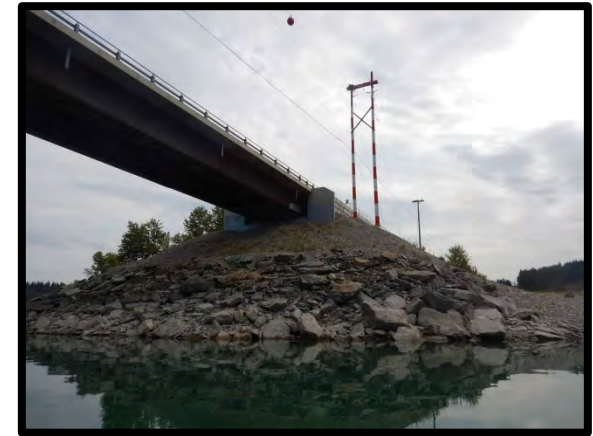
Lake Koochanusa Segment No. 36

Segment Length (km)	Shore Type	Shore Type Mod.	Slope	Land Use	Level of Impact	Livestock Access	Disturbed	Natural
1.4	Other	Road	Steep (20-60)	Industrial	High (>40%)	No	70	30
Comments:		east side Kikomun crossing causeway

Agriculture	Commercial	Forestry	Industrial	Natural Area	Park	Recreation	Rural	Single Family
0	0	0	70	30	0	0	0	0
Comments:		causeway overlaying natural gravel deposit

Class	Stage	Shrub Cover	Tree Cover	Distribution	Bandwidth (m)
Exposed soil	Sparse	None	None	Patchy	10
Comments:		grasses/shrub/trees on gravel deposit under causeway and spreading out both sides n and s at bridge

Retain Walls	% Ret. Wall	Ret. Wall Material	Docks	Docks per km	Boat Launch	% Rail Modifier	% Road Modifier	Marinas	Substrate Mod.	% Substrate Mod.
0	0	0	0	0	1	0	0	0	No	0
Comments:		1 orphan dock, low water boat launch

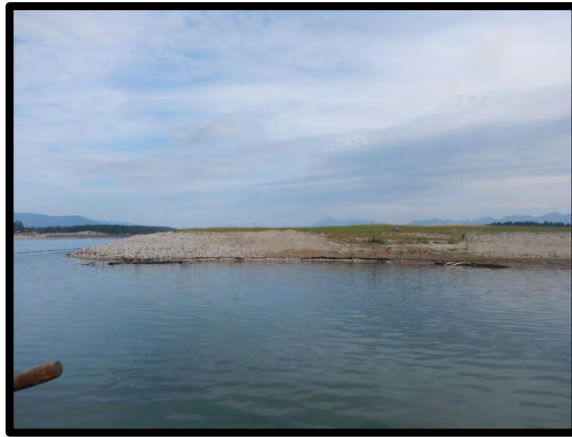
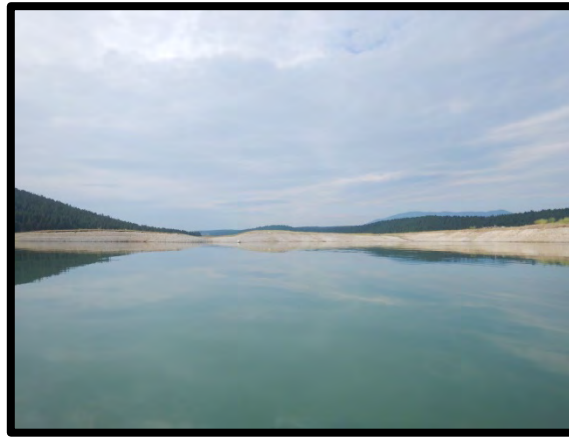
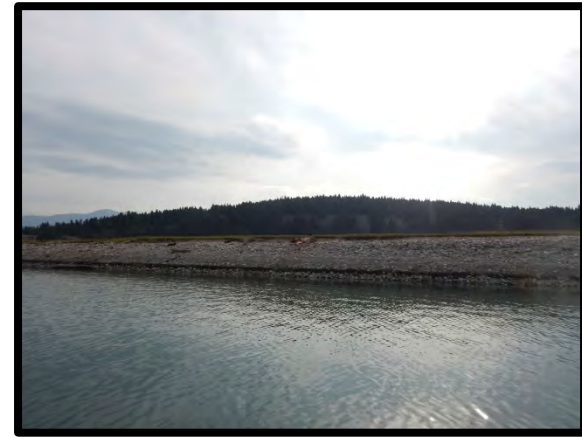
Lake Koocanusa Segment No. 37

Segment Length (km)	Shore Type	Shore Type Mod.	Slope	Land Use	Level of Impact	Livestock Access	Disturbed	Natural
1.9	Gravel	None	Moderate (5-20)	Natural Area	Low (<10%)	No	5	95
Comments:		island at south Kikomun crossing

Retain Walls	% Ret. Wall	Ret. Wall Material	Docks	Docks per km	Boat Launch	% Rail Modifier	% Road Modifier	Marinas	Substrate Mod.	% Substrate Mod.
0	0	0	0	0	1	0	0	0	No	0
Comments:		numerous gravel boat launches depending on water level

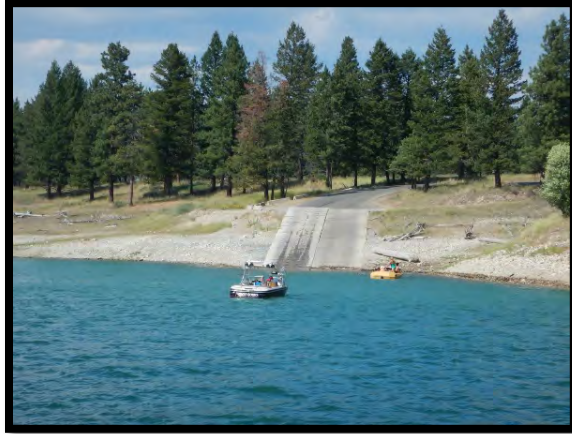
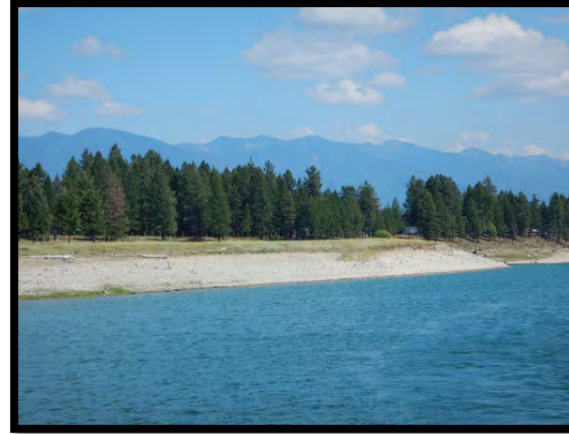
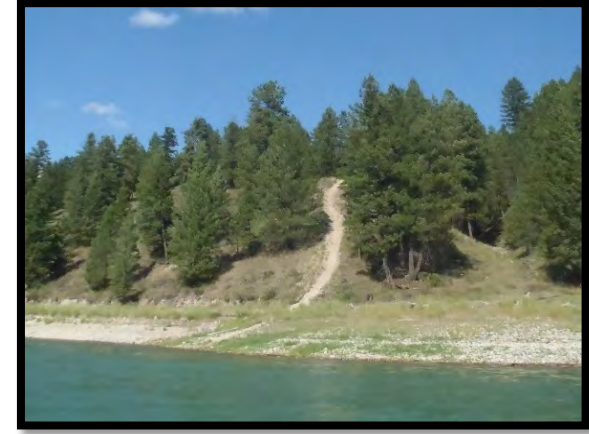
Lake Koocanusa Segment No. 38

Segment Length (km)	Shore Type	Shore Type Mod.	Slope	Land Use	Level of Impact	Livestock Access	Disturbed	Natural
5.9	Gravel	Other	Moderate (5-20)	Park	Medium (10-40%)	No	40	60
Comments:		Kikomun park

Retain Walls	% Ret. Wall	Ret. Wall Material	Docks	Docks per km	Boat Launch	% Rail Modifier	% Road Modifier	Marinas	Substrate Mod.	% Substrate Mod.
0	0	0	0	0	3	0	15	0	No	0
Comments:		foreshore was groomed by parks boat basins, 1 double concrete, 2 gravel

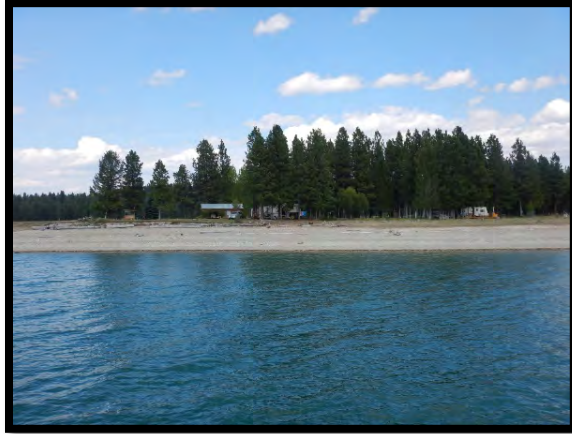
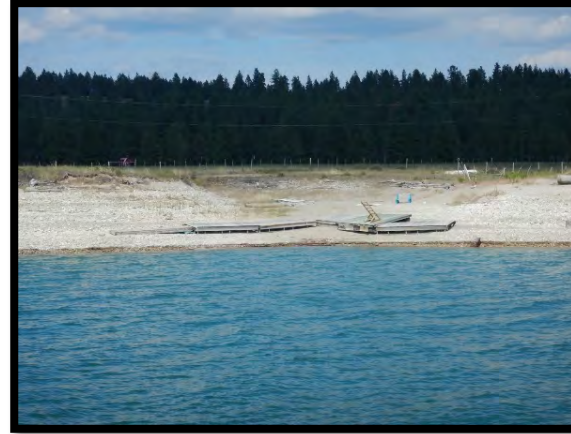
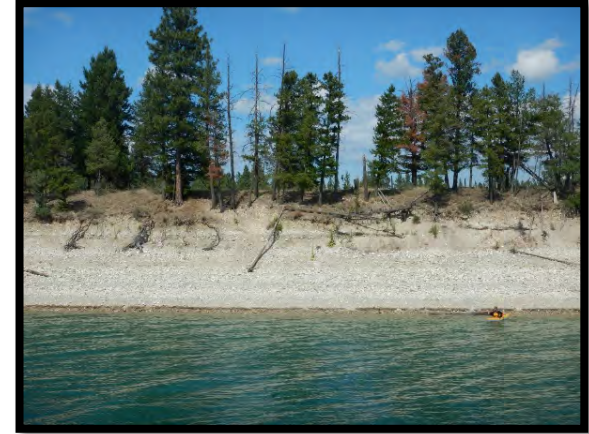
Lake Koochanusa Segment No. 39

Segment Length (km)	Shore Type	Shore Type Mod.	Slope	Land Use	Level of Impact	Livestock Access	Disturbed	Natural
0.7	Gravel	Road	Steep (20-60)	Single Family	High (>40%)	Yes	60	40
Comments:

Retain Walls	% Ret. Wall	Ret. Wall Material	Docks	Docks per km	Boat Launch	% Rail Modifier	% Road Modifier	Marinas	Substrate Mod.	% Substrate Mod.
0	0	0	1	0	0	0	0	0	No	0
Comments: 2 swimming platforms

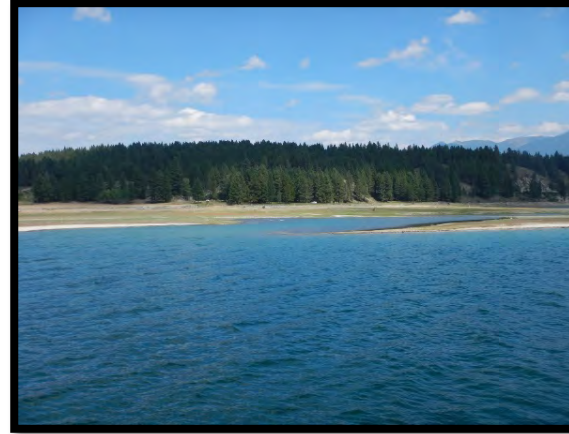
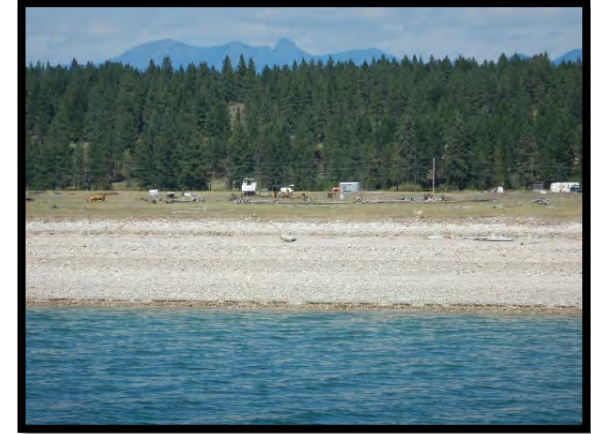
Lake Koocanusa Segment No. 40

Segment Length (km)	Shore Type	Shore Type Mod.	Slope	Land Use	Level of Impact	Livestock Access	Disturbed	Natural
3.2	Other	Road	Low (0-5)	Agriculture	High (>40%)	Yes	75	25
Comments: north end agriculture, south end natural with road

Retain Walls	% Ret. Wall	Ret. Wall Material	Docks	Docks per km	Boat Launch	% Rail Modifier	% Road Modifier	Marinas	Substrate Mod.	% Substrate Mod.
0	0	0	0	0	0	0	0	0	No	0
Comments: temporary electric fence

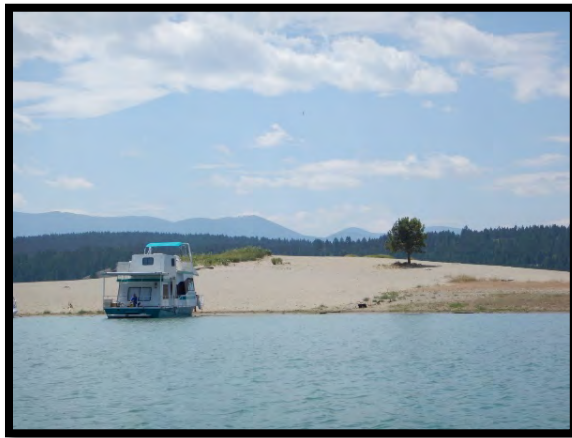
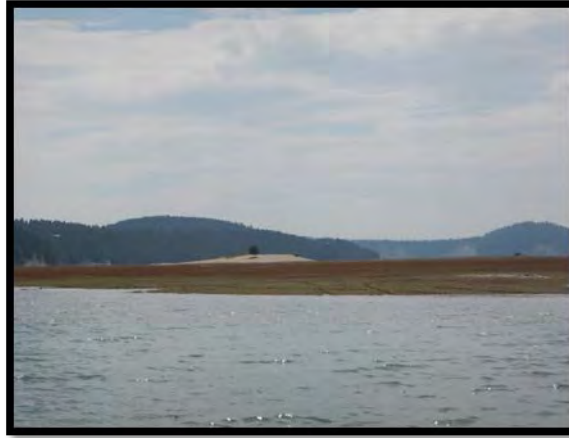
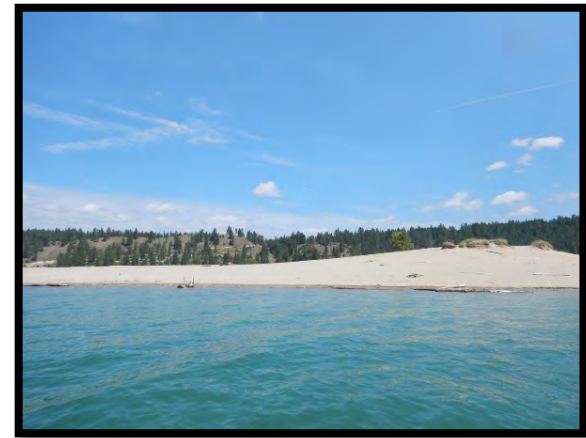
Lake Koochanusa Segment No. 41

Segment Length (km)	Shore Type	Shore Type Mod.	Slope	Land Use	Level of Impact	Livestock Access	Disturbed	Natural
1.9	Sand	None	Low (0-5)	Natural Area	Medium (10-40%)	Yes	10	90
Comments: area mostly inundated at full pool except sand beach island at s end

Retain Walls	% Ret. Wall	Ret. Wall Material	Docks	Docks per km	Boat Launch	% Rail Modifier	% Road Modifier	Marinas	Substrate Mod.	% Substrate Mod.
0	0	0	0	0	0	0	0	0	No	0
Comments: extensive orv, house boats, motor boats, pets, human use

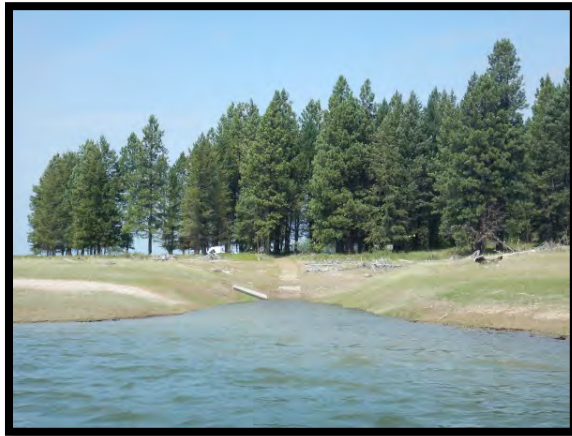
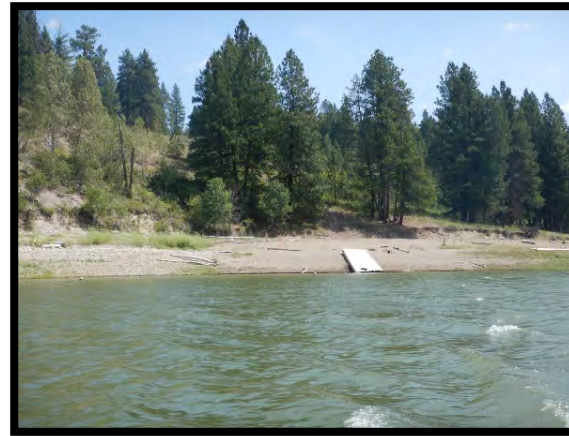
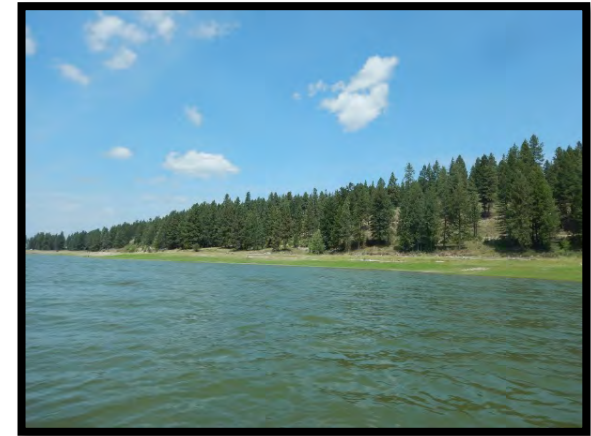
Lake Koocanusa Segment No. 42

Segment Length (km)	Shore Type	Shore Type Mod.	Slope	Land Use	Level of Impact	Livestock Access	Disturbed	Natural
0.9	Gravel	Road	Moderate (5-20)	Natural Area	High (>40%)	Yes	60	40
Comments: natural area with road through 95 percent of segment

Retain Walls	% Ret. Wall	Ret. Wall Material	Docks	Docks per km	Boat Launch	% Rail Modifier	% Road Modifier	Marinas	Substrate Mod.	% Substrate Mod.
0	0	0	3	3	1	0	90	0	No	0
Comments: 1 concrete boat launch

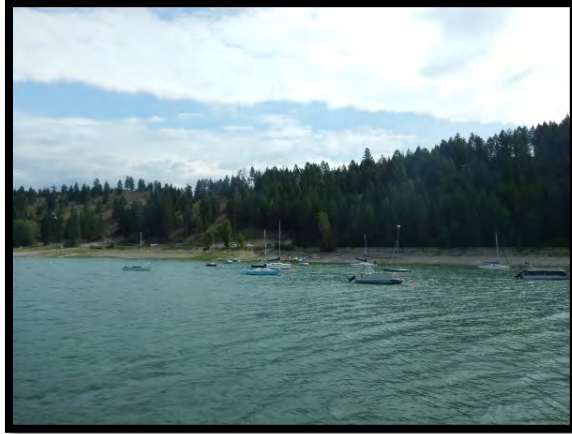
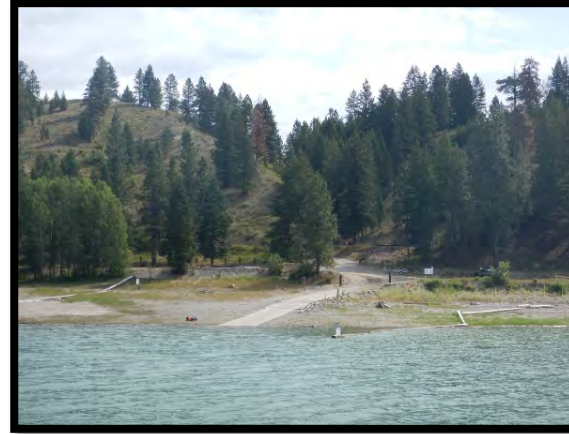
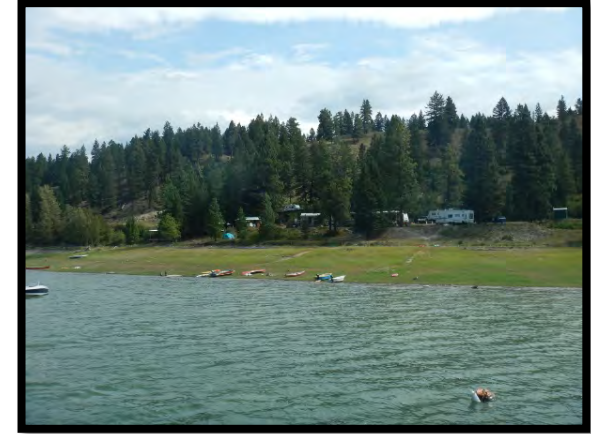
Lake Koocanusa Segment No. 43

Segment Length (km)	Shore Type	Shore Type Mod.	Slope	Land Use	Level of Impact	Livestock Access	Disturbed	Natural
1.9	Gravel	Road	Moderate (5-20)	Recreation	Medium (10-40%)	No	40	60
Comments: F.O.L.K.S campground, mooring, boat launch, pocket beach

Retain Walls	% Ret. Wall	Ret. Wall Material	Docks	Docks per km	Boat Launch	% Rail Modifier	% Road Modifier	Marinas	Substrate Mod.	% Substrate Mod.
0	0	0	1	1	1	0	35	0	Yes	8
Comments: 1 concrete launch, 29 mooring buoys, 51 boats, 2 platforms, 4 houseboats, 3 log booms 1 pocket beach

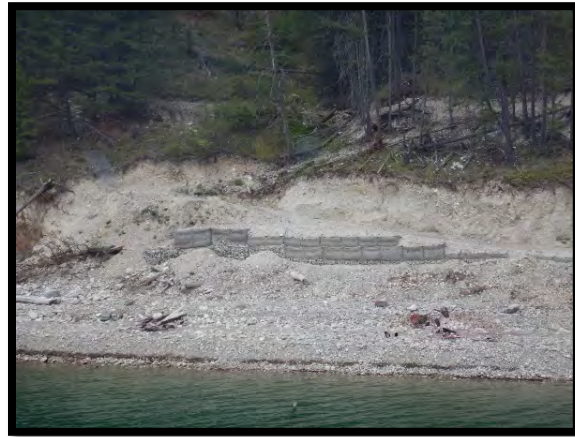
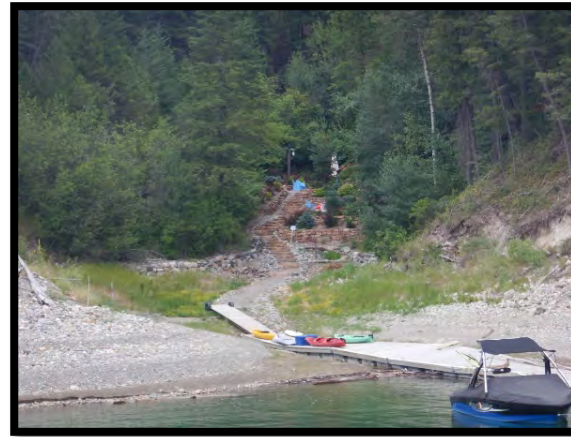
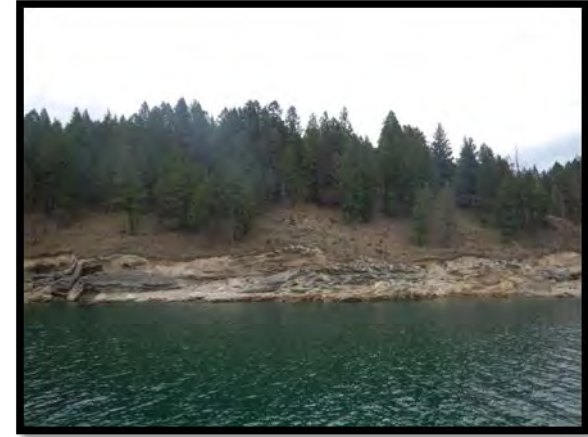
Lake Kocanusa Segment No. 44

Segment Length (km)	Shore Type	Shore Type Mod.	Slope	Land Use	Level of Impact	Livestock Access	Disturbed	Natural
1.2	Cliff/Bluff	None	Steep (20-60)	Natural Area	Low (<10%)	No	2	98
Comments: 30 percent crown, 70 percent natural, 2 obvious developments

Retain Walls	% Ret. Wall	Ret. Wall Material	Docks	Docks per km	Boat Launch	% Rail Modifier	% Road Modifier	Marinas	Substrate Mod.	% Substrate Mod.
1	1	Stonework	1	1	0	0	1	0	Yes	1
Comments: 1 swimming platform, 2 mooring buoys, 2 stair access, 1 log boom 150 m, atv trail to gabions

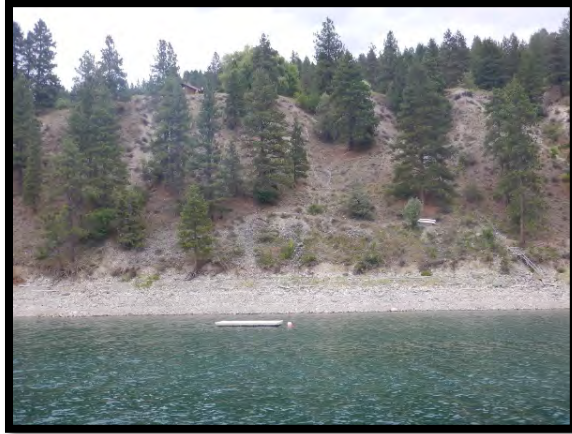
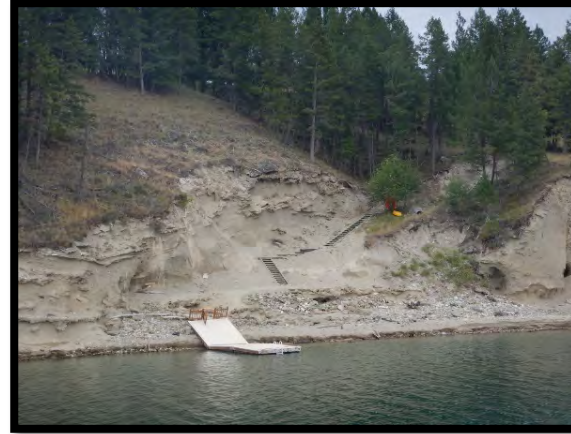
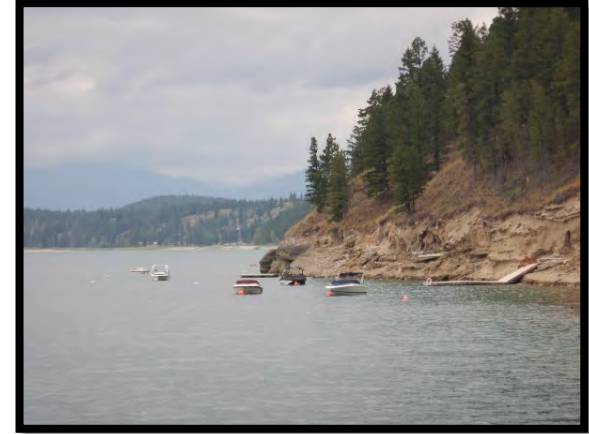
Lake Koochanusa Segment No. 45

Segment Length (km)	Shore Type	Shore Type Mod.	Slope	Land Use	Level of Impact	Livestock Access	Disturbed	Natural
0.7	Cliff/Bluff	Road	Steep (20-60)	Single Family	Medium (10-40%)	No	20	80
Comments: developed on flat at top of cliff, access to foreshore by steep trails, roads

Retain Walls	% Ret. Wall	Ret. Wall Material	Docks	Docks per km	Boat Launch	% Rail Modifier	% Road Modifier	Marinas	Substrate Mod.	% Substrate Mod.
0	0	0	2	2	1	0	2	0	No	0
Comments: 19 mooring buoys, 4 stairs, 4 swim platforms, 1 log breakwater - 100 m, 6 boats

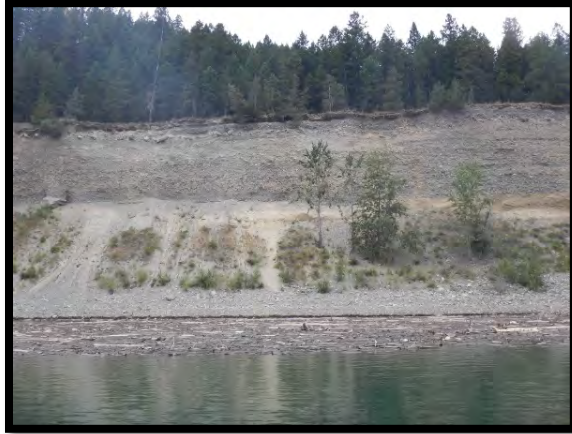
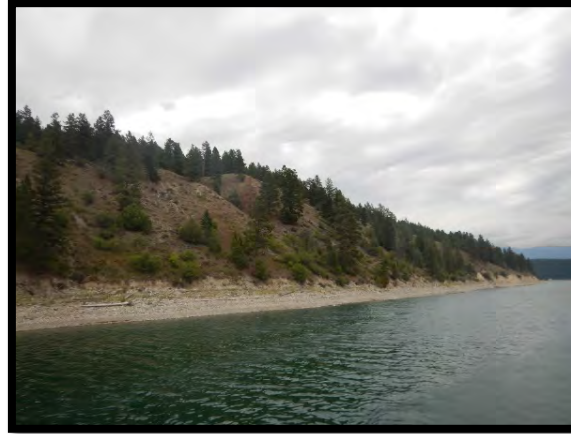
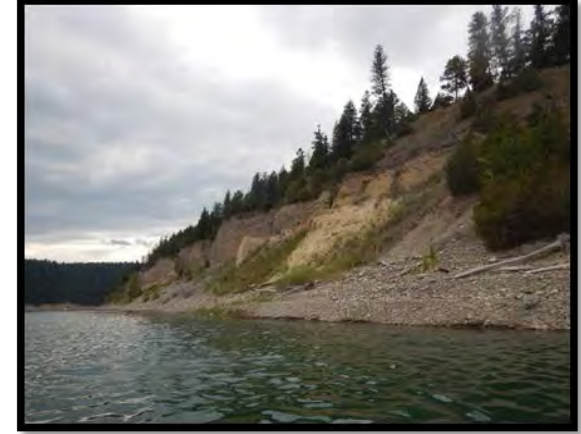
Lake Kocanusa Segment No. 46

Segment Length (km)	Shore Type	Shore Type Mod.	Slope	Land Use	Level of Impact	Livestock Access	Disturbed	Natural
3.3	Cliff/Bluff	None	Steep (20-60)	Forestry	None	Yes	0	100
Comments: some eroding clay banks/some gravel/sand slopes

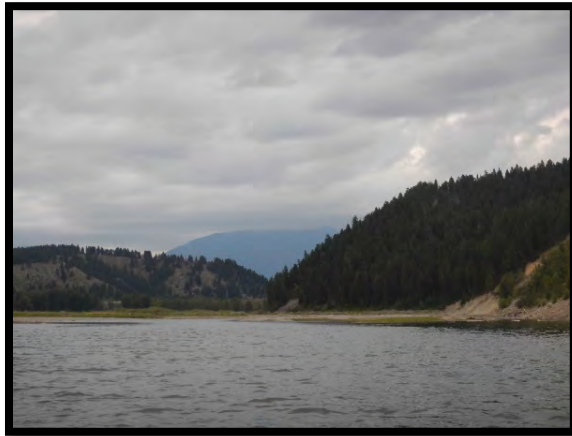
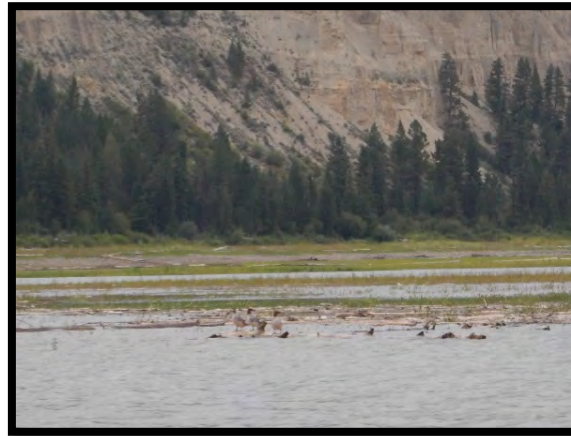
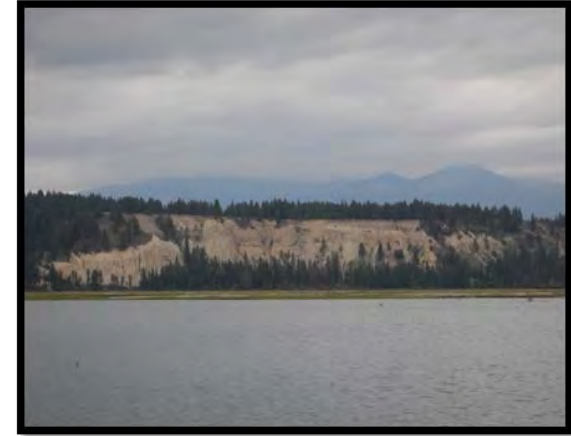
Lake Koocanusa Segment No. 47

Segment Length (km)	Shore Type	Shore Type Mod.	Slope	Land Use	Level of Impact	Livestock Access	Disturbed	Natural
5.9	Stream Mouth	None	Steep (20-60)	Natural Area	Low (<10%)	Yes	1	99
Comments: elk river wetland/outlet

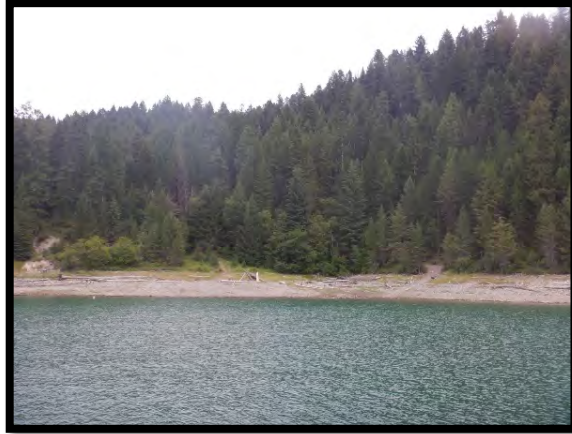
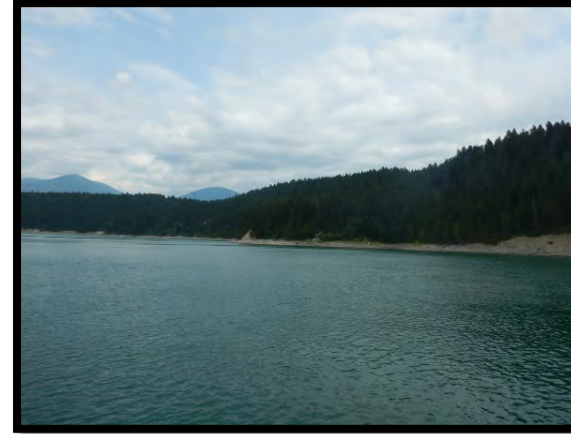
Lake Koochanusa Segment No. 48

Segment Length (km)	Shore Type	Shore Type Mod.	Slope	Land Use	Level of Impact	Livestock Access	Disturbed	Natural
1.5	Rocky Shore	None	Steep (20-60)	Forestry	Low (<10%)	No	1	99
<i>Comments:</i>

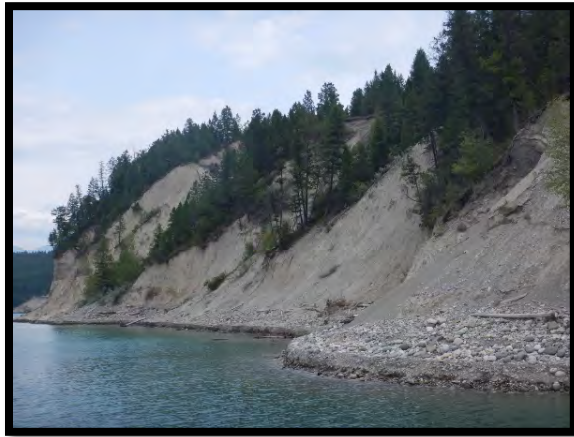
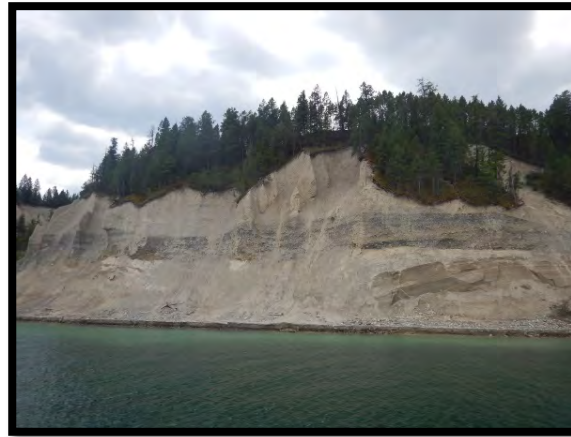
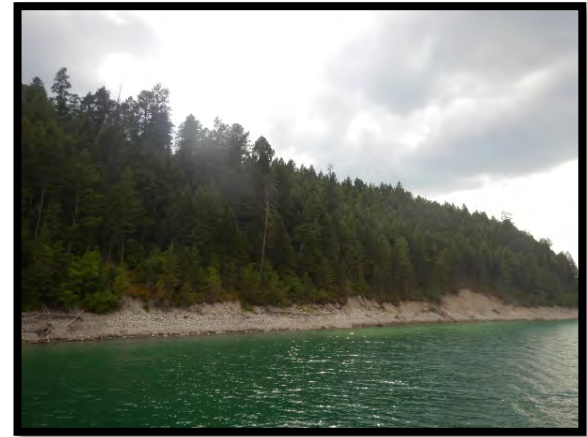
Lake Kocanusa Segment No. 49

Segment Length (km)	Shore Type	Shore Type Mod.	Slope	Land Use	Level of Impact	Livestock Access	Disturbed	Natural
3.3	Cliff/Bluff	None	Very Steep (60+)	Forestry	Low (<10%)	No	1	99
Comments: steep unstable cliffs

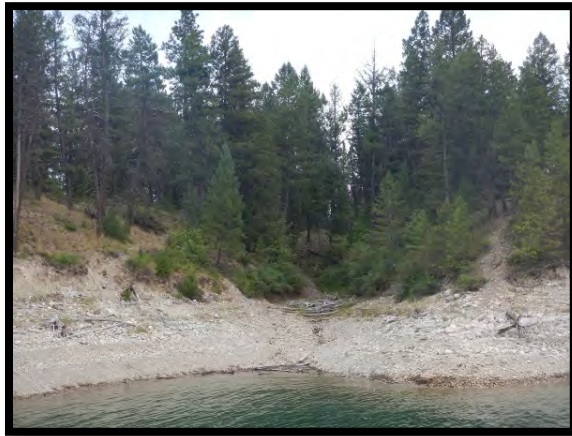
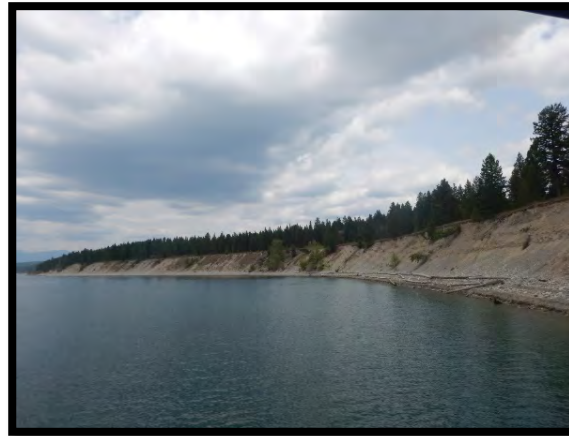
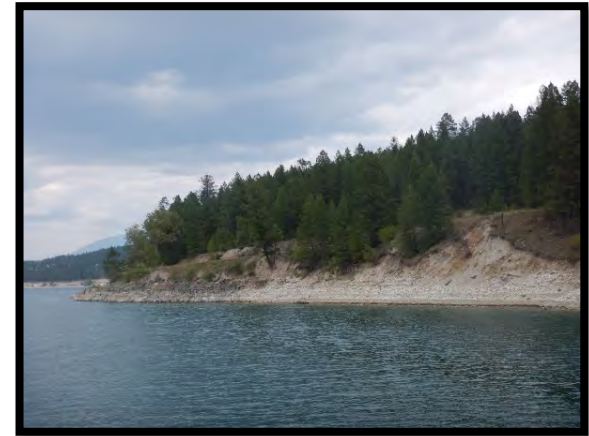
Lake Kocanusa Segment No. 50

Segment Length (km)	Shore Type	Shore Type Mod.	Slope	Land Use	Level of Impact	Livestock Access	Disturbed	Natural
2.5	Gravel	Road	Steep (20-60)	Forestry	Low (<10%)	Yes	1	99
Comments: 10 m steep gravel banks

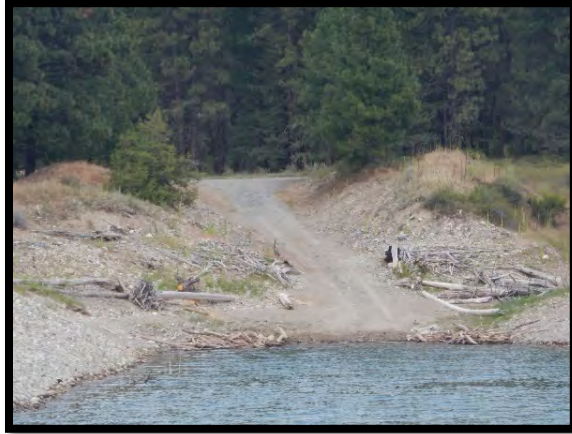
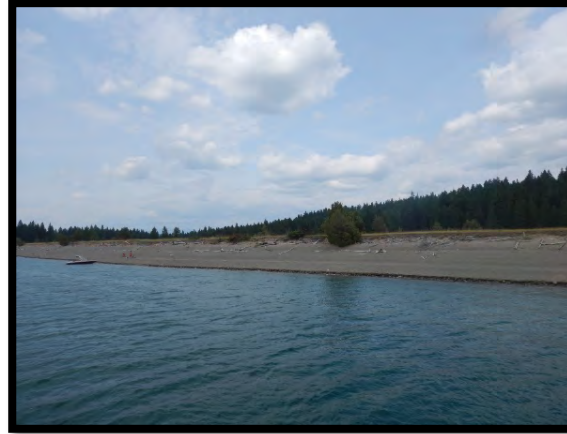
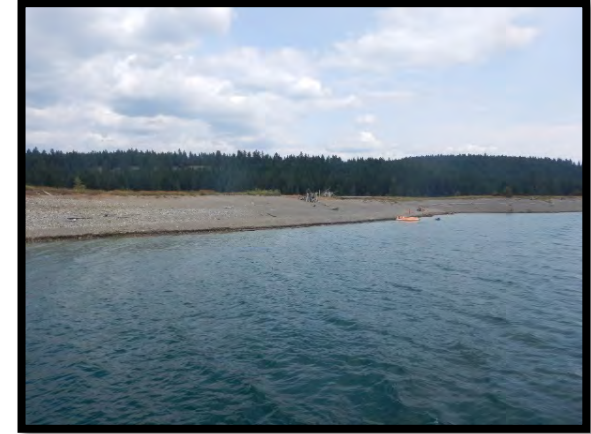
Lake Kocanusa Segment No. 51

Segment Length (km)	Shore Type	Shore Type Mod.	Slope	Land Use	Level of Impact	Livestock Access	Disturbed	Natural
2.4	Gravel	Road	Bench	Forestry	Low (<10%)	Yes	30	70
Comments: sand beach, organized camping, Dorr, grassy fields

Retain Walls	% Ret. Wall	Ret. Wall Material	Docks	Docks per km	Boat Launch	% Rail Modifier	% Road Modifier	Marinas	Substrate Mod.	% Substrate Mod.
0	0	0	0	0	1	0	50	0	No	0
Comments: check roads, Dorr official boat launch

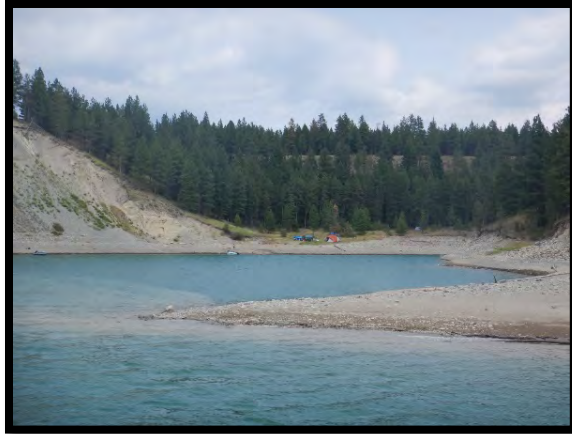
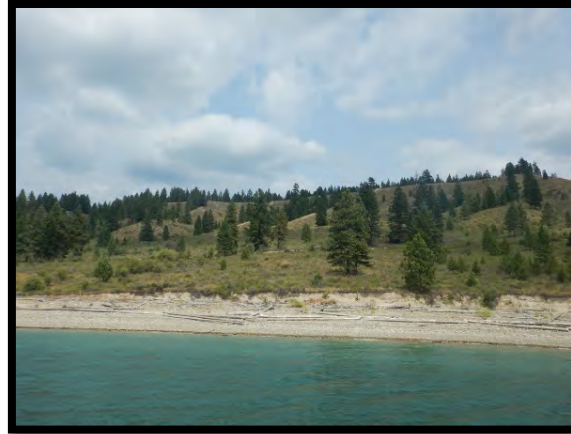
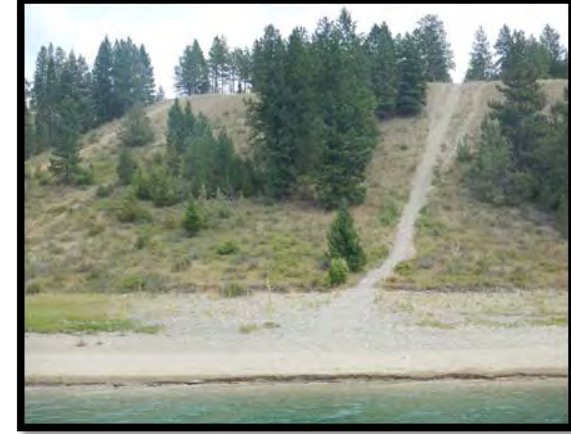
Lake Koocanusa Segment No. 52

Segment Length (km)	Shore Type	Shore Type Mod.	Slope	Land Use	Level of Impact	Livestock Access	Disturbed	Natural
5.2	Gravel	Road	Moderate (5-20)	Forestry	High (>40%)	Yes	50	50
Comments: good public access, 3 sand beaches

Agriculture	Commercial	Forestry	Industrial	Natural Area	Park	Recreation	Rural	Single Family
0	0	95	0	0	0	5	0	0
Comments: extensive upland and foreshore use, 5 unorganized campsites, heavy orv use with serious damage

Retain Walls	% Ret. Wall	Ret. Wall Material	Docks	Docks per km	Boat House	% Rail Modifier	% Road Modifier	Marinas	Substrate Mod.	% Substrate Mod.
0	0	0	1	0	0	0	95	0	No	0
Comments: informal boat launches, 2 mooring buoys, 10 boats
