**LAKE KOOCANUSA
FORESHORE INVENTORY AND MAPPING AND AQUATIC HABITAT
INDEX**

East Kootenay Integrated Lake
Management Partnership

VAST Resource Solutions Inc.

Oct 17, 2017

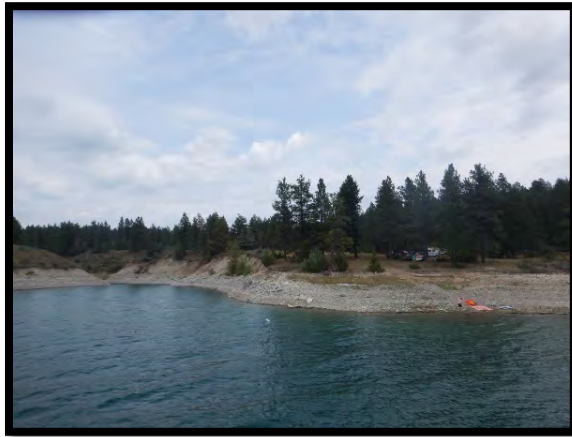
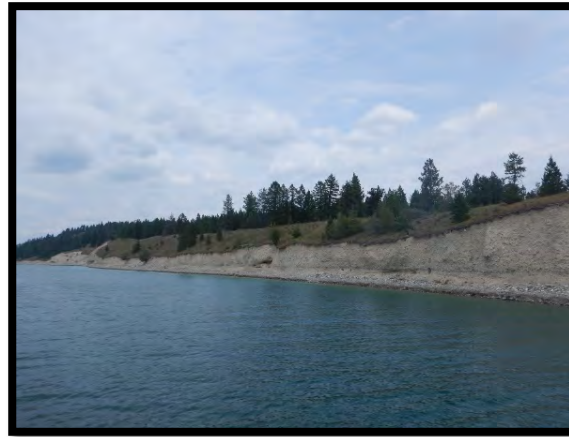
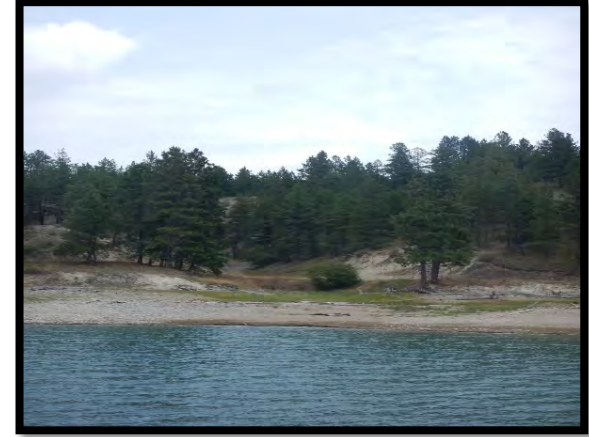
Lake Kocanusa Segment No. 53

Segment Length (km)	Shore Type	Shore Type Mod.	Slope	Land Use	Level of Impact	Livestock Access	Disturbed	Natural
4.4	Cliff/Bluff	None	Very Steep (60+)	Forestry	Low (<10%)	Yes	0	100
Comments: a few calcium formations, a few shale outcrops/ledges

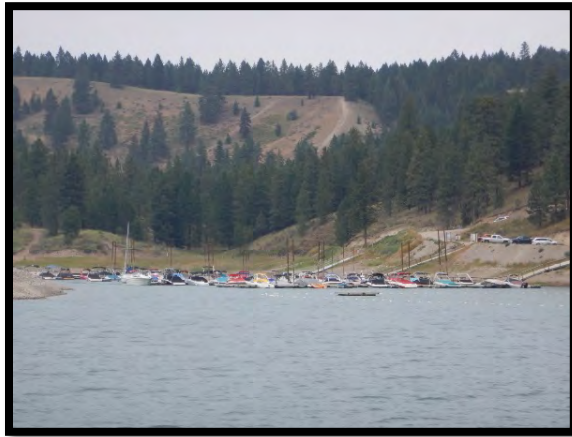
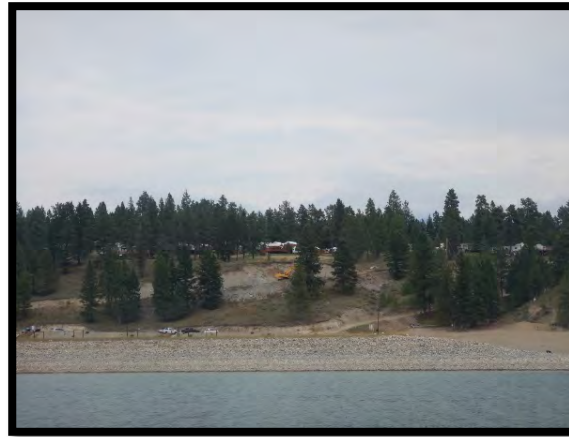
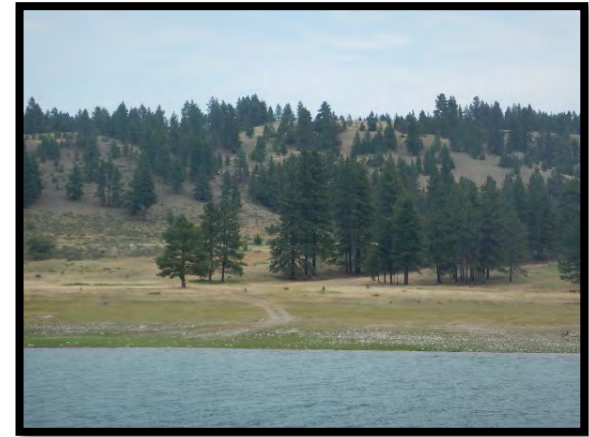
Lake Koocanusa Segment No. 54

Segment Length (km)	Shore Type	Shore Type Mod.	Slope	Land Use	Level of Impact	Livestock Access	Disturbed	Natural
3.1	Rocky Shore	Road	Low (0-5)	Forestry	Medium (10-40%)	Yes	40	60
Comments: unorganized recreation/marina

Retain Walls	% Ret. Wall	Ret. Wall Material	Docks	Docks per km	Boat Launch	% Rail Modifier	% Road Modifier	Marinas	Substrate Mod.	% Substrate Mod.
0	0	0	1	0	0	0	40	1	No	0
Comments: 1 large marina, unorganized road network

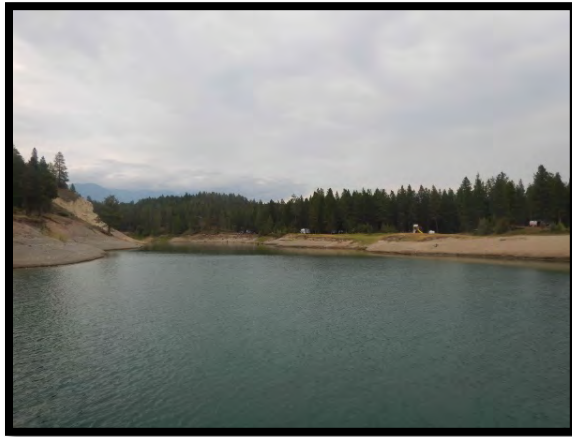
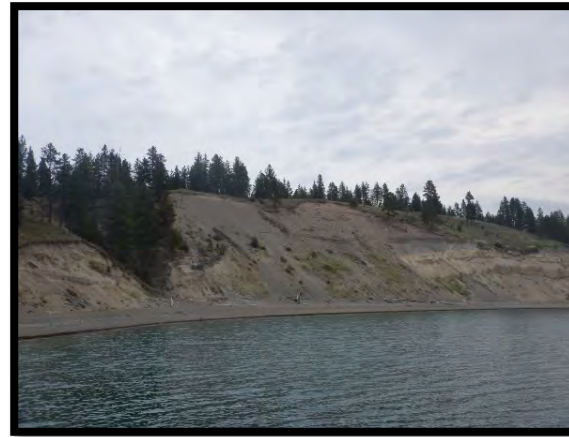
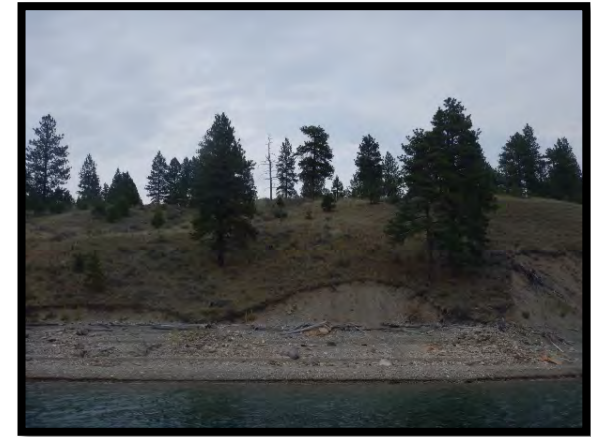
Lake Koochanusa Segment No. 55

Segment Length (km)	Shore Type	Shore Type Mod.	Slope	Land Use	Level of Impact	Livestock Access	Disturbed	Natural
1.1	Cliff/Bluff	None	Very Steep (60+)	Rural	Low (<10%)	Yes	5	95
Comments: private no buildings /check ownership

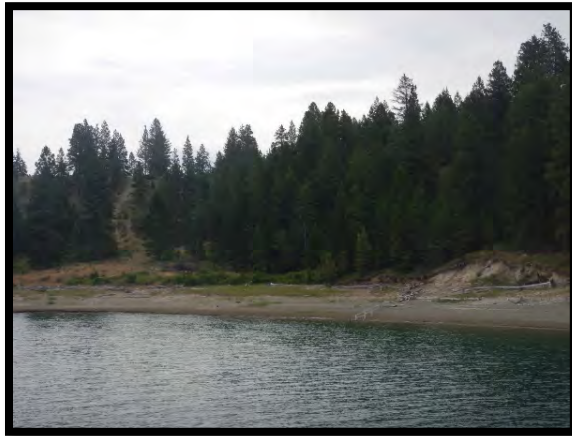
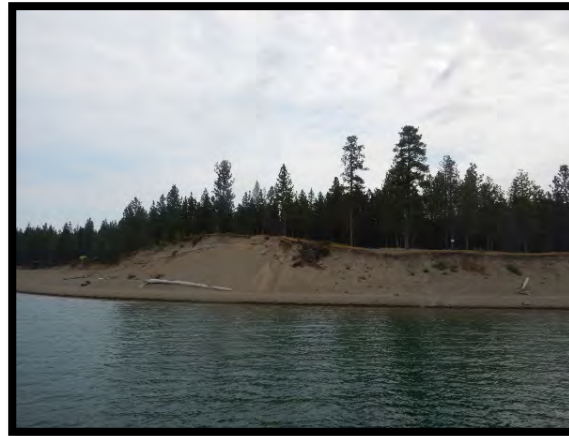
Lake Koochanusa Segment No. 56

Segment Length (km)	Shore Type	Shore Type Mod.	Slope	Land Use	Level of Impact	Livestock Access	Disturbed	Natural
3	Sand	Other	Low (0-5)	Recreation	Low (<10%)	Yes	70	30
Comments: big springs campground

Retain Walls	% Ret. Wall	Ret. Wall Material	Docks	Docks per km	Boat Launch	% Rail Modifier	% Road Modifier	Marinas	Substrate Mod.	% Substrate Mod.
0	0	0	0	0	2	0	0	0	No	0
Comments: log swim breakwater

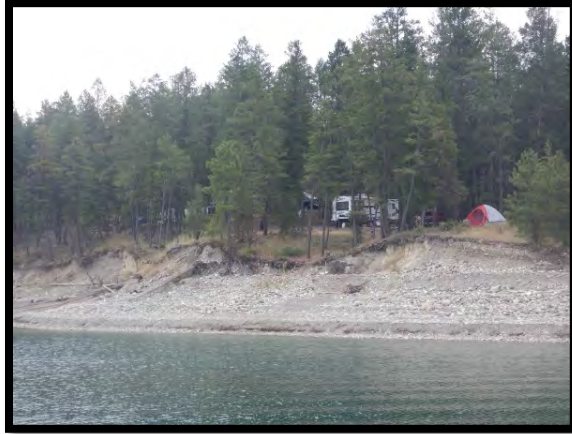
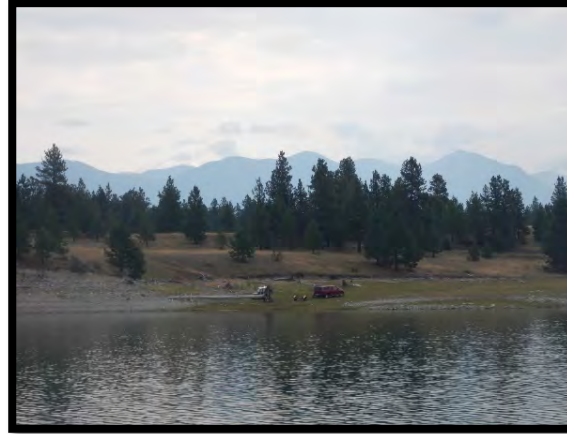
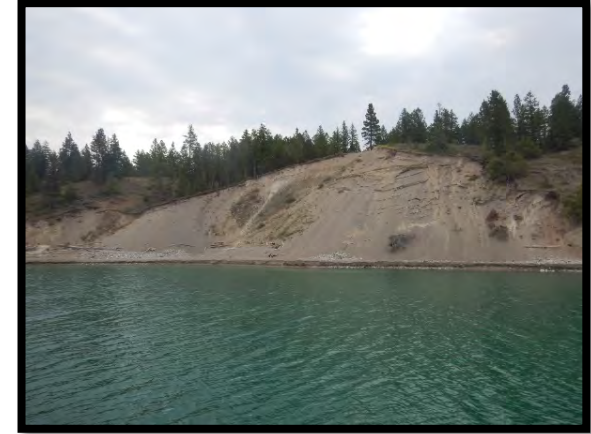
Lake Kocanusa Segment No. 57

Segment Length (km)	Shore Type	Shore Type Mod.	Slope	Land Use	Level of Impact	Livestock Access	Disturbed	Natural
6.8	Rocky Shore	None	Steep (20-60)	Forestry	Low (<10%)	Yes	5	95
Comments: orv use, camping, grazing
