The Hydrogeology of the Silverton Creek Watershed

November 3, 2016

Prepared for
Slocan Lake Stewardship Society
By
Richard Johnson and Susan Johnson
Opus Petroleum Engineering Ltd.

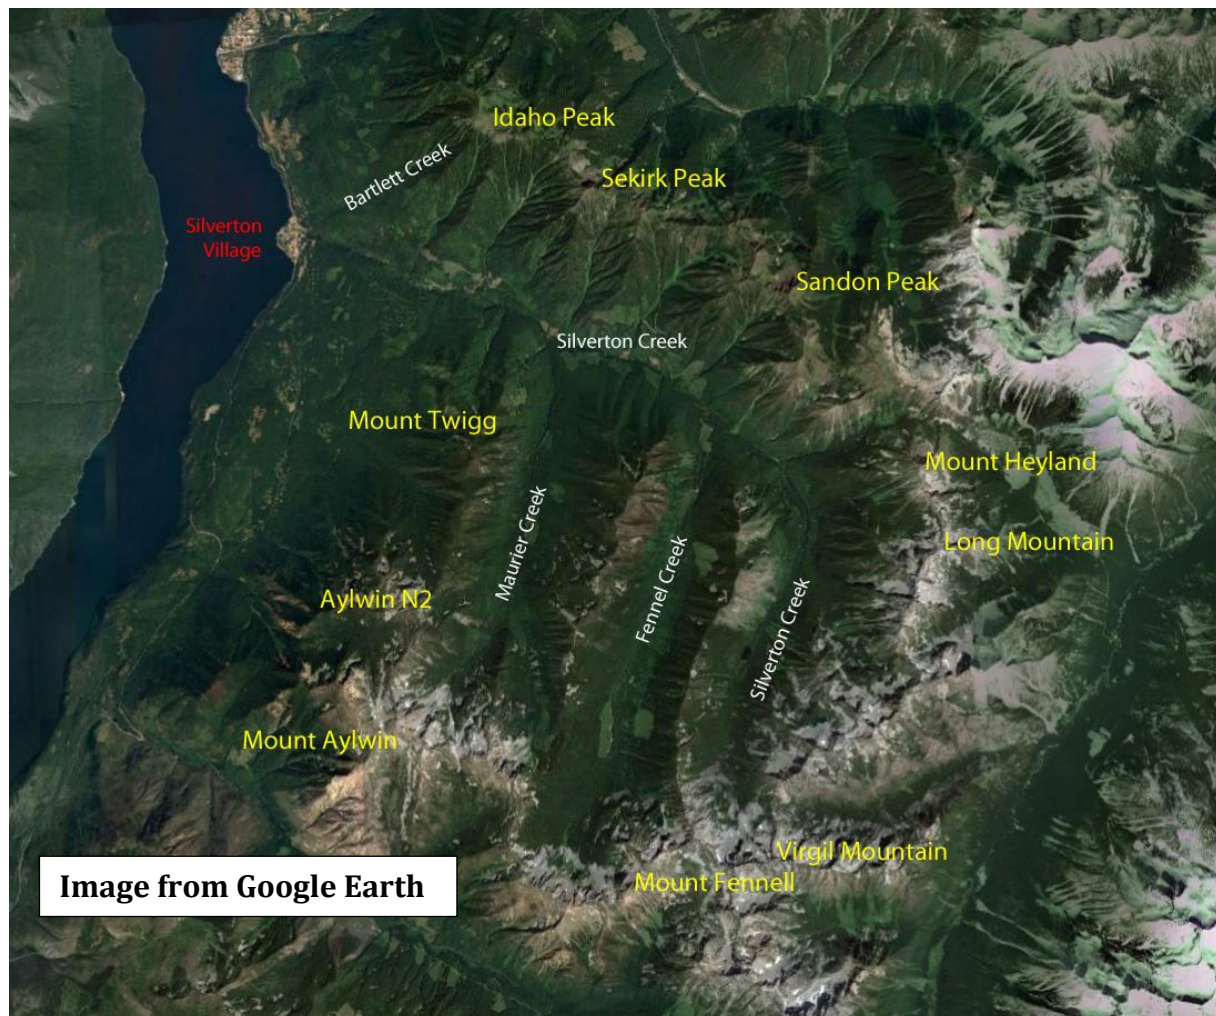
The Silverton Creek watershed is formed by the main valley which runs east-south-east from the Village of Silverton and three tributary valleys that join it from the south at approximately right angles to the main valley. A fourth tributary valley containing Bartlett Creek joins the main valley immediately east of the Village of Silverton boundary. The other three tributary valleys are roughly parallel to each other and join the main valley at about 6 kilometers 9.5 kilometers and 11 kilometers east southeast of the Village. The first valley coming in from the south is the Maurier Creek valley. The second valley contains Fennel Creek. About 11 kilometers up the valley Silverton Creek makes a 90 degree turn to the south. The creek in this valley is still called Silverton Creek.

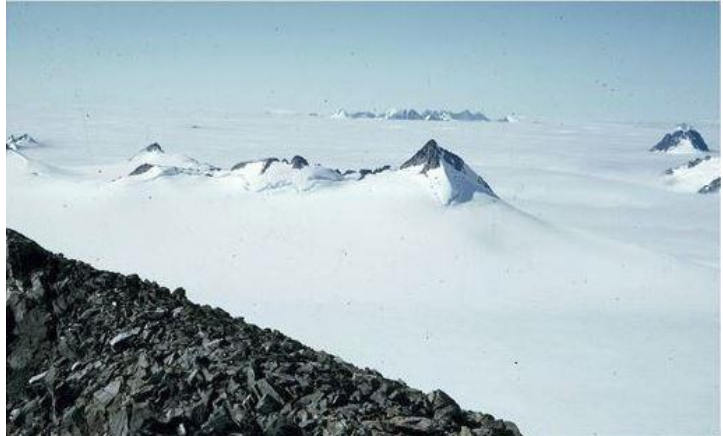
The Silverton Creek Valley deposits are related to the glacial history of the valley. When the entire area was covered with ice and snow the movement of the ice scoured the underlying bedrock producing the three U-shaped valleys which make up the Silverton Creek watershed. The photo at the right shows a modern day, glacier filled mountainous area. (All the glacier photos are from the USGS).

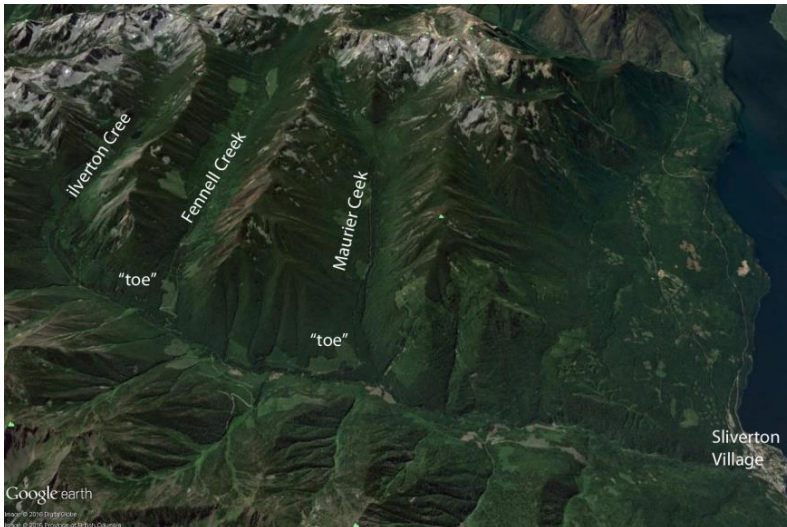
The northwest end of the ridge separating Silverton Creek and Fennell Creek is the start of a medial moraine. The remains still cling to the “toe” of the ridge but the main “stream” of glacial debris would have ended up on the valley floor and been reworked by water flowing down the valley.

The same thing occurred at the junction of Maurier Creek and Silverton creek. One can see the shape of a “toe” at the northwest end of both these ridges. The low slope indicates underlying till rather than scoured bedrock.

In both locations there are significant sand deposits. One can easily see this on the Maurier Creek road immediately south of the bridge across Silverton Creek. Another exposure is further up the same road where the road turns left, rounding the toe and continuing south. The

occurrence of sand indicates that flowing water sorted the sediment, removing the small particles and leaving sand at the location.
