Columbia Lake Sensitive Habitat Inventory and Mapping

Prepared for the East Kootenay Integrated Lake
Management Partnership

**Final Report
August 2010**

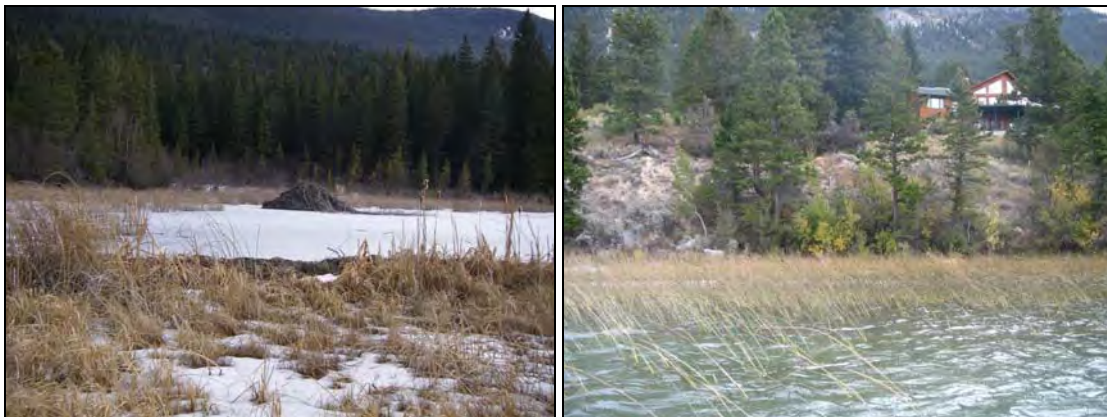
Figure 7. Wetland shore type or marsh wetland class (left) versus emergent vegetation area or shallow-water wetlands (right).

The areas delineated as marsh wetlands at Columbia Lake had a variety of plants but most were dominated by bulrush and also had sedges. These plants were not identified to species and thus all marshes were categorized together whether they were sedge or bulrush dominated. Many also had common pondweed, cattails, reedgrass, pond lily, horsetail, etc in varying percentages (RDEK 1997). According to the Wetlands of BC Guide (MacKenzie and Moran 2004), the marsh wetlands would be classified as Wm06 in complex with Wm05 while others would be a complex of Wm06, Wm05, and Wm-sedges in general. These marsh wetlands were differentiated from the shallow-water wetlands (emergent vegetation) (Figure 7).

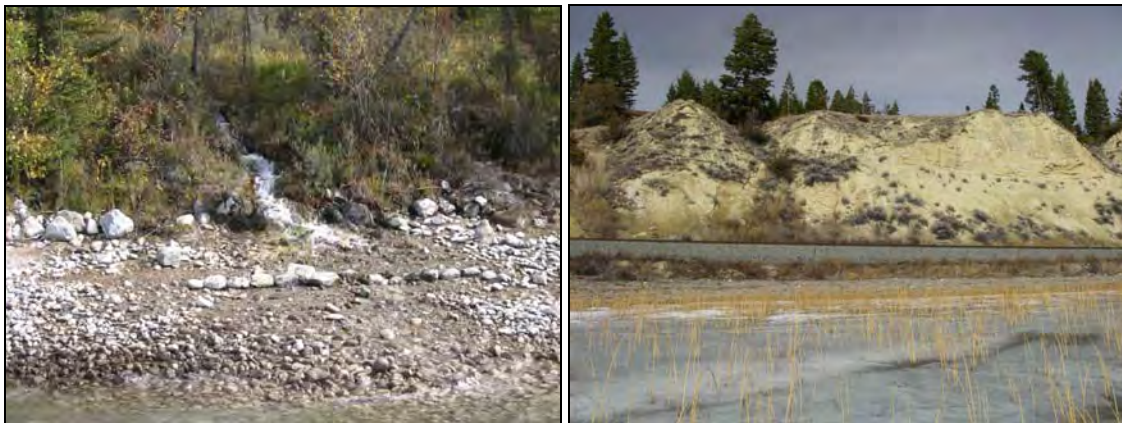
Figure 17. Gravel beach shore types - left photo shows beach backed by vegetated area along the eastern shore (Leschied Sept 2007) and the right shows railway and bluff features beyond (McPherson Mar 2009).

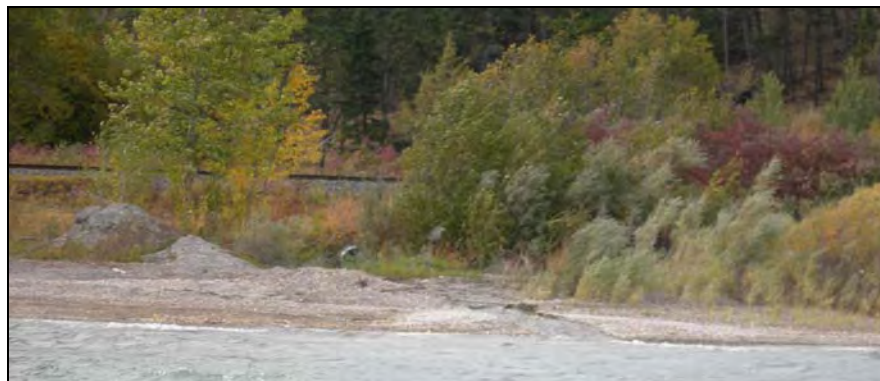
Figure 19. Marion Creek in Segment 7 entering lake through culvert under the railway. Photo: Porto Sept 2007.

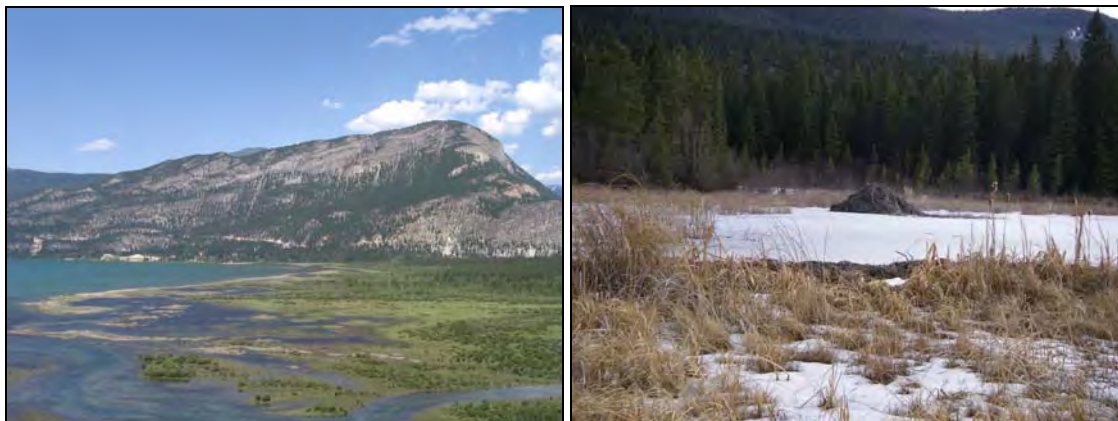
Figure 20. View of south end wetland and unnamed creek (left photo: Leschied June 2007), and wetland along eastern shore in Segment 3 (right photo: McPherson 2009).

Wetlands are an important Shore Type along Columbia Lake. There are extensive wetlands at the north and south ends of the lake (Segments 4 and 8 respectively) and some along the east shore in the low lying areas between the bluffs (Segment 3) (Figure 20). All of these wetlands are incorporated in the WMA. In Segment 3, wetlands were found along approximately 15% (or 1,932 m) of the shore. Wetlands comprised 80% (or 3,574 m) of Segment 4, and 95% (or 6,767 m) of Segment 8.

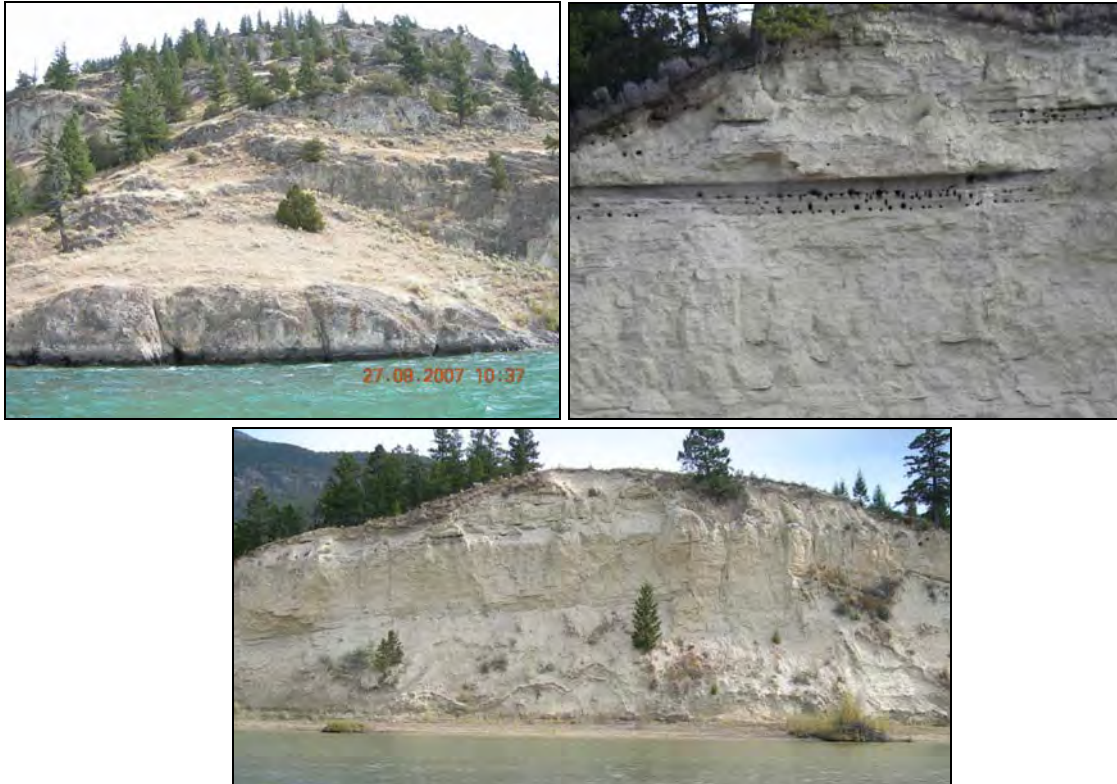
Figure 21. Cliff Shore Type with steep shoreline in Segment 2 (top left, photo: Porto Sept 2007); Bluff Shore Type with swallow nest sites in Segment 3 (top right, photo: McPherson Mar 2009); and Bluff Shore Type with beach in Segment 3 (bottom photo: Porto Sept 2007).

The cliffs and bluffs were distinguished from one another in this investigation since they provide different habitats and influences along the shoreline (See Methods). There was only a small extent of Cliff Shore Type, which was identified in Segment 2 (Figure 21). Conversely, Bluff Shore Type extended along substantial lengths of Segment 3, as well as Segments 6 and 7 (in the upland area beyond the railway).

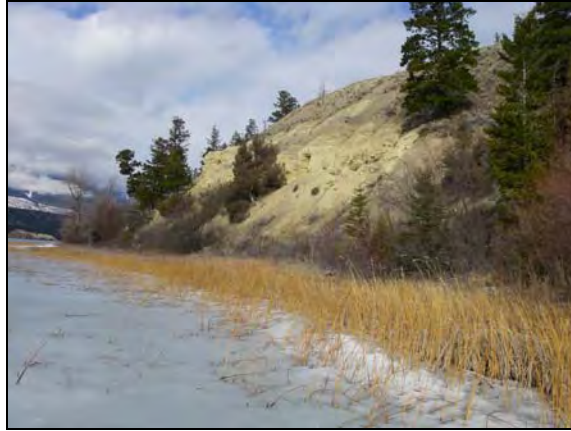
Figure 22. Bulrush above the ice along the shoreline of Segment 3. Photo: McPherson, Mar 2009.

Emergent aquatic vegetation (shallow-water wetlands) was common along the shallow-water habitats of the littoral zone (Figure 22). Our field investigations found the dominant emergent species to be bulrushes (Appendix E). Other species such as floating pondweed, rushes, sedges, grasses (including invasive reed canary grass) were also evident during 2009 site sampling. The emergent aquatic vegetation was mapped on the Foreshore Summary Maps (Appendix A). As Appendix E further reveals, submerged vegetation species were also identified during 2009 site investigations and included species such as coontail, potamogeton species (e.g., submerged pondweed) and charophytes. The percentage of submerged species coverage; however, was not determined during field investigations.

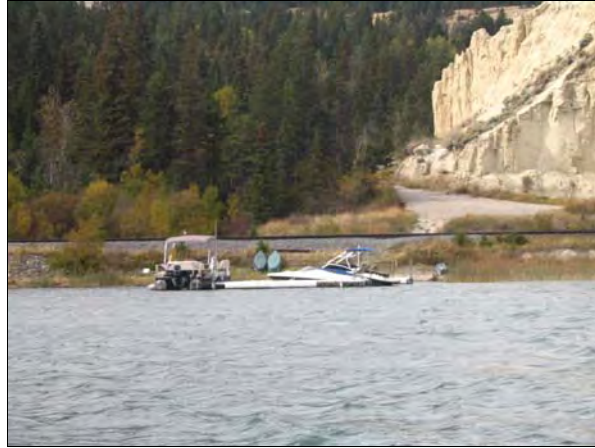
Figure 25. Sparse or no riparian vegetation was evident along the railway, as evidenced by this photo of Segment 6. Photo: Leschied Sept 2007.

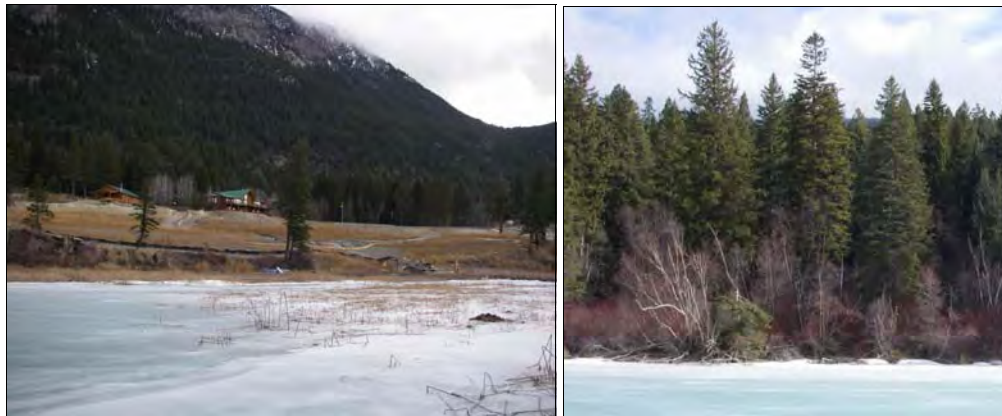
Figure 26: Development has impacted some of the riparian area along Segment 1, although it is rated as having a high shore cover (>20%) (Left); while, Segment 2 was reported to be moderately vegetated, although there were areas with dense mature riparian habitat (Right). Photos: McPherson, Mar 2009.

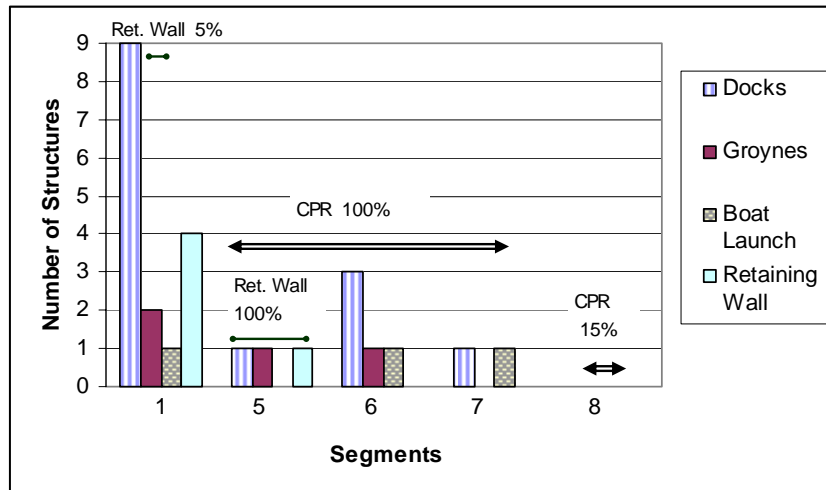
Figure 27. Segment modifications, depicted as numbers of structures, and percent of segment length (for CP Rail & retaining walls).

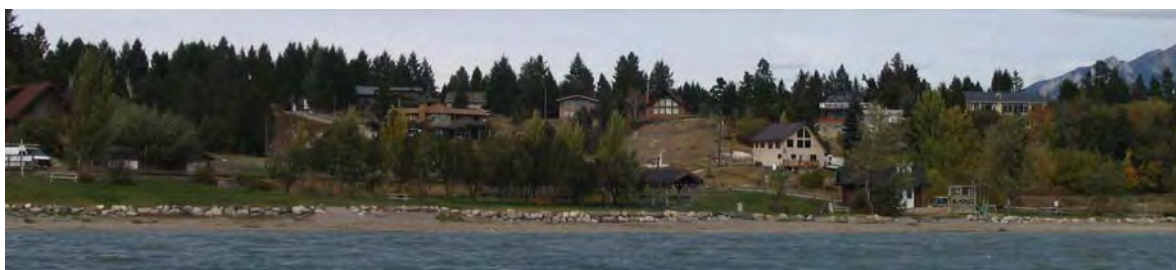
Figure 29. Shoreline modifications along Segment 5 (Columere) include retaining wall, riparian and aquatic vegetation removal and railway. Photo: Leschied Sept 2007.

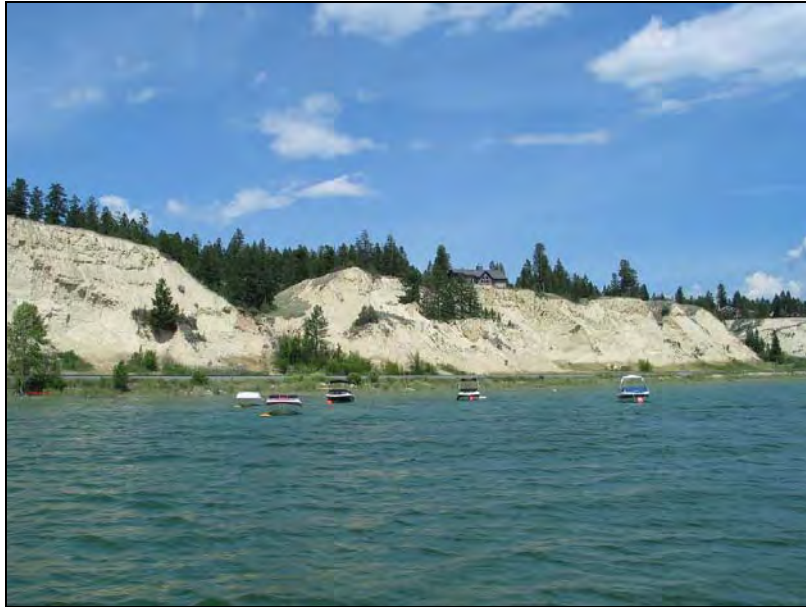
Figure 30. Boats anchored offshore along Segment 6 (Site 6.3), where cables and anchors noted to be scouring the substrate and vegetation. Photo: Holmes July 2009.

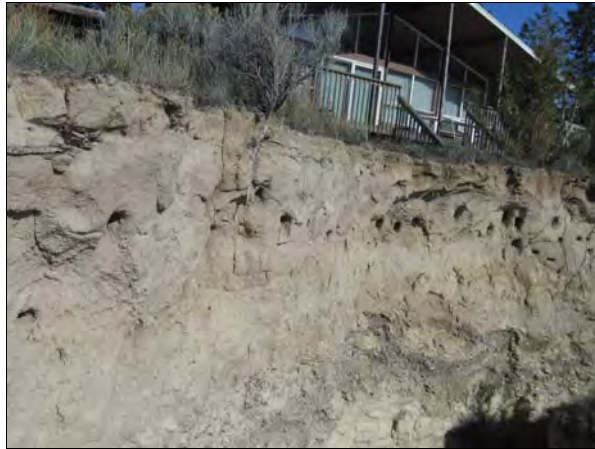
Figure 32. Swallow burrow nests in silt bluff on north shore of Columbia Lake at Columere.

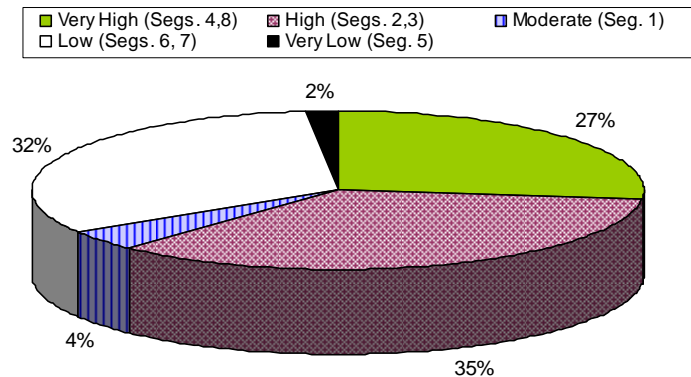
Figure 36. Current Ecological Value rankings and associated percentage (%) of shoreline.

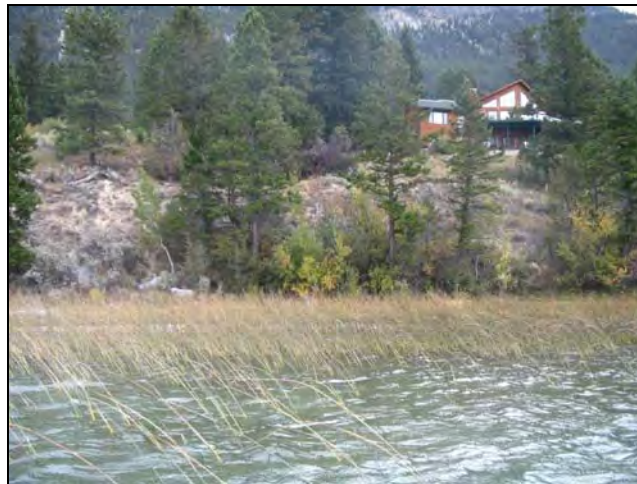
Figure 37. Residence set back on the bluff with minimal foreshore disturbance evident. Photo: Leschied Sept. 2007.

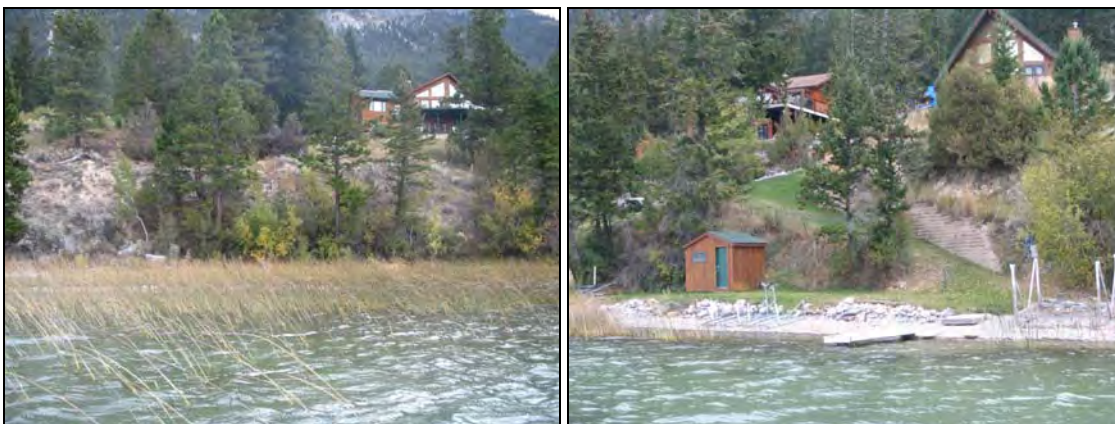
Segment 1. Emergent vegetation along bluff area (left photo: Porto Sept 2009), and developed foreshore property (right photo: Leschied, Sept 2009).

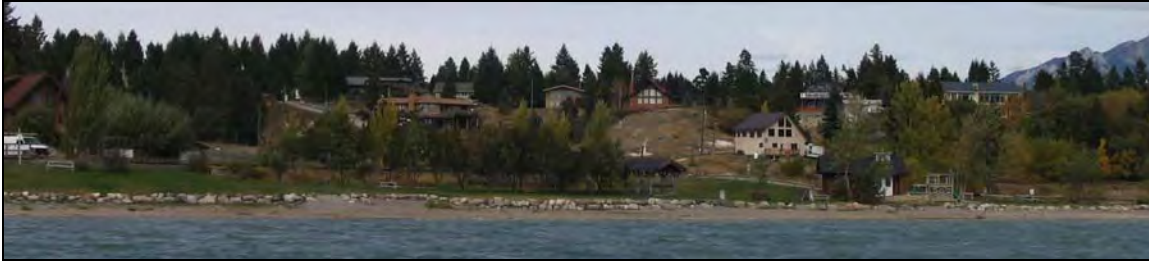
Segment 5. Columere shoreline, which has been largely altered from its natural condition (Photo: Leschied Sept 2007)

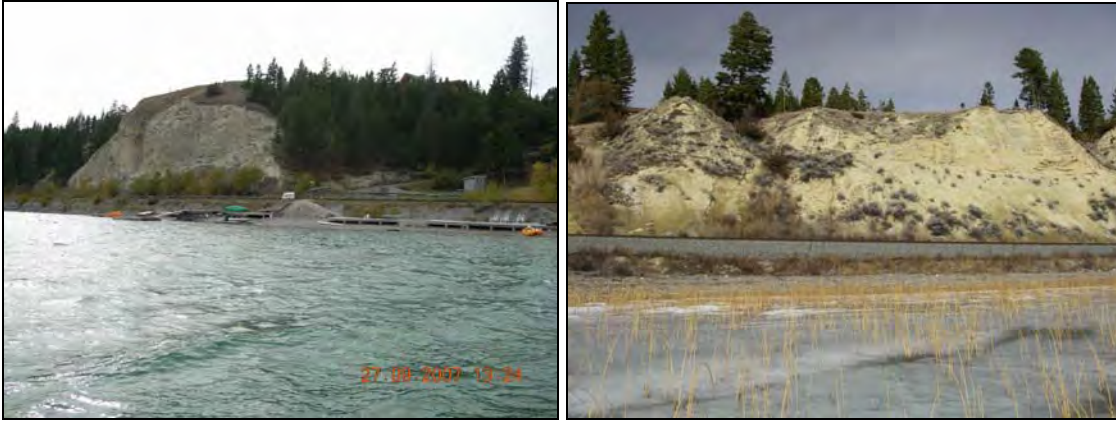
Segment 6. The cross section of the shoreline up from the lake in this segment is gravel beach, railway and then bluffs. Photos: left - Leschied Sept 2007, right - McPherson, Mar 2008.

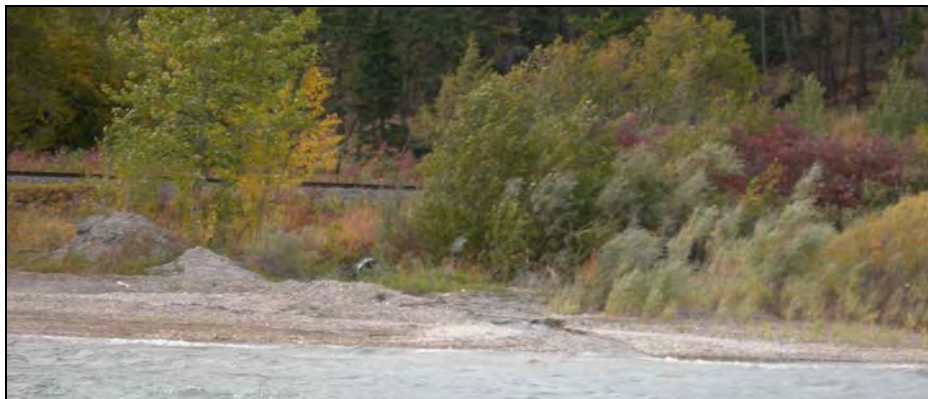
**Segment 7. Marion Creek flow entering into the lake through a culvert under the railway.
Photo: Porto Sept 2007.**
