REVELSTOKE COMMUNITY FOREST CORPORATION

WATER QUALITY MONITORING ON TFL 56

March 8th, 2021

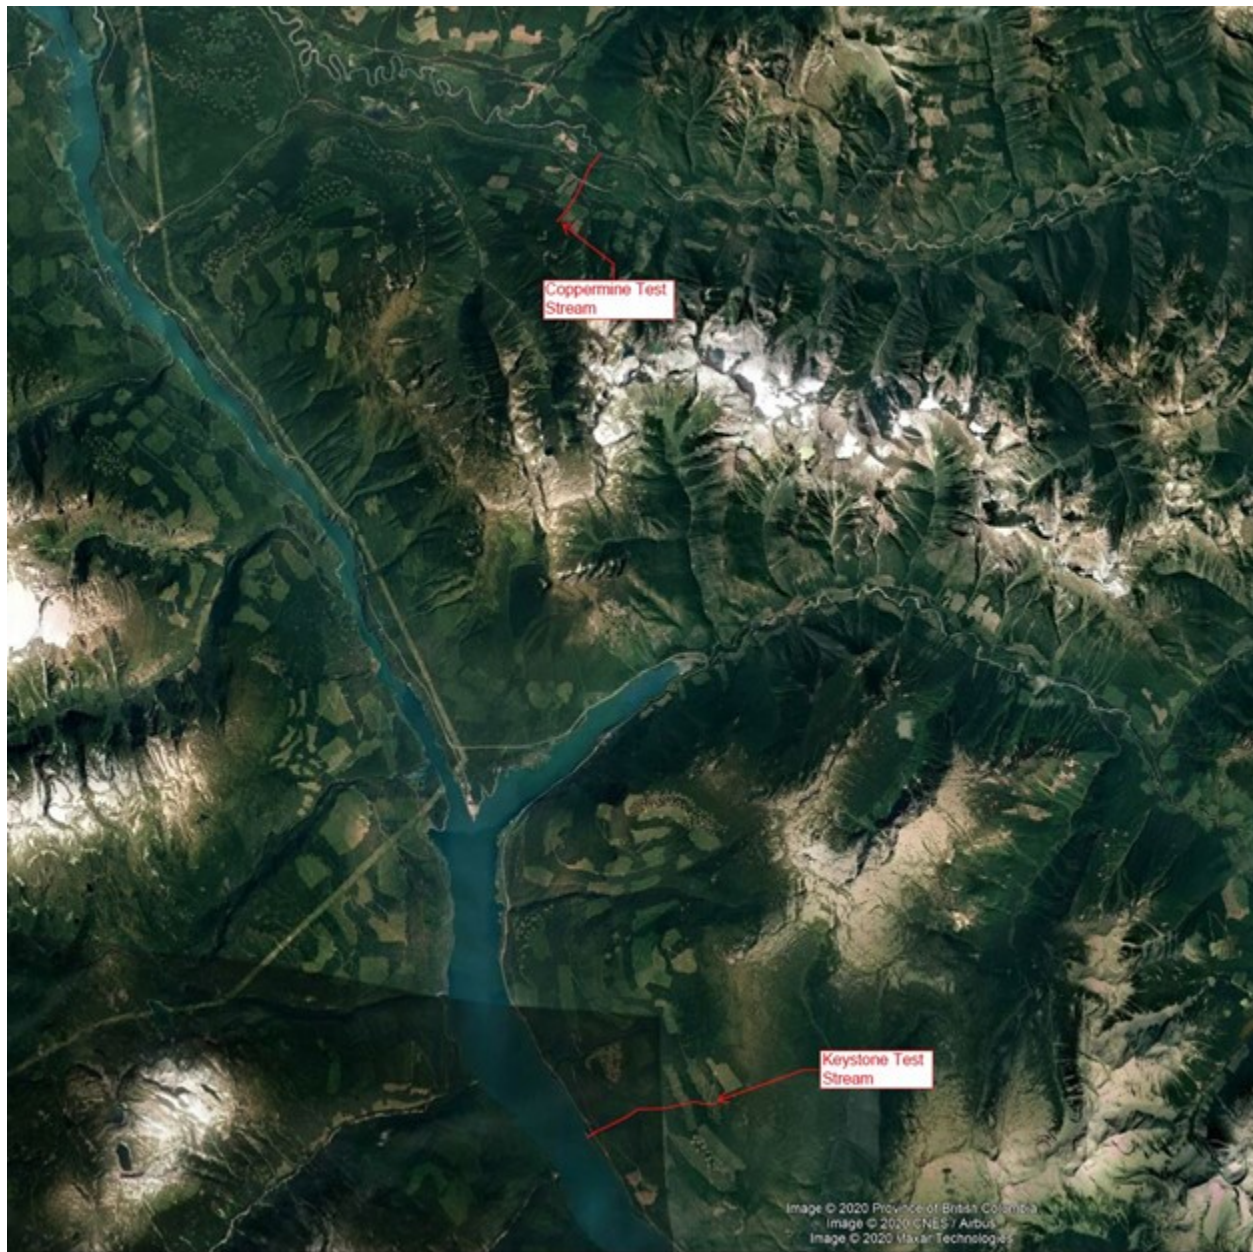
Figure 2. Overview of TFL 56 and approximate location of the Coppermine (upper) and Keystone (lower) water quality test streams

The two sites were chosen based on finding mid-sized streams that ran through or adjacent to fertilization treatment areas. Easy vehicular access to the test site and control site was also a factor in stream choice. One stream was selected up the Coppermine (upper) and Keystone (lower) areas (Figure 2).

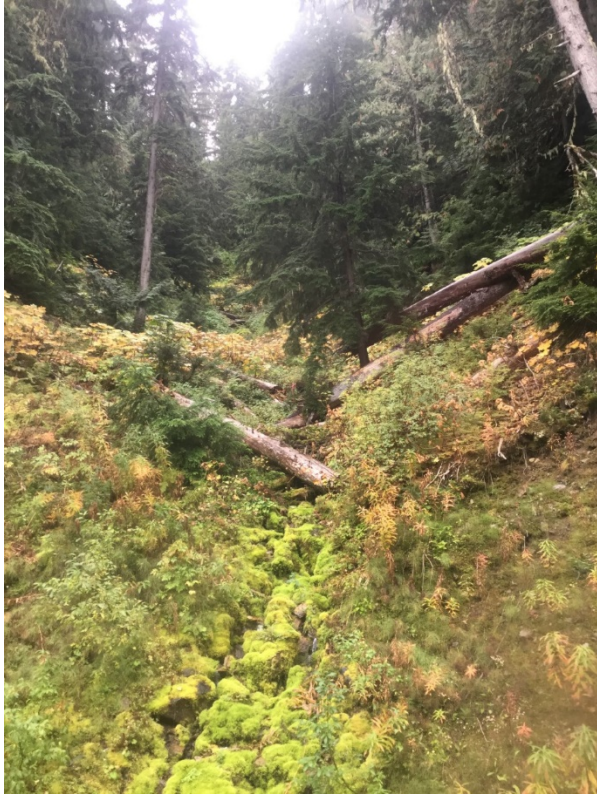
Figure 3. Coppermine stream at control test site, upstream from fertilization treatment areas

The Coppermine, S-6 stream, chosen for water quality monitoring, flows through and by multiple treatment areas near the Coppermine Road before emptying into the Goldstream River. Two test sites were established on the Coppermine stream, one upstream above any treatment areas (Figure 3), and one downstream below treatment areas (Figure 4). The stream flows through 729-4 and 728-303 (not visible from the air, thus not buffered) and west of 728-8 and 728-202. These areas were treated on the same day as the first samples were taken (above and downstream from the treatment area) (Figure 5 and 6).

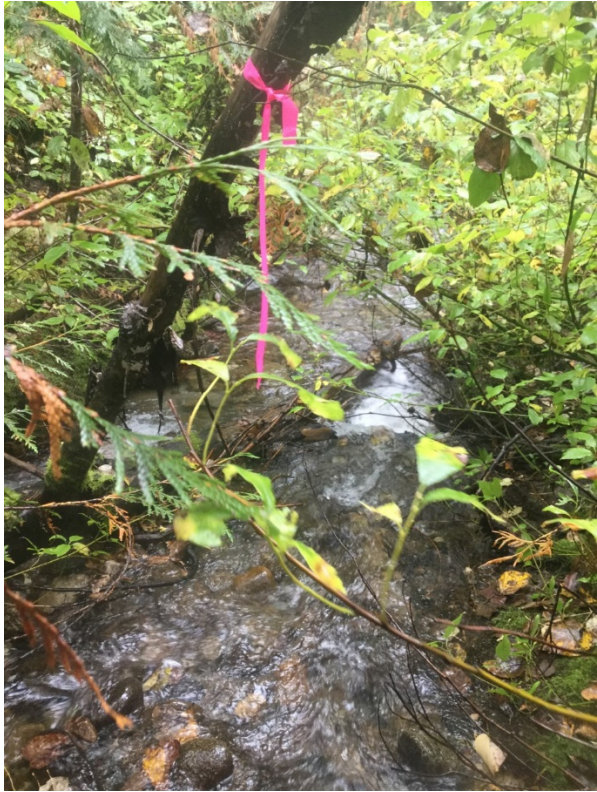
Figure 4. Coppermine stream at test site downstream from fertilization treatment areas

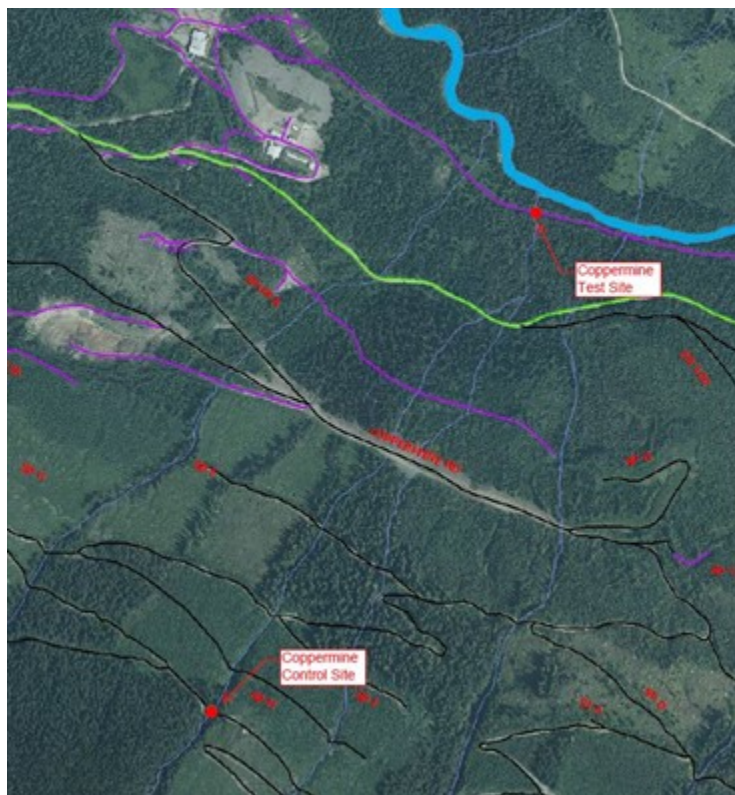
Figure 6. Ortho photo of Coppermine area, stream, and location of control and test sites

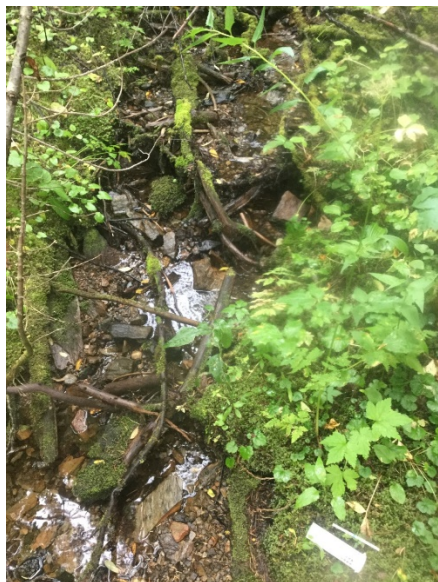
Figure 8. Keystone stream at control test site upstream from fertilization area

The Keystone S-6 stream chosen for water quality monitoring begins in the subalpine, eventually flowing down into the Revelstoke Reservoir Lake. This stream was not visible from the air and runs unbuffered through treatment areas 686-304 and 686-5A (Figure 7). The Keystone site was also chosen as there was still time to collect pre-treatment samples. Two sample sites were established on the Keystone stream, one above any fertilizer treatment areas (Figure 8), and the other established downstream of any affecting treatment areas (Figure 9 and 10).

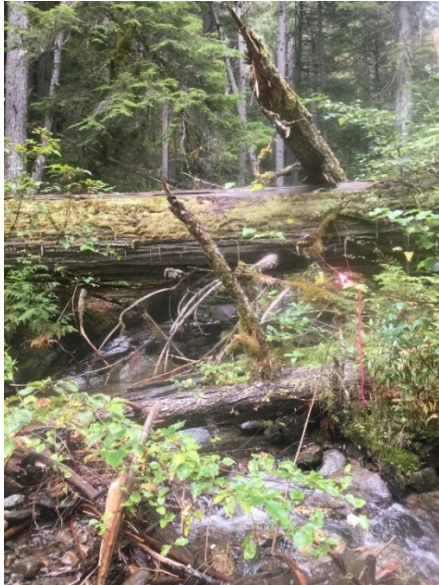
Figure 9. Keystone stream at test site downstream from fertilization treatment area
