Alexander Creek Water Quality Monitoring Report 2015 – 2017

Prepared by:
Lotic Environmental Ltd, Mainstreams Environmental Society, and
Elk River Alliance

Prepared for:
The Columbia Basin Water Quality Monitoring Project

June 2018

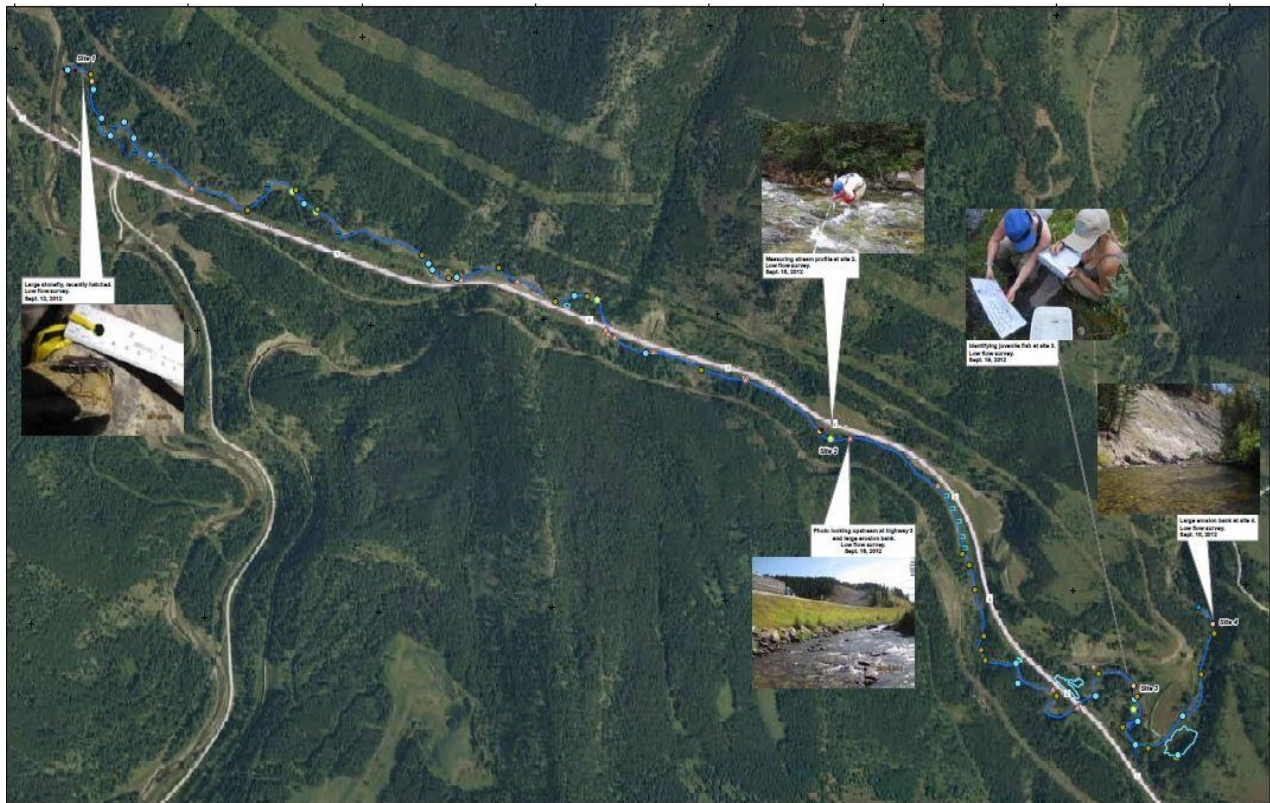
Figure 1. Sensitive Habitat Inventory and Mapping of Alexander Creek, 2012.¹

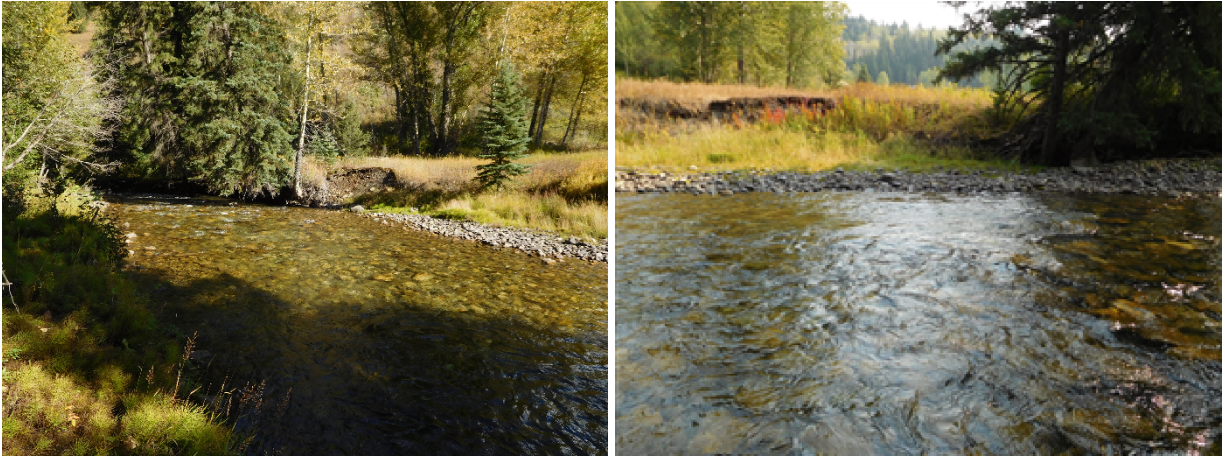
Figure 3. Downstream and across stream view of NGALX03 monitoring site, September 2016 and 2017, respectively. Photos by Ayla Bennett and Allie Ferguson.

The riparian zone at the monitoring location is generally dominated by coniferous trees, including Engelmann Spruce, Douglas Fir and Subalpine Fir. Major deciduous trees and shrubs include red osier dogwood, trembling aspen and black cottonwood. The Sparwood Rod and Gun Club rifle range is located immediately upstream of the monitoring location.

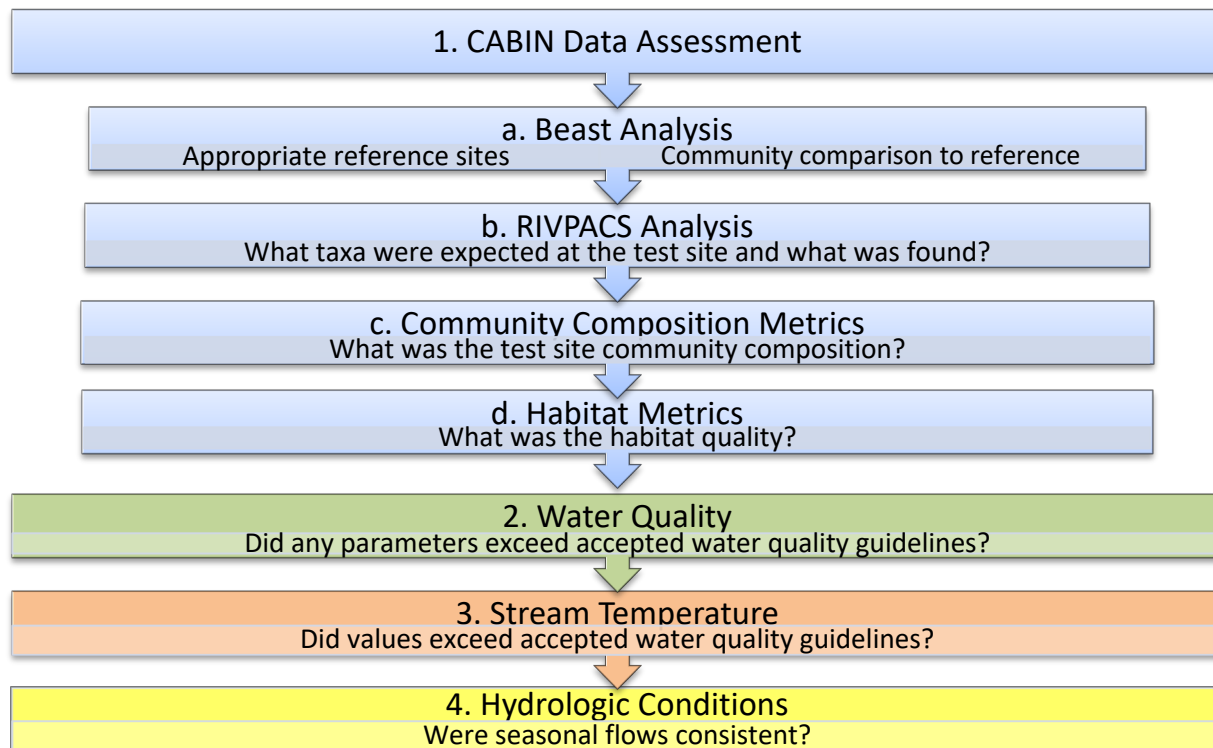
Figure 4. Stream condition analysis steps.

The Reference Condition Approach (RCA) in CABIN was used to determine the condition of the benthic macro-invertebrate community at the test site (as sampled by the CBWQ group), by comparing the test site results to a group of reference sites with similar environmental characteristics. The Analytical Tools function in the CABIN database was used to run four analyses to review invertebrate test site data (Steps 1a – 1d in Figure 4): Benthic Assessment of Sediment (BEAST), River Invertebrate Prediction and Classification System (RIVPACS), community composition metrics, and habitat metrics. Water quality (Step 2), stream temperature (Step 3) and hydrometric (Step 4) analyses followed to provide an overall understanding of stream condition.

The reference model used in the RCA analysis was the Preliminary Okanagan-Columbia Reference Model (2010) provided in the online CABIN database. Because the model was still considered preliminary, with some potential data gaps, caution was exercised when interpreting RCA results (obtained from Steps 1a to 1d). Furthermore, it was important that all subsequent analyses (Steps 2 – 4) were conducted.

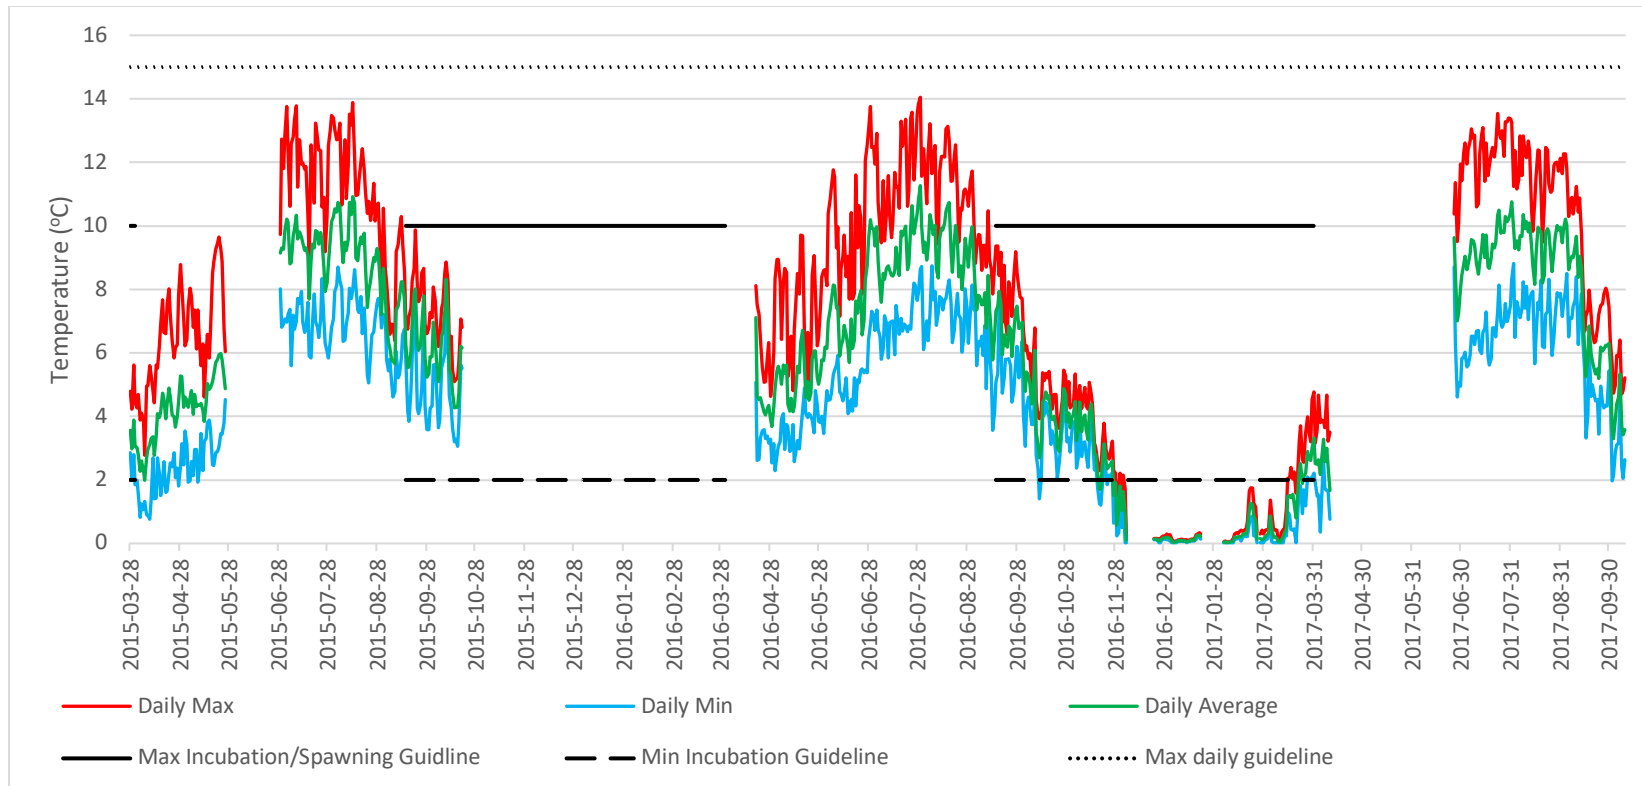
Figure 5. Stream average daily temperatures in Alexander Creek (NGALX01) from March 28, 2015 to October 10, 2017. The guidelines presented are for the protection of aquatic life for streams with Bull Trout present (BC MoE 2018b).

Because of Bull Trout's presence in Alexander Creek, the temperature data were compared to the guidelines for streams with Bull Trout. In general, summer stream temperatures in all years were below the maximum daily Bull Trout rearing temperature of 15 °C (Figure 5). These fish likely seek out cooler waters (e.g., in deep pools), during the warm summer months.

Bull Trout spawning generally occurs from mid-September to late October and often is initiated when water temperatures drop below 9 °C (McPhail 2007). The maximum daily stream temperatures in Alexander Creek during spawning season did not exceed optimal spawning temperature guidelines (i.e. a max daily temperature of 10 °C). However, it is unknown if fish spawn in the area of the temperature logger, as monitoring of spawning or potential for spawning (based on habitat including gravel size, flows, and water depths) was not part of this study. If Bull Trout spawning occurred, the eggs would incubate overwinter. Bull Trout egg incubation period is temperature dependant, taking 119-126 days at 2 °C, 92-95 days at 6 °C, 74-76 days at 6 °C, 74-78 days at 8 °C, and 70 days at 10 °C (McPhail 2007). After hatching, fry remain in the gravel and generally emerge in June. Based on the available winter stream temperature data collected, the guideline for minimum temperature during incubation of 2 °C was generally not met from mid-November 2016 through early April at the monitoring site. These results suggest Bull Trout spawning likely occurs in other locations where groundwater-surface water interactions are high (Baxter and Hauer 2000), as these areas provide consistent year-round water temperatures (i.e., approximately 5°C) (Meisner et al. 1988).

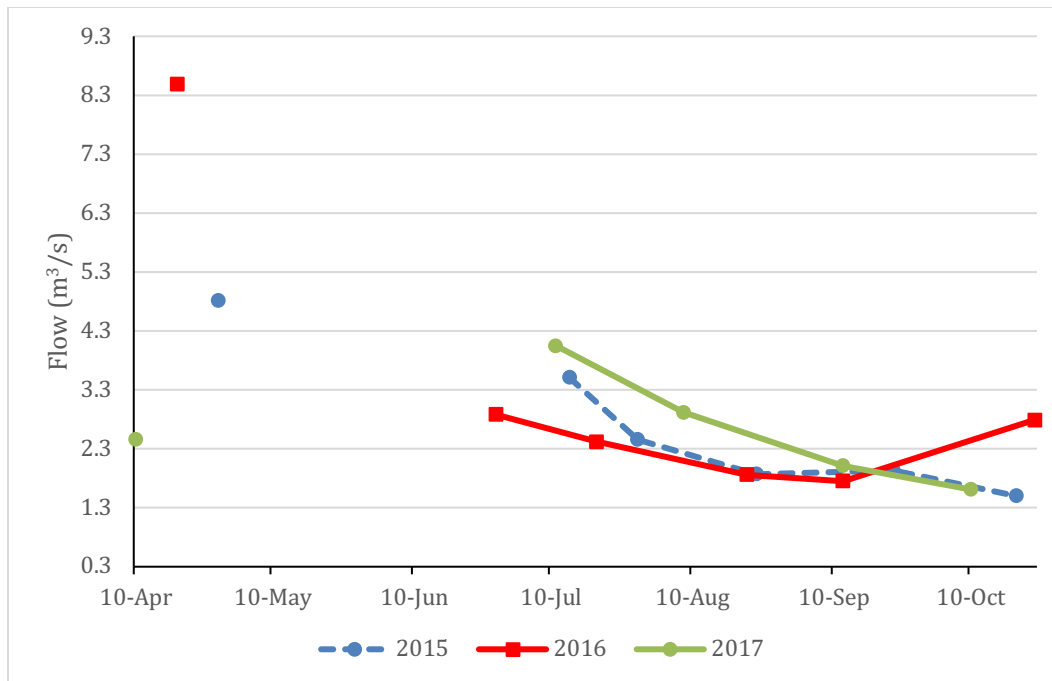
Figure 6. Streamflow at NGALX03, 2015-2017. No measurements were collected during the spring high flow period, due to safety concerns.

The CBWQ generally aimed to collect instantaneous streamflow data monthly from spring through fall. The results show consistencies in streamflow patterns amongst the three years sampled at Alexander Creek. Freshet (i.e. high flows due to snowmelt and/or heavy rain) occurred April – June, followed by decreasing flows (Figure 6). In 2016, there was a slight increase in streamflow in October, which was caused by heavy precipitation.
