Wolverton Creek Hydrogeomorphic Assessment and Risk Analysis

(Apex File: HA-06-KL-01)

Prepared For: Stan Hadikin, R.P.F.
Kalesnikoff Lumber Co. Ltd.
P.O. Box 3000
Highway 3A
Thrums, B.C.

Prepared By: Kim Green, P.Geo., M.Sc.
Apex Geoscience Consultants Ltd.
1220 Government Street,
Nelson, B.C.

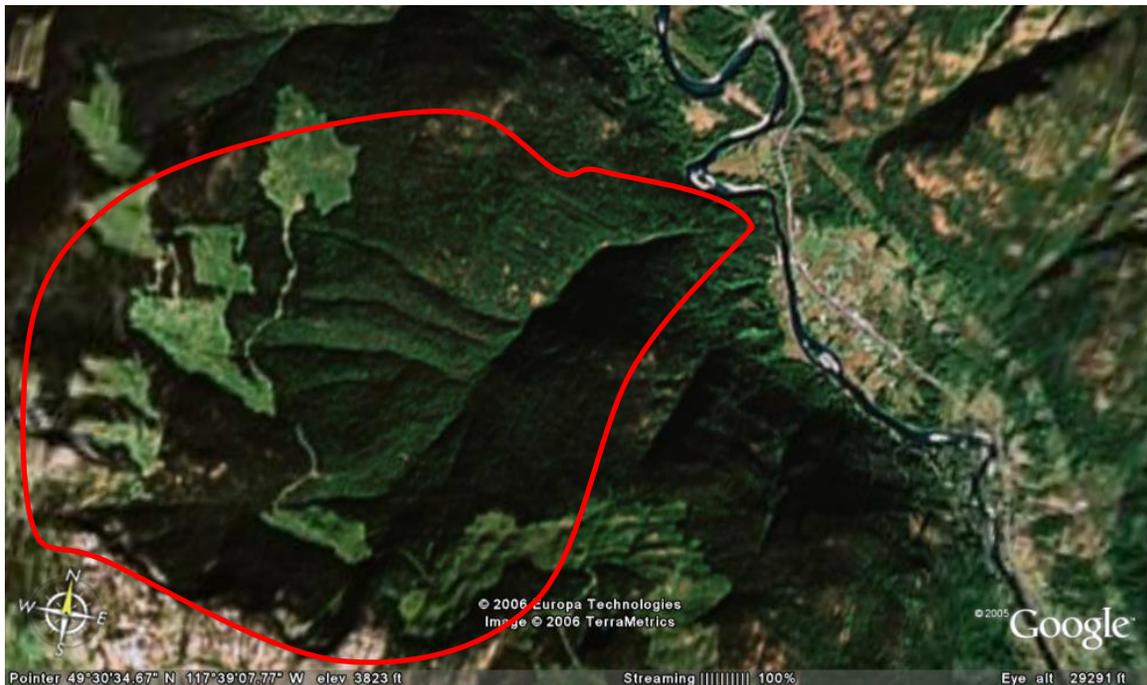
Figure 2. Satellite image showing distribution of 1970's and 1980's cut blocks in upper Wolverton Creek.

Logging activities commenced in Wolverton Creek in 1973. Six cut blocks totalling 267 hectares or roughly 17.6 % of the watershed area were removed from in the headwater portion of the catchment between 1974 and 1984.

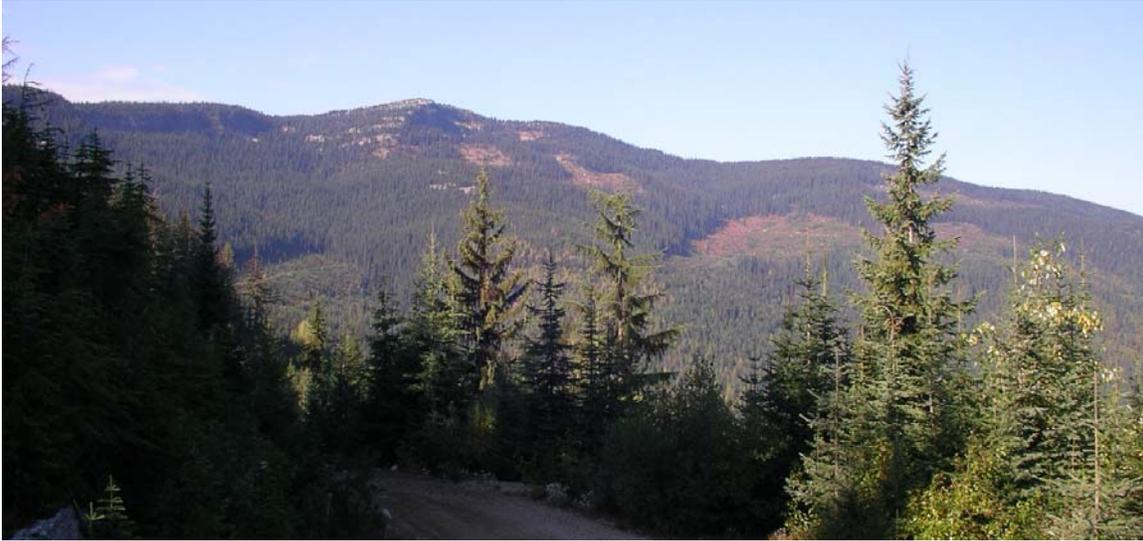
Photo 1. View from FSR looking north at upper Wolverton Creek. 1980's logged blocks are evident on the southeast aspect slopes.

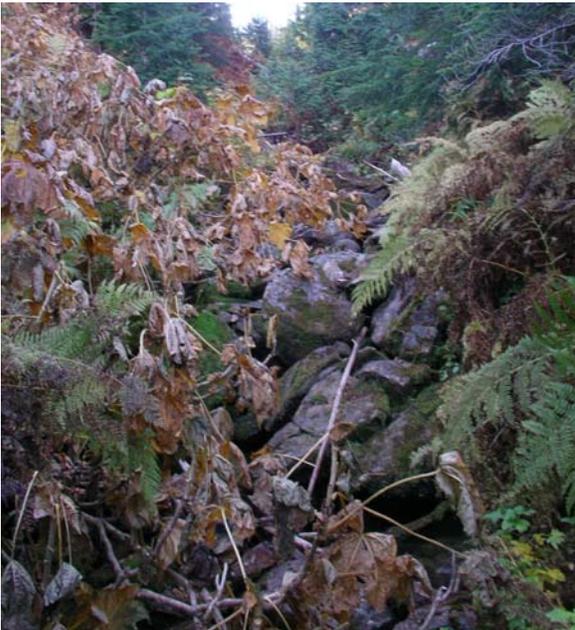
Photo 2. Headwater tributary of Wolverton Cr. above FSR at UW2 (Figure 1). Channel has very steep (>35%) colluvial boulder and bedrock cascade morphology

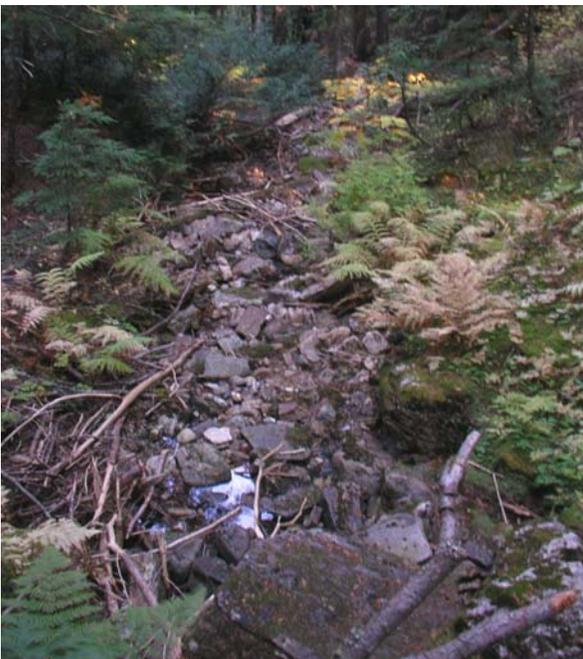
Photo 4. Looking downstream on small tributary east at GPS site UW6 (Figure 1).

Below approximately 1200 metres the channel gradient steepens to greater than 20 % and bedrock is exposed in the channel bed and side slopes. The morphology of the channel consists of bedrock and boulder falls and cascades. Mobile bed load consists of sub-angular to sub-rounded boulders, cobble and gravel. LWD is less significant in controlling channel structure or moderating bed load transport through this section. Local scour of channel banks and bright bed load suggest that Wolverton Creek experienced a high peak discharge in the last several years.

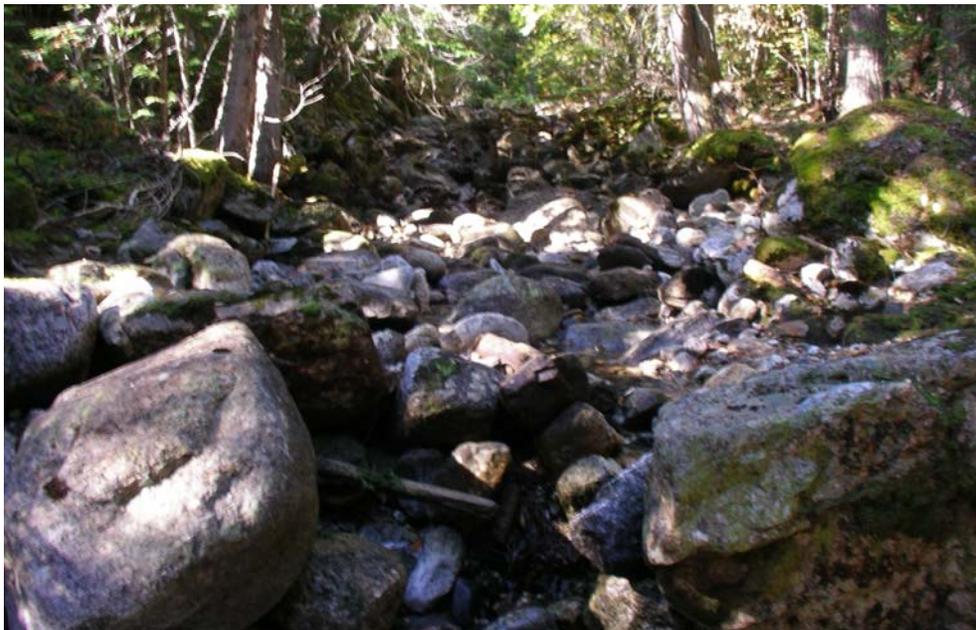
Photo 6. Looking upstream at site W5. Bed load is very coarse textured. Morphology is boulder cascade to step pool.

The lower reaches of Wolverton Creek between the lowest bedrock falls and the confluence with the Slocan River have a boulder cascade morphology. The channel width ranges from 6 to 10 metres wide and channel gradient ranges from 6 to 14%. The bed load consists of large sub-rounded boulders ($d_{90} = 76\text{cm}$) and finer sediment. Moss and lichen on the largest boulders suggest these have not moved for at least a decade but most of the smaller material ($<40\text{ cm}$) appears to move annually.

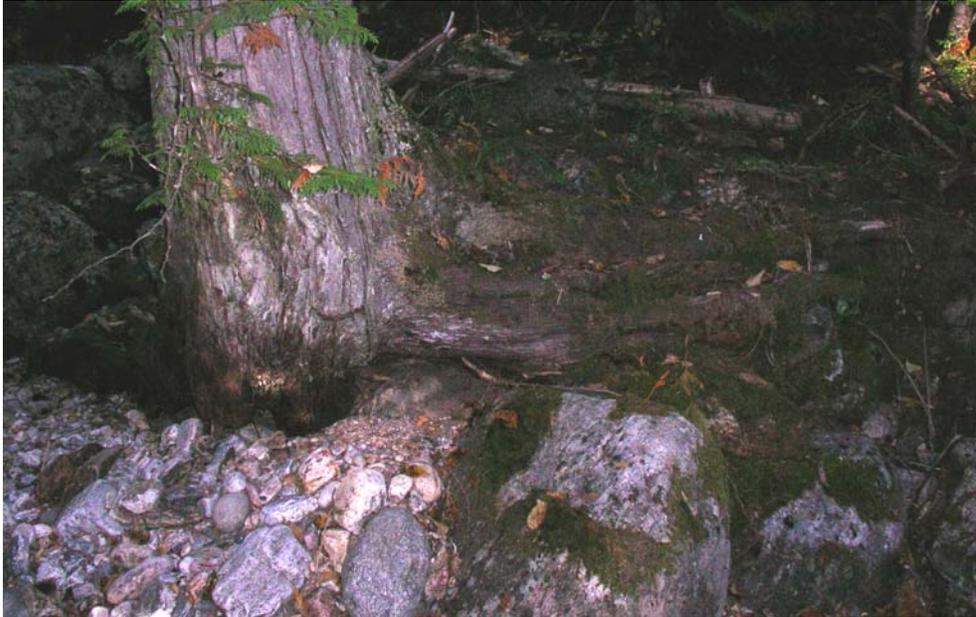
Photo 7. Cedar along channel bank on lower Wolverton illustrates armouring function of roots.

The lower reaches of Wolverton Creek are entrenched in places up to 2 meters into a 25 metre wide valley flat formed by past flood deposits. There is no functioning LWD in the channel. Cut stumps along channel margins suggest logging has occurred in the recent past. It also appears that this section of the channel has been cleared of LWD. Riparian vegetation consists mainly of small diameter ($<40\text{cm}$) cedar, Douglas fir and cottonwood. Cedar has established along channel margins and is providing some armouring to channel banks (Photo 7).
