Elk River Westslope Cutthroat Trout (WCT) Research Initiative: 2019 Report

Prepared by: The Elk River Alliance, Fernie, BC

Date: 28-06-2020

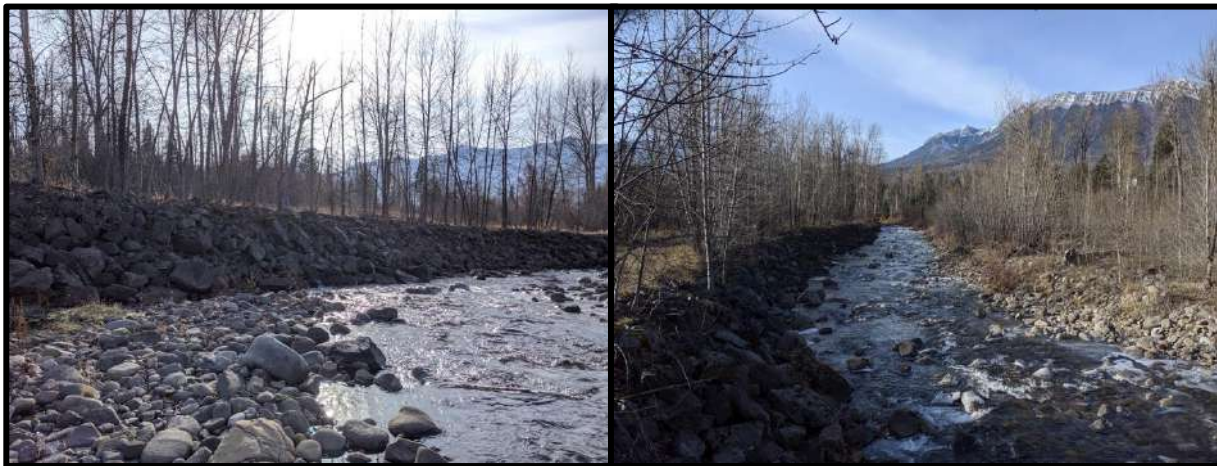
Figure 18. Photos of HACOL02 (Site #16) on Coal Creek.

HACOL02 is an identified site located at 49.49540, -115.06190 extending approximately 250 upstream from the Cokato Rd bridge. This site received a habitat assessment score of 36, priority score of 28, and evaluation score of 78 (Table 7). HACOL02 is a section of stream that has been severely channelized and lacks suitable habitat for fish (Fig. 20). There are no pools or rooted cutbanks, and minimal large woody debris and overhanging vegetation; 80-85% of the bank is devoid of vegetation and consists of large boulders. The riparian zone has been heavily impacted by human activity and is constrained between a logging road and urban development. Coal Creek has historical impacts stemming from an abandoned township, defunct coal mine and logging, while contemporary impacts include ongoing logging and public use of forestry roads, all of which have had a negative impact on WCT.

A heavily rip-rapped and channelized section of Coal Creek that has few habitat features and cover for inhabiting fish.

could benefit from earthmoving equipment, though this section is located on bedrock so erosion is not as severe as other sites. Given ongoing cumulative impacts on Coal Creek (particularly sedimentation from ongoing logging, among other factors), restoration and habitat enhancement would help offset upstream effects. Creating deeper pools with LWD habitat will slow down flow, allowing suspended sediments to settle from the water column. Additionally, given the high level of existing rip-rap throughout the site it may be an ideal location for a vegetated riprap pilot project. This may be a project the City of Fernie would be interested in partnering on.

This reach is easily accessible from town and could provide an opportunity for a high visibility restoration and community outreach program. Enhancement work could involve community in hands-on restoration and riparian planting, as well as provide an opportunity for contractors to educate these volunteers on the importance in creating WCT habitat. Sign placement would provide ongoing educational opportunities.

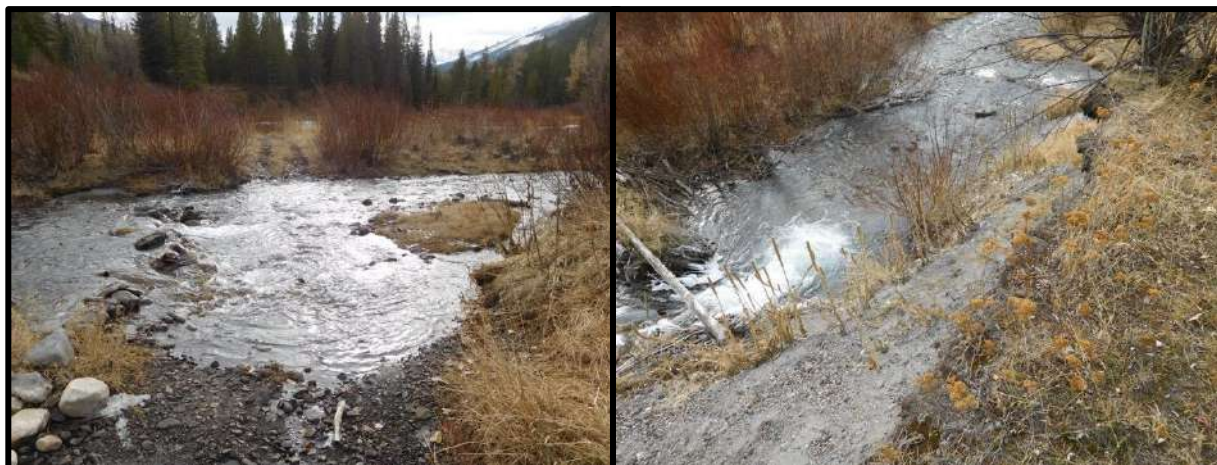
Figure 19. Photos of HACOR01 (Site #26) on Corbin Creek.

An uncontrolled, unmarked ATV crossing below the embankment is likely causing the stream to widen and encourages irresponsible recreational use through gravel beds that would otherwise provide good rearing habitat (Fig. 21). Juvenile trout have been found near this site and in-stream which would be adversely affected by ATV use of the stream.

A section of stream that has been driven through by vehicles can be seen here alongside a failing bank that is just upstream from vehicle crossing.

Further restoration activities should include removing surrounding debris and invasive plants from the site through a series of cleanup events, and planting native shrubs and grasses along the eroded bank to reduce erosion. This will reduce issues of bank destabilization and erosion resulting in sedimentation, though a proper reclamation of the eroding abutments would be preferred.

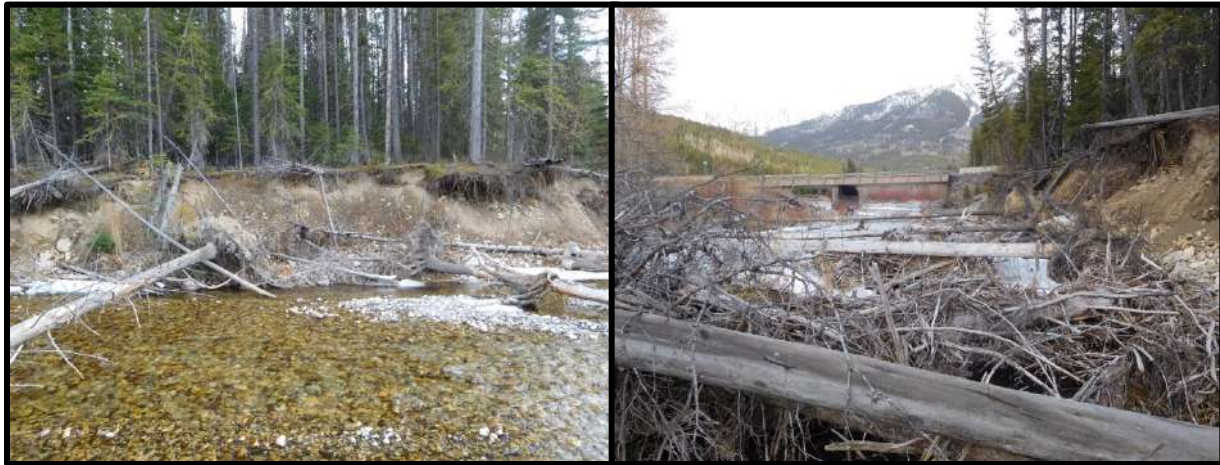
Figure 20. Photos of HAAG01 (Site #27) on Andy Goode Creek.

A section of stream consists of a slope failure and stream widening creating shallow stream morphology and sedimentation concerns.

The road adjacent HAAG01 is not frequented by the general public aside from trout fishers and back country enthusiasts; however, if restoration efforts took place a complementary public outreach initiative could be implemented. This could involve community volunteer assistance in hands-on restoration and riparian planting work, as well as provide an opportunity for contractors to educate volunteers on the importance in conserving WCT habitat.

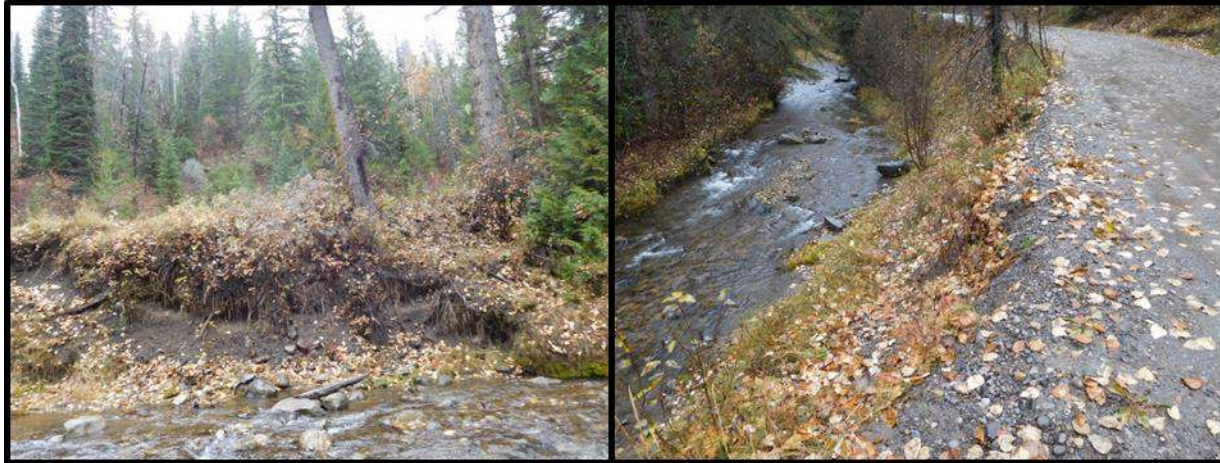
Figure 21. Photos of HALIZ01 (Site #13) on Lizard Creek.

HALIZ01 is an identified site of concern located at 49.49010, -115.10577 that received a habitat assessment score of 72, priority score of 26, and evaluation score of 36 (Table 7). The site includes a steep, eroding slope that threatens to undercut the adjacent access road. Despite this, the site provides good fish habitat with a 31 m cutbank, 11 pieces of LWD and several small pools. 27% of the surveyed reach includes overhanging vegetation and good overhead cover. Gradient of the site is 2.05% and the substrate consists of 16% gravel and 84% cobble.

The unstable slope is 22.7 m long and is immediately adjacent to a road. This is of immediate concern as the erosion is threatening to undercut the road, which risks eventually failing into the stream (Fig. 23). The lack of space between road and stream could complicate re-vegetating and re-shaping the slope. The road lies within the provincial park boundaries, and will likely be a project of interest to them as this is a critical piece of infrastructure on their land. Further, Island Lake Lodge may also be interested in partnering on this project as the road is necessary for accessing the property. Consultation with environmental restoration experts including geomorphologists and engineers will be required to assess what can be done to accommodate the restoration of the site given the steep pitch of the eroding slope and proximity to the road. Likely the road would need to be moved or narrowed in order to accommodate reshaping the slope and placing LWD instream to deflect erosional forces. A combination of adding/repositioning LWD, re-shaping the stream bank and planting native riparian vegetation on the bank would be effective. This would stabilize the bank, limit sedimentation and turbidity, promote vegetation of the riparian zone and create in-stream habitat for WCT. A smaller scale, less costly, and shorter-term fix would be to plant a number of native shrubs such as willows along the eroding slope to help stabilize the soil and reduce sedimentation into the stream. This would provide benefit unless a larger scale flood should occur and wash out the vegetation before it becomes established.

These photos illustrate the steep stream bank erosion and its concerning proximity to the adjacent road.

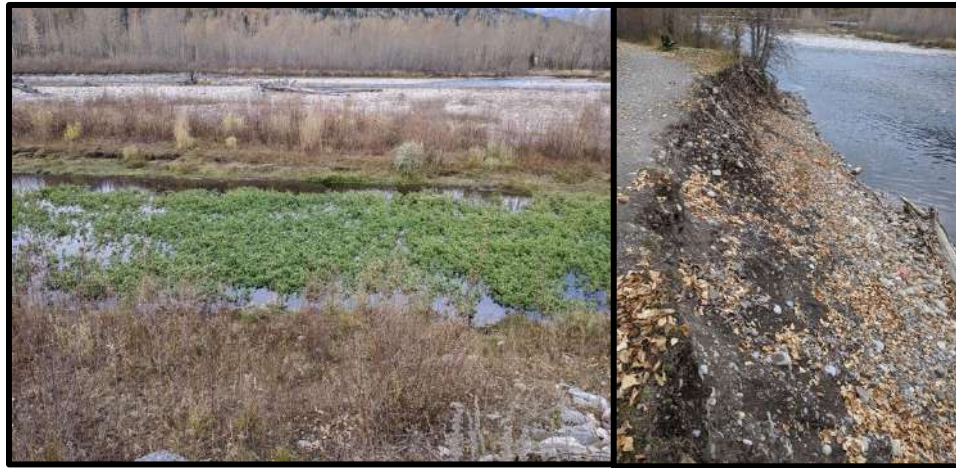
Figure 22. Photos of HAELK01 (Site #11) on the Elk River.

HAELK01 is an identified site of concern located at 49.52321, -115.05245 that received a habitat assessment score of 36, priority score of 25, and evaluation score of 69 (Table 7). The site consists of a 200 m long shallow side/back channel of the Elk River that, on the date of surveying, was holding an estimated 200+ juvenile Westslope cutthroat trout and mountain whitefish (Figure 22). The site also includes a steep eroding section of bank that is cutting into a walk path creating sedimentation and community safety concerns.

These photos illustrate side channel that was of concern and the steep stream bank erosion that is almost undercutting the adjacent walkway.

There is good opportunity for partnership at this site given the number of stakeholders that may be interested, including: The City of Fernie, Fernie Trails Alliance, Fish Guiding Outfitters and the nearby RV

park. The site is adjacent to a well used trail, presenting a good opportunity to publicise restoration work and educational signage placement. Community involvement should include volunteer rehabilitation and planting and an opportunity for contractors to educate volunteers.

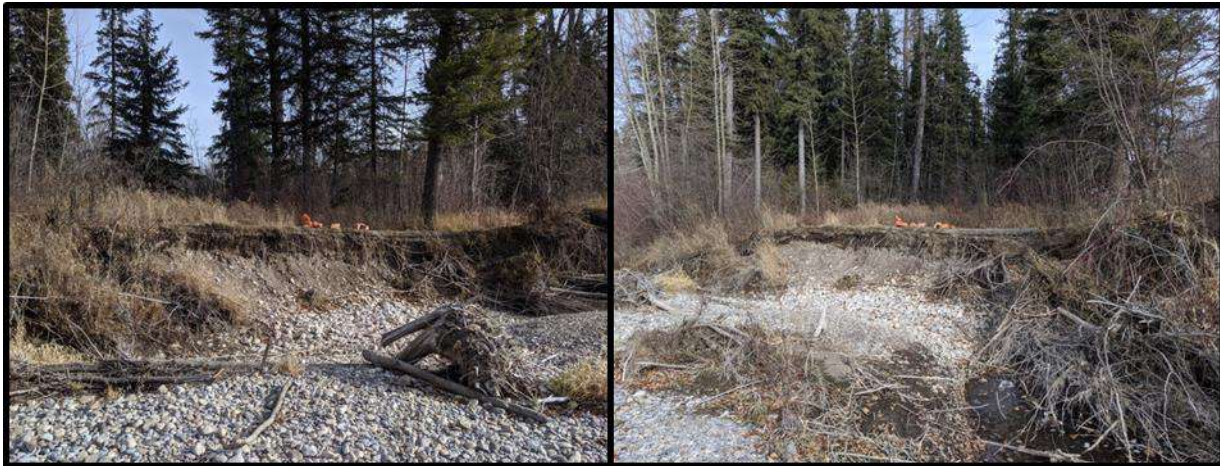
Figure 23. Photos of HAELK02 (Site #6) on the Elk River.

HAELK02 is an identified site of concern located at 49.4910, -115.0787 that received a habitat assessment score of 71, priority score of 22, and evaluation score of 31 (Figure 7). The site is centered around a 16 m long, 2.5 m tall eroded bank undercutting a footpath, (Figure 23) similar to at HAELK01.

The eroded bank is undercutting a footpath posing a safety hazard to recreational users. The lack of space between the walking path and bank could complicate re-vegetating and re-shaping the slope. The site lies within the City of Fernie boundaries, and would likely be an area that they consider armouring with riprap as a lower investment option. In this instance we would suggest vegetating the riprap to provide improved habitat values through overhanging vegetation. A smaller scale, less costly, and short-term fix would be planting/live staking native shrubs along the eroding slope to help stabilize the soil and reduce sedimentation into the stream. The site is easily accessed from the trail making it a good candidate for small scale rehabilitation. Alternatively, bioengineering, including the placement of LWD, re-shaping the eroding bank, and planting native riparian vegetation on the bank to protect both bank and trail, would help to stabilize the bank, limit sedimentation and turbidity, promote restoration of the riparian zone and create new in-stream habitat for WCT.

These photos illustrate the stream bank erosion that is undercutting the adjacent walkway and the associated vegetation that has fallen into the seasonal streambed.

Restoration on the main stem introduces the potential damage during spring freshet and high-water events and would likely be exposed to high water events within a 5 to 10 year timespan. Durable

restoration options could be explored including heavy duty LWD anchoring could be a viable option to improve restoration longevity.

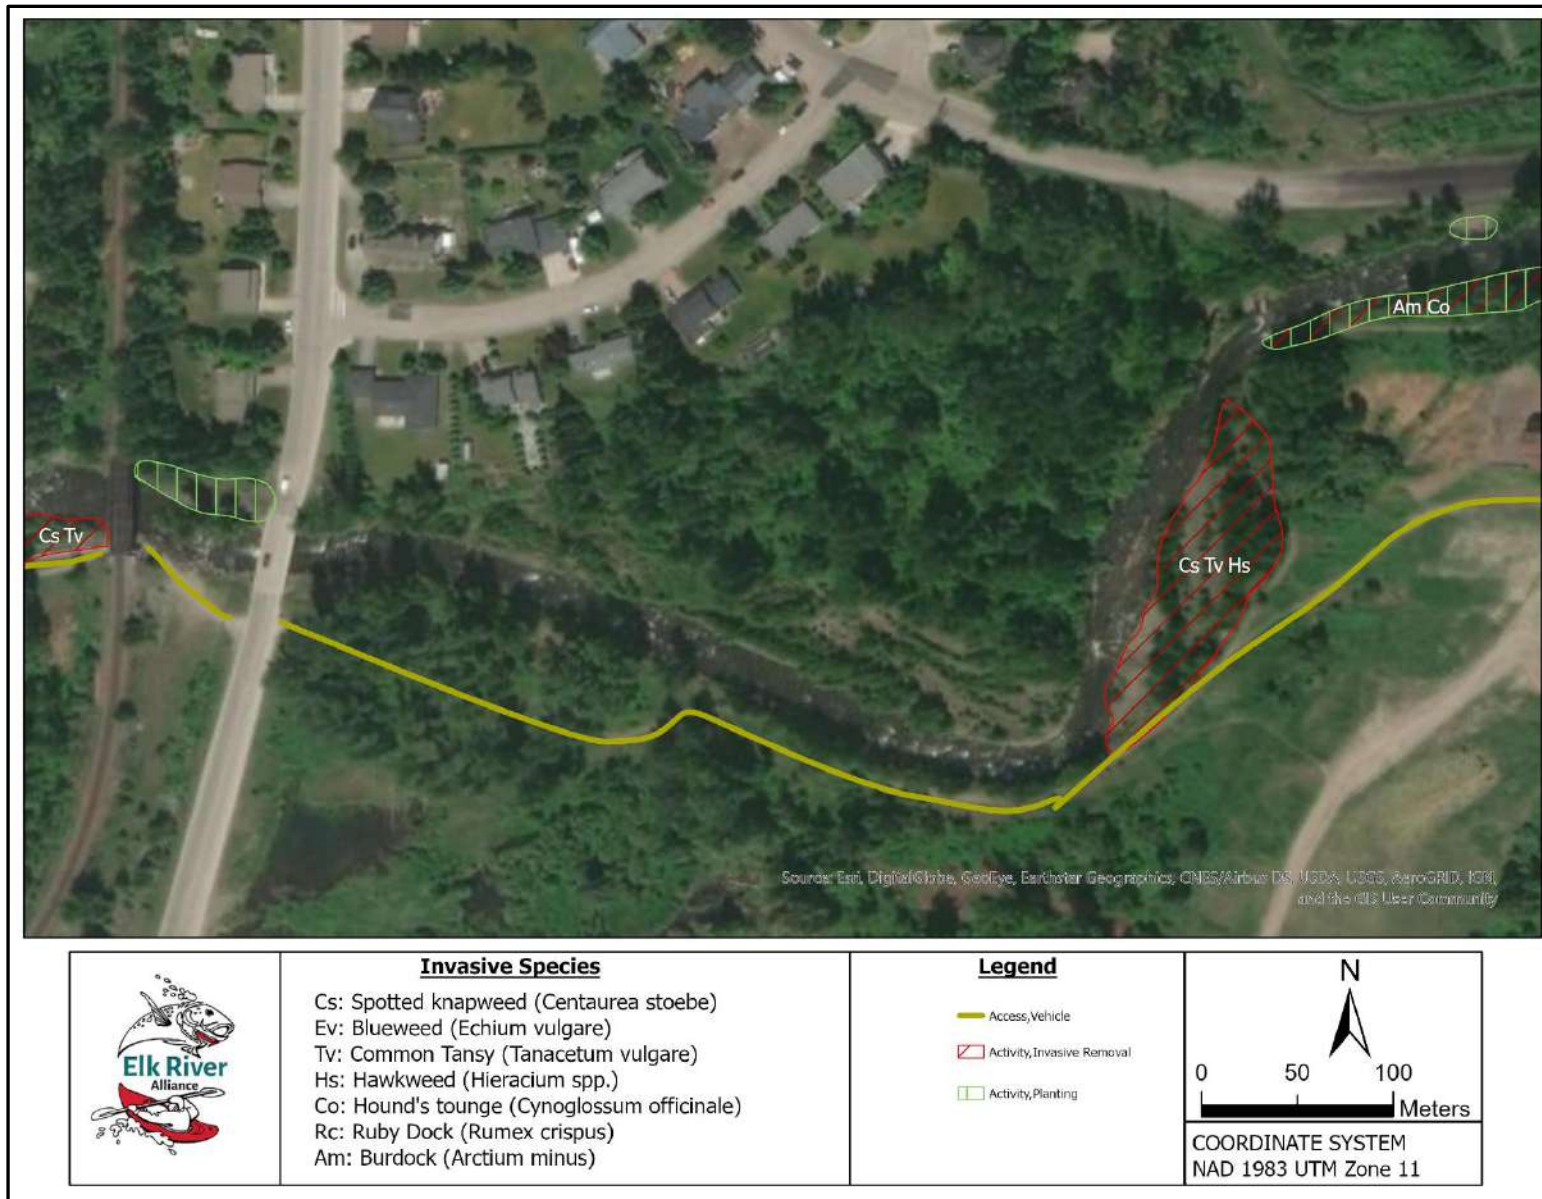
Figure 10: Proposed restoration activities on Coal Creeks 2/3

A 250m stretch of riverway upstream from the road bridge seen in Figure 10 is currently closed to the public due to construction activities and is not included in this restoration plan. This section is largely riprapped and is relatively stable with acceptable streamside vegetation. Future potential restoration activities will be considered when construction plans are released.

Proposed restoration activities are detailed in Figure 9, Figure 10 and Figure 11
