Slocan Lake Foreshore Integrated Management Planning – 2021

Wood Project# VE52823-2021A

Living Lakes Canada Nelson, BC

31 March 2022

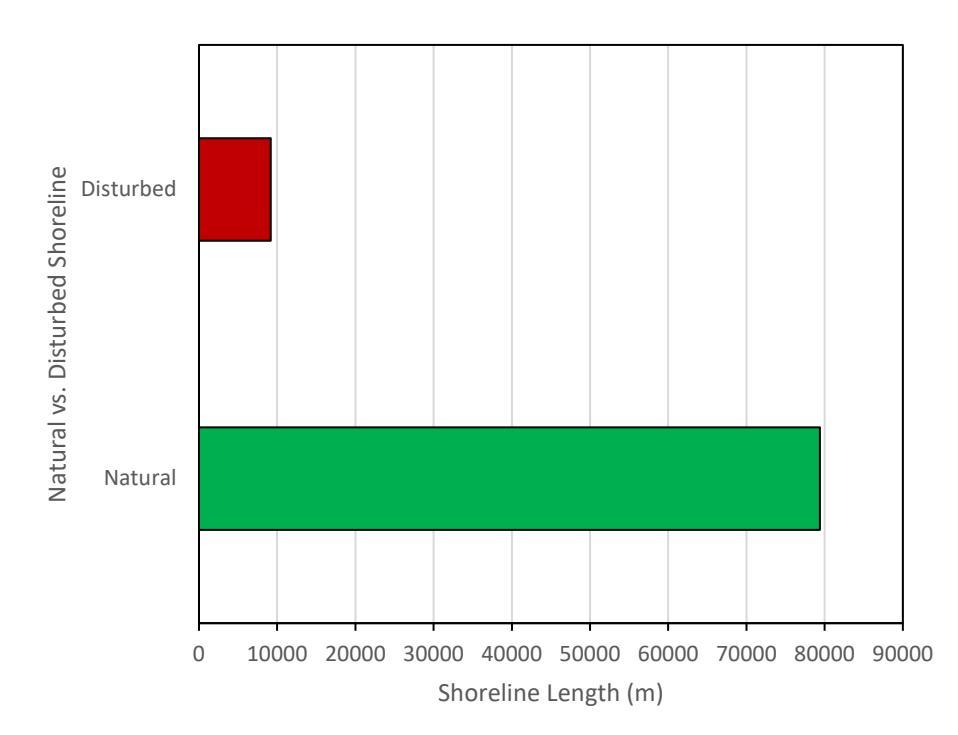
Figure 2: Total shoreline length (m) that is disturbed or natural for Slocan Lake.

The re-FIM was completed along the entire 88,566 m of the Slocan Lake shoreline. The shoreline was divided into 34 segments ranging in length from 239 to 22,970 m. The total length of disturbed shoreline was 9,174 m (10%) while the total length of shoreline that remained in natural condition was 79,392 m (90%); (Figure 2).

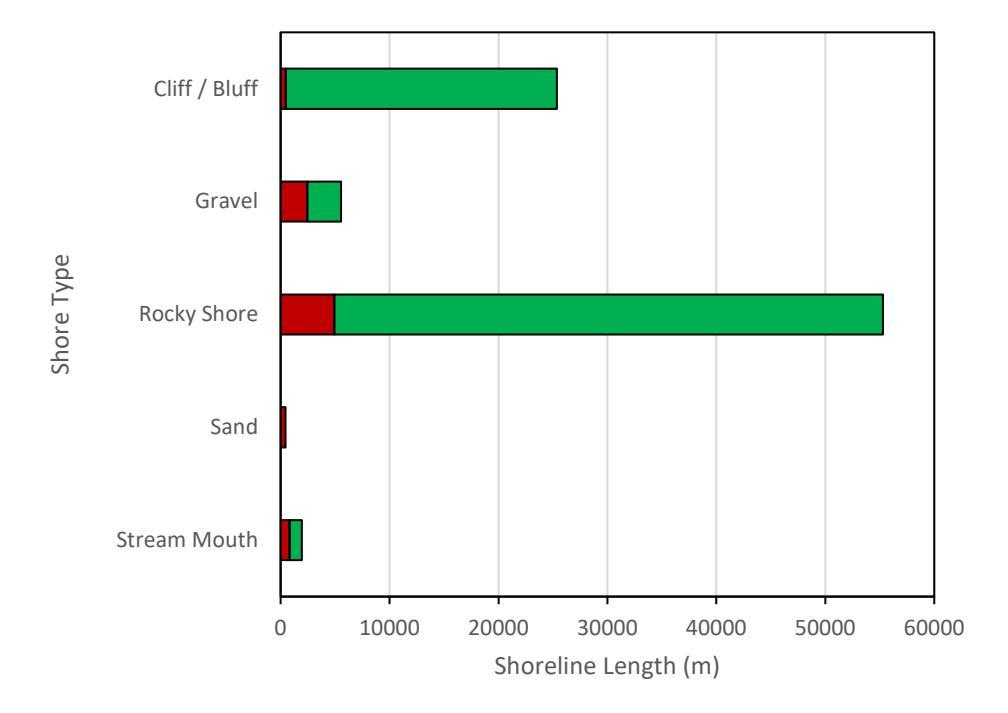
Figure 3: Shore types and length of natural (green) versus disturbed (red) shoreline for Slocan Lake.

The predominant shore type was rocky shore which was observed along 55,281 m (62%) of Slocan Lake (Figure 3). Other shore types observed included cliff/bluff (25,346 m; 29%), gravel (5,549 m; 6%), stream mouth (1,952 m; 2%) and sand (436 m; <1%). Wetland shore types were not observed. One segment classified as gravel shore type (Segment 15) was noted as being entirely imported fill. In areas with cliff/bluff and rocky shores, 98% and 91% of the shoreline remained in natural condition, respectively. Less of the shoreline remained in natural condition in areas with stream mouth and gravel shore types (57% and 56%, respectively) while the one segment classified as sand shore type (Segment 21) was completely disturbed with no natural shore remaining (Figure 3). The Slocan River outlet accounted for most of the stream mouth shore type observed (Segments 1 and 28) with the remaining area located at the Wilson Creek outlet (Segment 17).

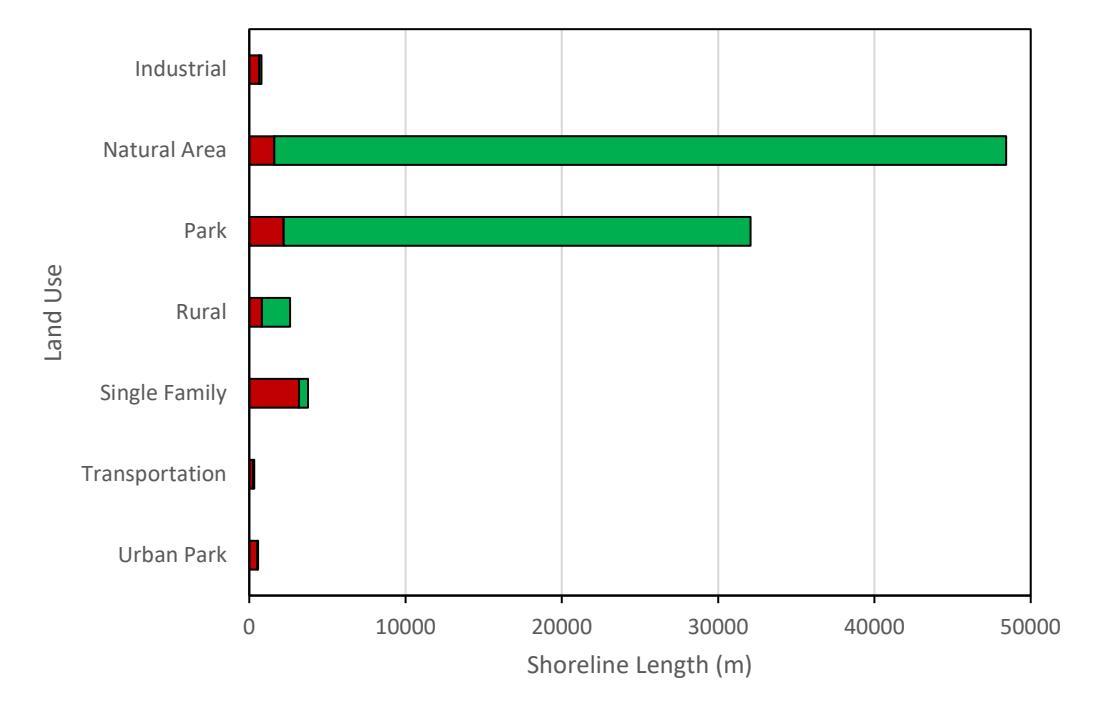
Figure 4: Land use types and length of natural (green) versus disturbed (red) shoreline for Slocan Lake.

The predominant land use along the Slocan Lake shoreline was natural area (48,428 m; 55%) followed by park (34,075 m; 36%) (Figure 4). Lesser amounts of single family residential (3,766 m; 4%), rural (2,618 m; 3%), industrial (779 m; <1%), urban park (572 m: <1%) and transportation (327 m; <1%) land uses were also observed (Figure 4).

Most of the shoreline in segments classified as natural area and park were in a natural state (3% and 7% disturbed, respectively) (Figure 4). Disturbance in natural areas was due to small areas of rural and single-family residential development or transportation corridors (e.g., Highway 6) in a portion of the segment. Disturbance in areas with park land uses was also due to small areas of rural and single-family residential as well as park infrastructure. More disturbance was observed in segments classified as rural (31% disturbed) where shoreline modification was associated with beach access, docks and substrate modification. Segments with transportation and industrial land uses had similar levels of disturbance (70% and 81%, respectively) mainly due to erosion protection, retaining walls and infilling adjacent to the shoreline. The highest levels of disturbance were associated with segments classified as single-family residential and urban park land uses (85% and 90%, respectively) due to numerous shoreline modifications including docks, groynes, retaining walls, boat launches, erosion protection and substrate modification.

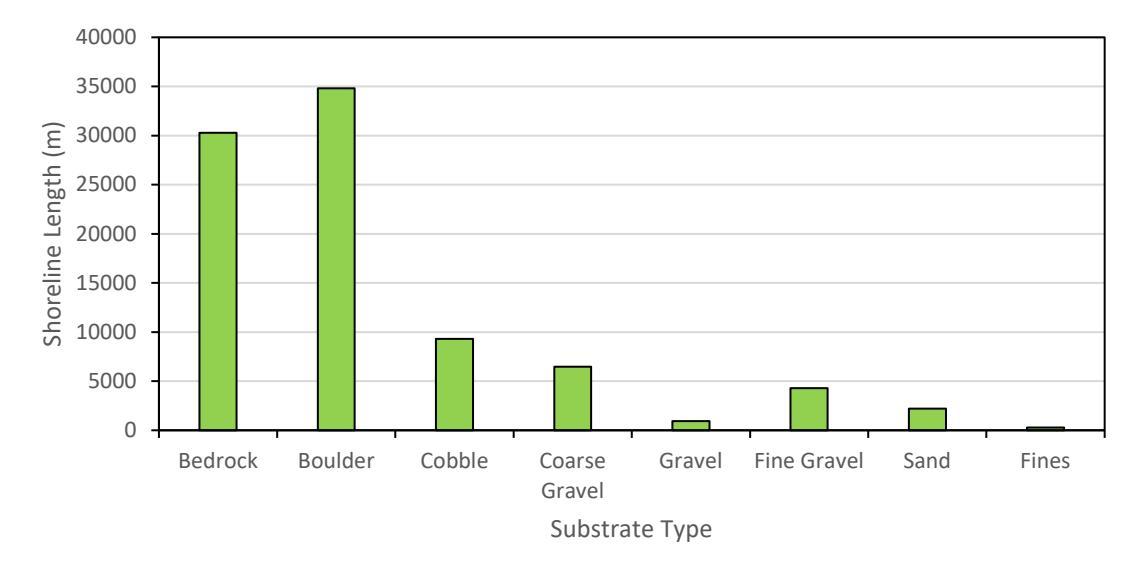
Figure 5: Substrate types observed along the foreshore of Slocan Lake.

Boulder (34,795 m; 39%) and bedrock (30,290 m; 34%) were the predominant substrate types observed along the foreshore of Slocan Lake (Figure 5). Lesser amounts of cobble (9,301 m; 11%), coarse gravel (6,457 m; 7%), fine gravel (4,290 m; 5%), sand (2,210 m; 3%), gravel (923 m; 1%) and fines (299 m; <1%) were also observed.

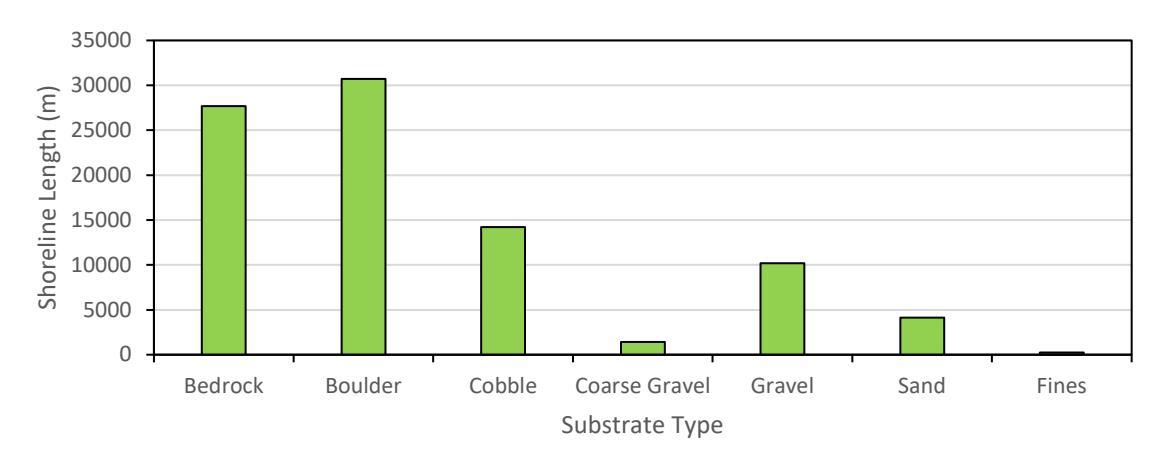
Figure 6: Substrate types observed in littoral areas of Slocan Lake.

Littoral substrates were found in similar amounts as foreshore substrates in Slocan Lake. Boulder (30,714 m; 35%) and bedrock (27,700 m; 31%) were the predominant substrate types observed in littoral areas of Slocan Lake (Figure 6). Lesser amounts of cobble (14,197 m; 16%), gravel (10,175 m; 12%), sand (4,112 m; 5%), coarse gravel (1,430 m; 2%) and fines (237 m; <1%) were also observed.

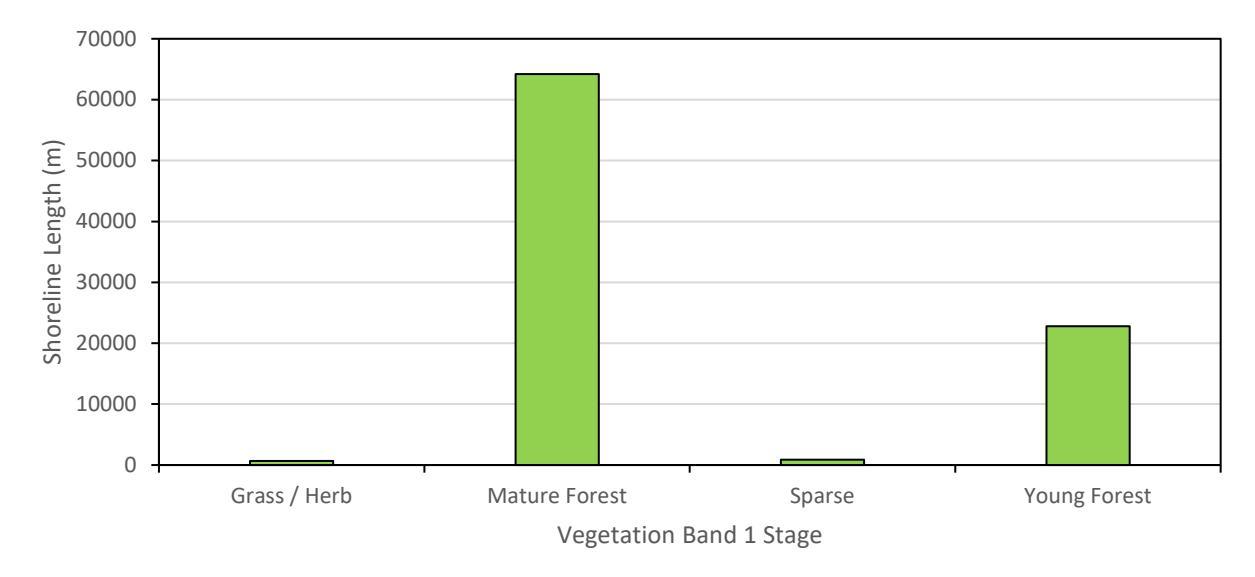
Figure 7: Vegetation stages observed in Vegetation Band 1 for Slocan Lake.

The nearshore riparian vegetation band (Vegetation Band 1) was 50 m or greater in all shoreline segments; secondary vegetation layers (i.e., Vegetation Band 2) within 50 m of the shoreline were not observed (Appendix B). The majority of riparian vegetation in Vegetation Band 1 was coniferous (87,019 m; 98%) with small areas of herbs/grasses (974 m; 1%) and landscape/lawn (572 m; <1%). The dominant stage of riparian vegetation was mature forest (64,208 m; 73%) followed by young forest (22,811 m; 26%), sparse vegetation (871 m; 1%) and grass/herb (675 m; 1%) (Figure 7). Riparian vegetation was continuous in just over half (n=20) of the shoreline segments and patchy in the remainder. Areas with continuous riparian vegetation had abundant (>50%) tree cover while areas with patchy vegetation had sparse (<10%) or medium (10-50%) tree cover.

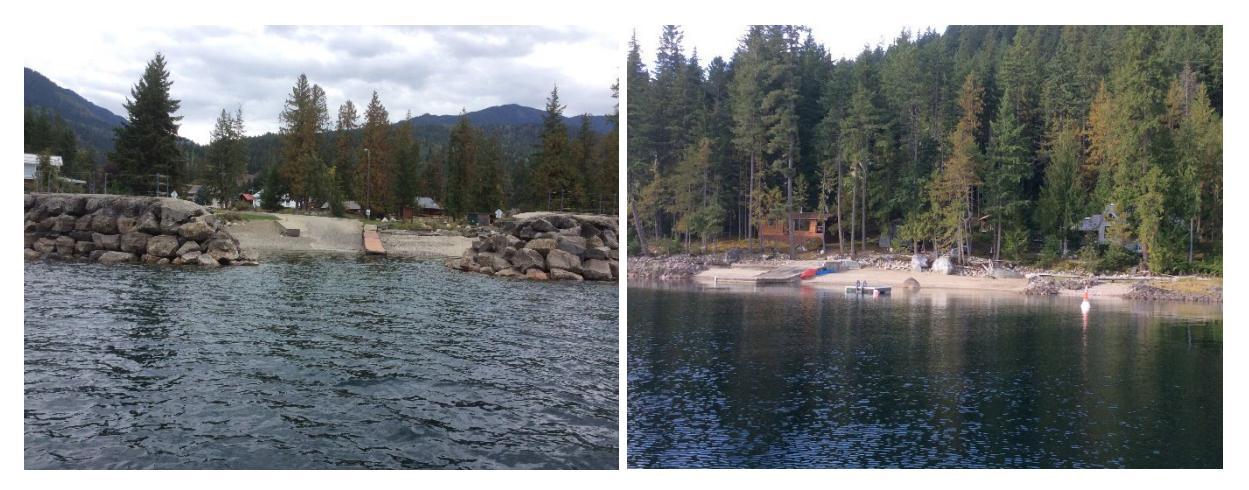
Figure 9: Example of shoreline modifications observed on Slocan Lake including a boat basin with boat launch, dock and erosion protection in Segment 10 (left) and docks, groynes, mooring buoys and substrate modification at boat access residential properties in Segment 26.2 (right).

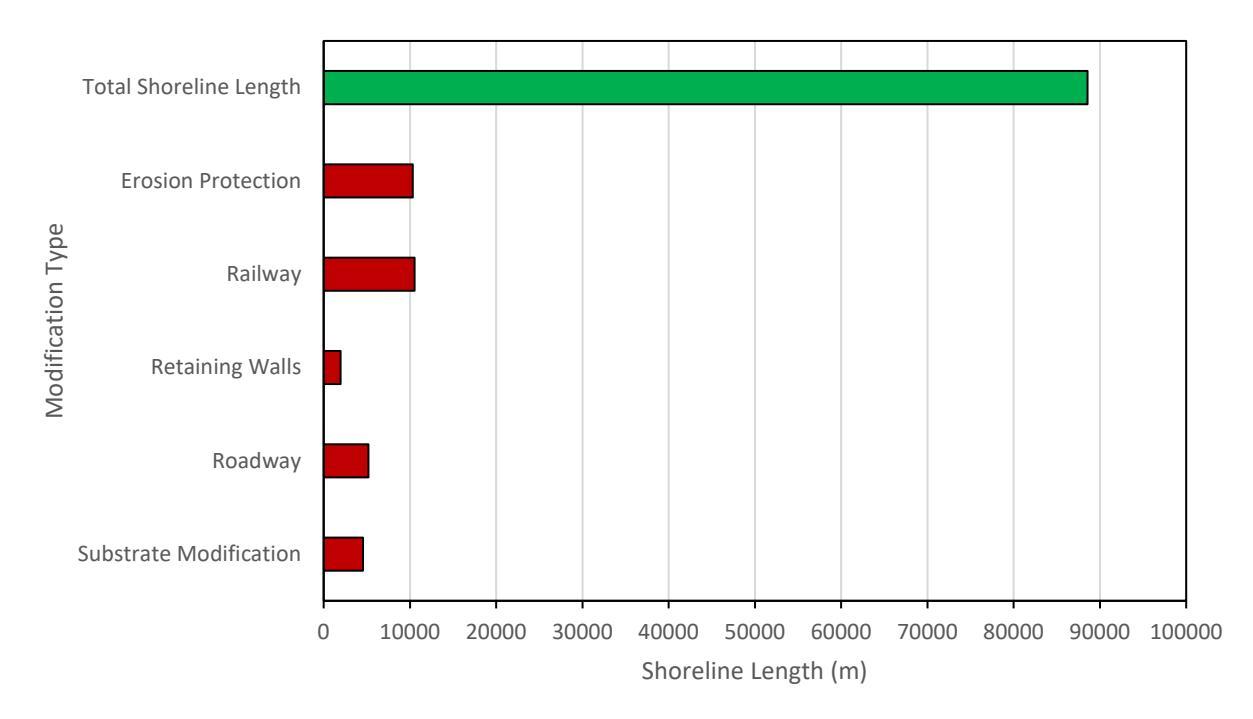
Figure 10: Total shoreline length that has been impacted by lineal modifications along the shoreline of Slocan Lake.

The most prevalent lineal modification was historic railway locations, which occurred along 10,540 m (12%) of the shoreline, followed by erosion protection (10,330 m; 12%), roadway including both historic and active (5,190 m; 6%), substrate modification (4,561 m; 5%) and retaining walls (1,959 m; 2%) (Figure 10). A historic railway line that is now used as a bike/walking trail is present on the east side of the lake from New Denver to the north end of the lake. Erosion protection included retaining walls, groynes, and rip rap material along historic railway locations, roadways and abandoned industrial sites (log yards and a sawmill). A historic highway is located at the southeast side of the lake near Slocan (Segments 3 and 4) and active roadways included Highway 6, village roads and/or property access in various segments. Substrate modification was mainly caused by beach grooming and infilling along retaining walls; retaining walls were constructed of concrete, wood cribbing, cobble/boulder substrates and riprap (Appendix A).

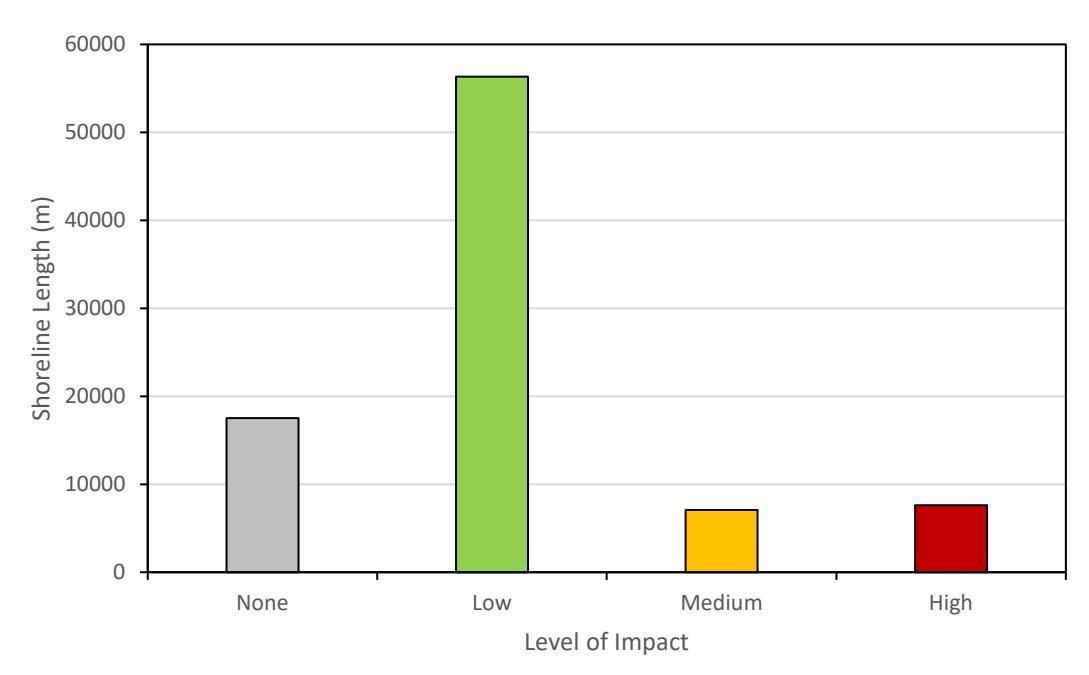
Figure 11: Level of Impact (None, Low, Medium or High) observed along the shoreline of Slocan Lake.

The highest level of impact (≥90% disturbed) was observed in segments modified by historic log yard and sawmill operations (Segments 2 and 15), a beach park with retaining walls, docks and a boat launch (Segment 1) and modifications associated with single-family residential development including retaining walls, groynes, docks and riparian clearing (Segments 10 and 21). Shoreline segments with medium level of impact were mostly rural properties with a few shoreline modifications such as docks (e.g., Segment 7 and 26.4) or boat house on land (e.g., Segment 28). A low level of impact was observed in natural areas that had one or a few shoreline modifications such a dock or riparian clearing near beaches (e.g., Segments 8 and 9), or in Valhalla Provincial Park where minor modifications were observed at campsites and trailheads (e.g., Segments 26.1 and 26.5). No impacts were observed along steep natural areas along the northwestern shoreline (Segments 22 and 24) and in sections of Valhalla Provincial Park (Segments 25, 26.3, 27.1 and 27.3).

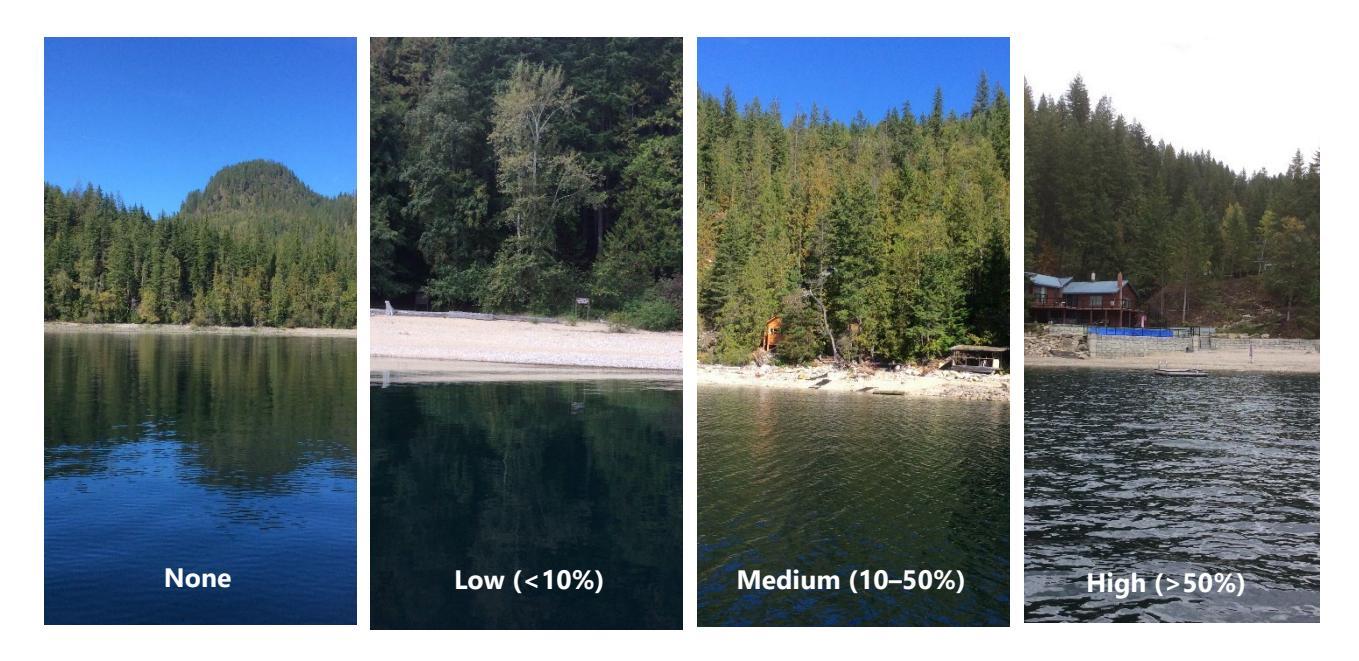
Figure 12: Examples of the different levels of impact assessed along the shoreline of Slocan Lake.

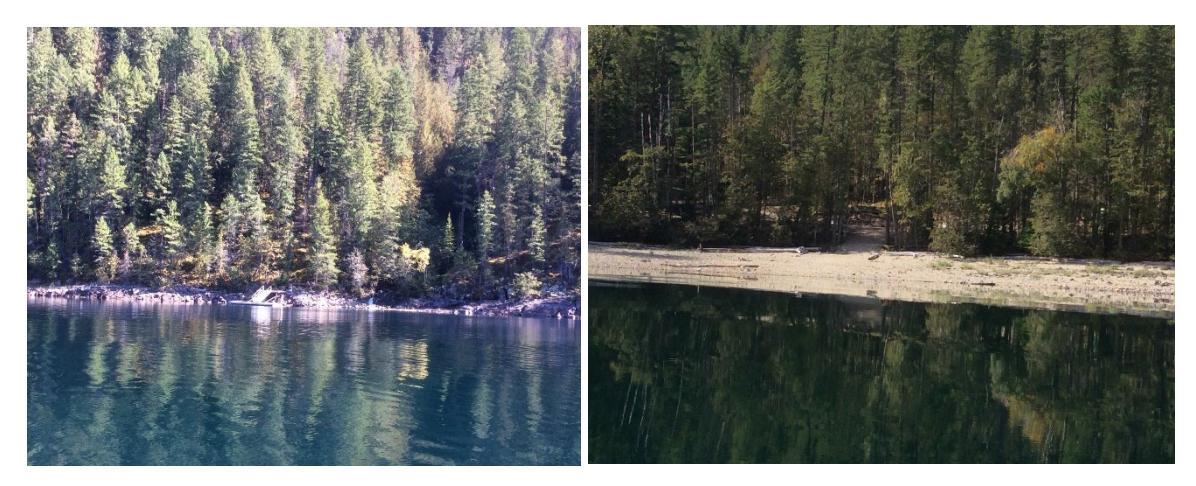
- Southeast side of the lake (Segment 6) a new permanent dock was observed along an undeveloped shoreline (Figure 14). However, no riparian impacts were observed. The disturbance level increased by 1%, the minimum amount possible (from 0% to 1%), resulting in approximately 58 m of modified shoreline. This suggests the amount of disturbance in Segment 6 increased by approximately 5 m (0.1% of the segment) per year. And,
- Northwest side of the lake at Wragge Beach Forest Recreation Site (Segment 24) a new gravel boat launch/lake access path was observed at the rustic camping area (Figure 14). The disturbance level increased by 1% (from 0% to 1%) resulting in approximately 22 m of modified shoreline. This suggests the amount of disturbance at Segment 24 increase by approximately 2 m (0.1% of the segment) per year.

Figure 14: Dock observed in Segment 6 (left) and gravel boat launch/lake access observed in Segment 24 (right) in 2021 that were not present in 2010.

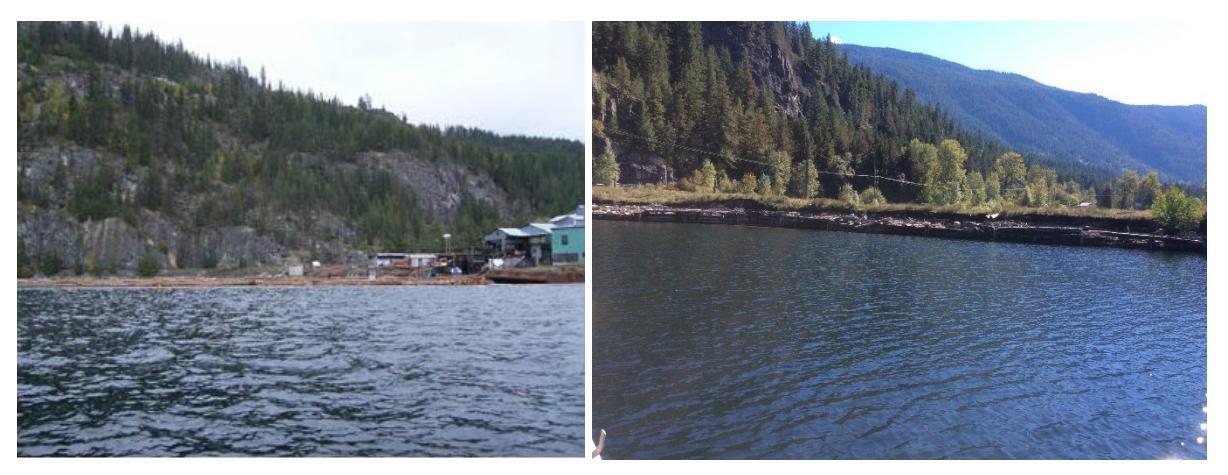
- Former Springer Creek Forest Products site in Slocan (Segment 2) All mill-related infrastructure has been removed from the property as well as from the lake itself. Retaining walls, cribbing and old access road remnants remain along the entire shoreline, therefore the segment remained 100% disturbed (Figure 15).
- A residence in Rosebery (Segment 16) A dock, mooring buoy, pole with solar panel and concrete ballast observed in a photo taken during the 2010 FIM were no longer present at the same residence during the 2021 re-FIM survey (Figure 16).

Figure 15: Photo of the former mill site in Segment 2 in 2010 (left) and the same property in 2021 (right).

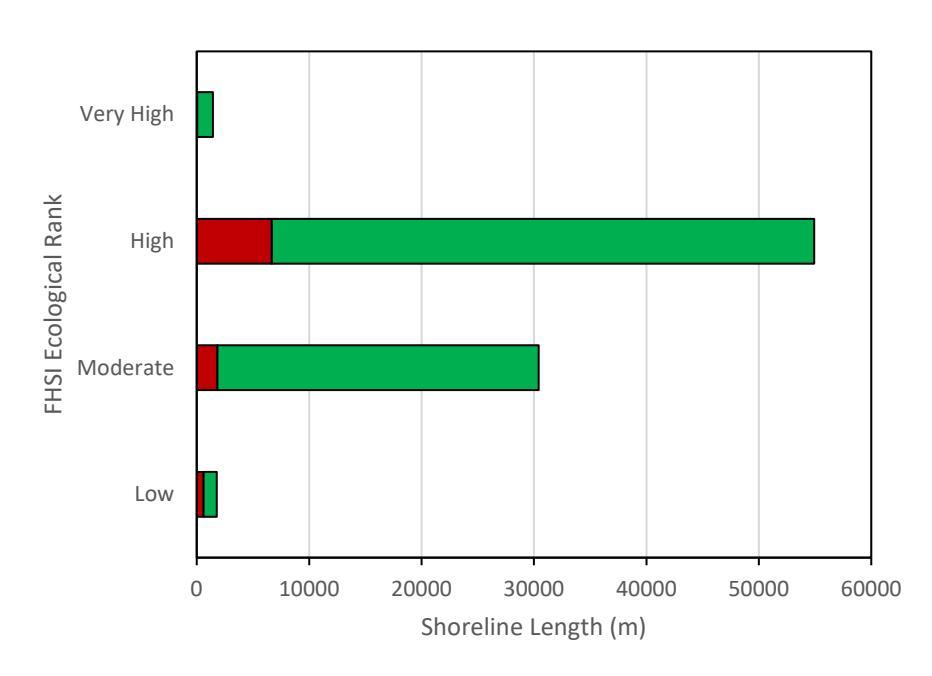
Figure 19: FHSI Ecological Rankings and length of natural (green) versus disturbed (red) shoreline for Slocan Lake.

All Very High ecological value segments had gravel or wetland shore types present while High ecological value segments had rocky shore, gravel or stream mouth shore types (Table 5). Moderate ecological value segments had a variety of shore types while Low value segments had cliff/bluff or rocky shore types (Table 5). Land uses observed in segments with Very High ecological value included natural areas and park while land uses were variable in segments with High and Moderate ecological value (Table 6). Natural area and single family residential land uses were observed in segments with Low ecological value (Table 6).

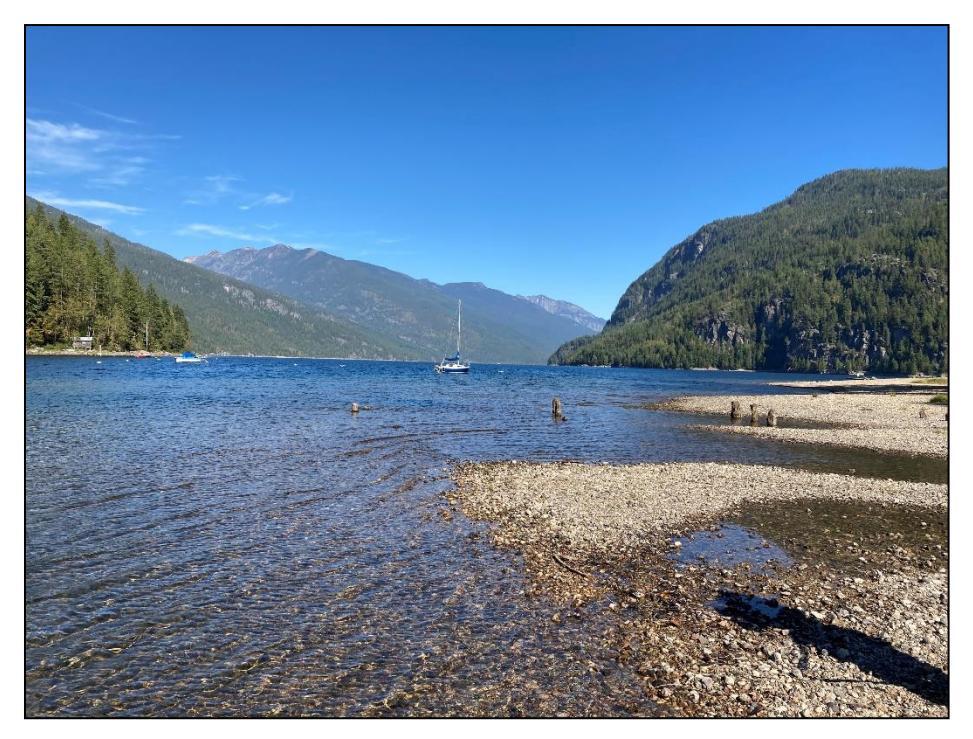
Photo A1: Facing north at the Slocan Lake outlet (Segment 1) sample site where Shorthead Sculpin (n=2) were observed, 25-Sep-21.

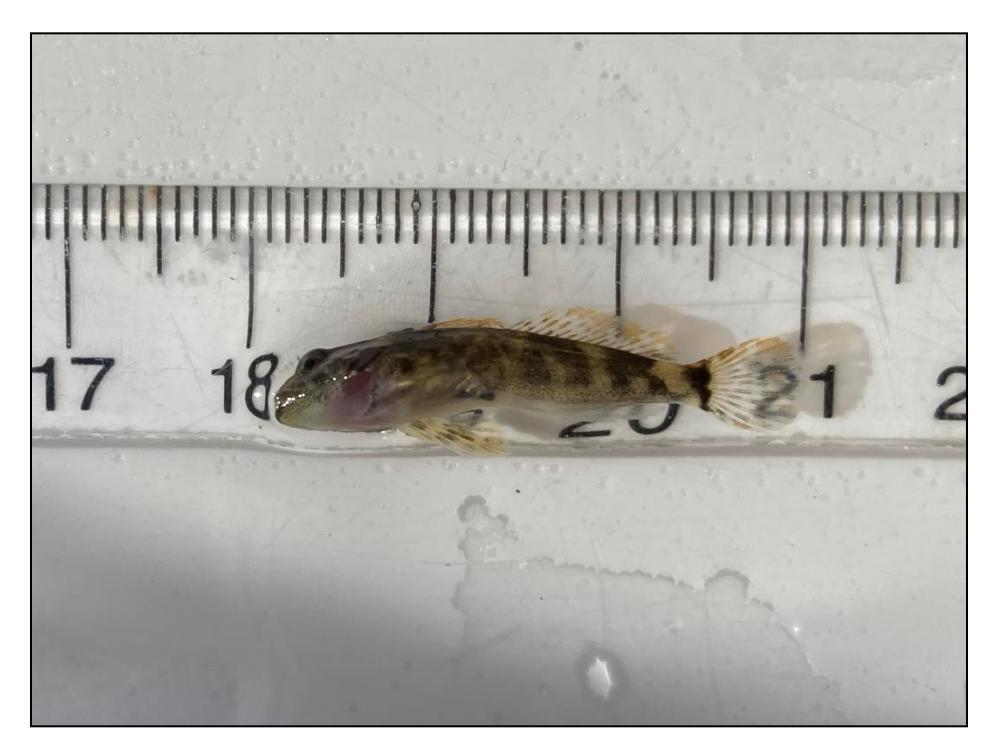
Photo A2: Shorthead Sculpin captured at the Slocan Lake outlet (Segment 1) sample site, 25-Sep-21.
